# The effect of vegetation on the bank erosion pattern and the lateral migration rate of the Groenlose Slinge, the Netherlands

## MSc Thesis Physical Geography

S.H.A.M. De Keijzer (3221598)  
Supervisor: Dr. M.G. Kleinhans  
Second corrector: F. Schuurman  
27 January 2012

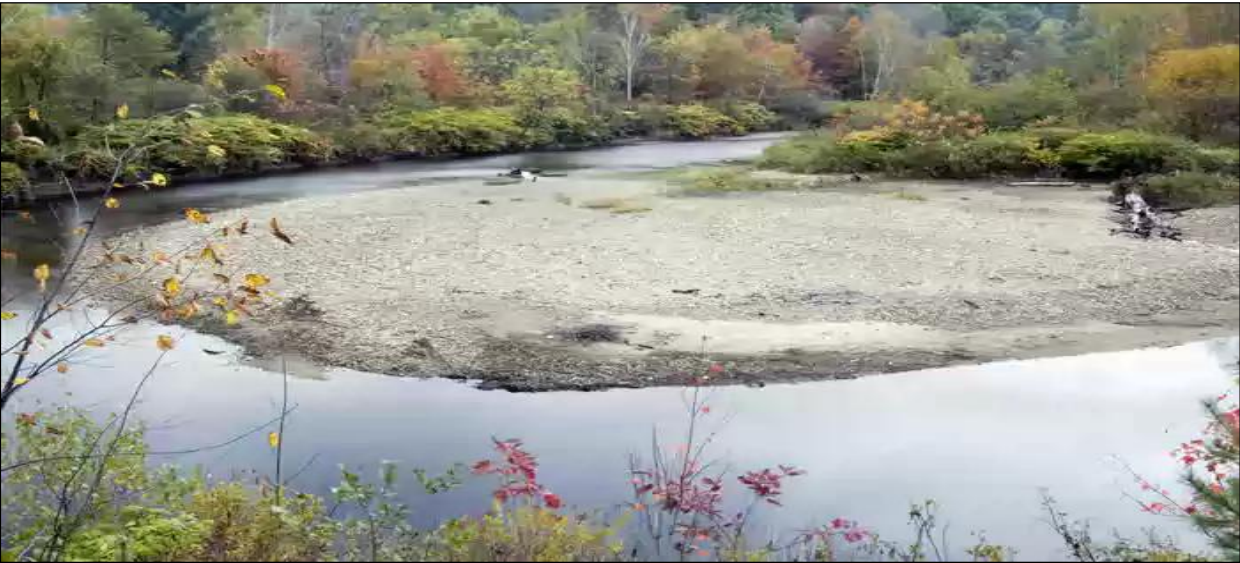
**Figure 3: Point bar in the inner bend of a meandering stream (Moorhead, 2011).**

*Figure 2* gives a schematic view of a meandering river. Notice that this figure represents the morphology of a river and not of a stream. The difference between a river and stream is that a stream is shallower, narrower and has smaller stream velocities, but no exact values to distinguish between them exist. The morphology of a stream and a river are globally the same, but the morphology of a stream is less obvious than the morphology of a river. This is because of the smaller dimensions and smaller stream velocities in case of streams. A point bar, which is noted in *Table 1* and in *Figure 2*, is a bedform that consists of scroll bars (De Kramer et al., 2000). *Figure 3* also represents a scroll bar. Scroll bars are crescent-forming bars that are mostly located at the inner bend of the channel, more or less parallel to the stream. They form at peak discharge as a compensation for the released space due to bank erosion. Scroll bars often form a pattern of ridges in the inner bend (Kleinhans and Van den Berg, 2010 and De Kramer et al., 2000). This pattern is the typical ridge and swale topography which is the result of lateral accretion. *Figure 4* shows the typical ridge and swale topography consisting of scroll bars.

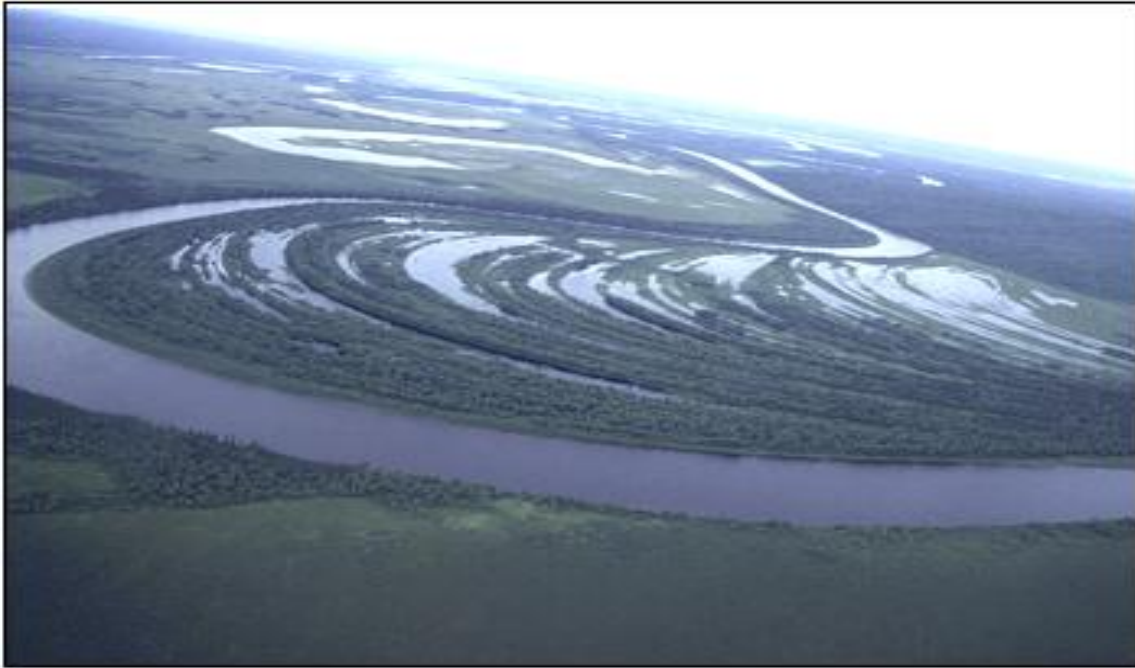
**Figure 4: Typical ridge and swale topography consisting of scroll bars, meandering river in Alaska (U.S. Fish & Wildlife Service Digital Library System, 2011).**

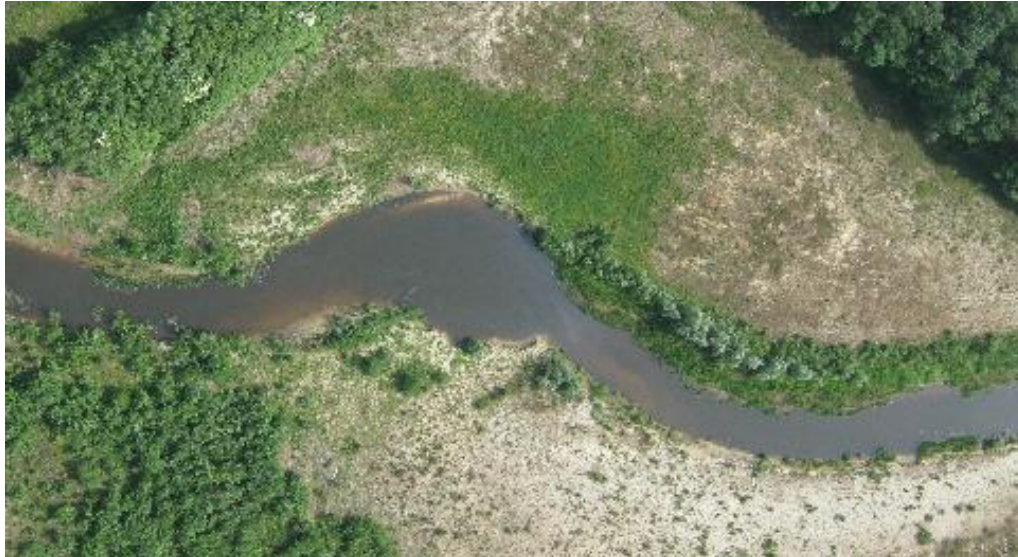
**Figure 7: Sharp bend in the Groenlose Slinge. In this picture the flow direction is from right (south) to left (north) (Photo taken by Henk Markies, May 2011).**

In sharp bends the flow pattern as well as the erosion and deposition pattern is different than in gentle bends. In nature, sharp bends are associated with channels with strong banks and limited to no dynamical meandering (Ferguson, 1987). Natural sharp bends can be found in rivers of all dimensions. Because only in case of strong banks, sharp bends can exist, the existence of sharp bends depends on the bank strength (Friedkin, 1945 and Ferguson, 1987.) There is no dependence of Froude number as found by Leeder and Bridges in 1975 (Blanckaert et al., 2010). An example of a sharp bend can be seen in *Figure 7*. Notice that this bend is constructed by human and is not existed by nature. *Section 2.4.1.* is about when a bend can be classified as a sharp bend and *Section 2.4.2.* is about the stream pattern in sharp bends and about the erosion and deposition pattern in sharp bends.

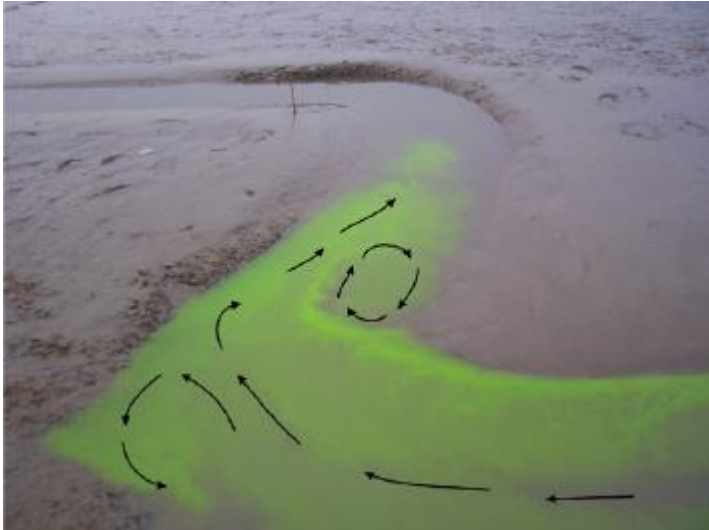
**Figure 8: Flow separation in sharp bends: there are slow flowing vortices upstream of the outer bend apex and downstream of the inner bend apex (Kleinhans et al., 2009).**

In sharp channel bends the flow separates from the bank which leads to a bank erosion and deposition pattern that differs from gentler meander bends (Bridges and Leeder, 1976; Leeder and Bridges, 1975; Andrie, 1994; Hodskinson and Ferguson, 1998 and Ferguson et al., 2003). In case of flow separation, the main flow separates from the inner-bend channel boundary and directly impinges on the outer bank at a high angle just downstream of the apex (Leeder and Bridges, 1975 and Ferguson et al, 2003) (*Figure 8*). Upwelling and erosion occurs at that location, which focuses the water to flow to both left (*Figure 8*) (upstream) and right (*Figure 8*) (downstream) of the stagnation point. The flow to the left results in the slow flowing outer-bank vortex where deposition takes place. The flow to the right of the stagnation point has still a high velocity and stays at the outer bank. Because of this stream pattern in the outer bend, just downstream of the apex at the inner bank, a so called 'dead flow zone' (an extreme slow flow zone) occurs with a recirculation cell. This is the second horizontal vortex (Kleinhans et al., 2009) in which deposition takes place. These complicated three-dimensional vortices upstream of the outer bend and downstream of the inner bend are also called recirculation cells or recirculation eddies. As a result of this deposition and erosion pattern the bend sharpens and may develop a peculiar angular shape (Kleinhans, 2009) (*Figure 9*).

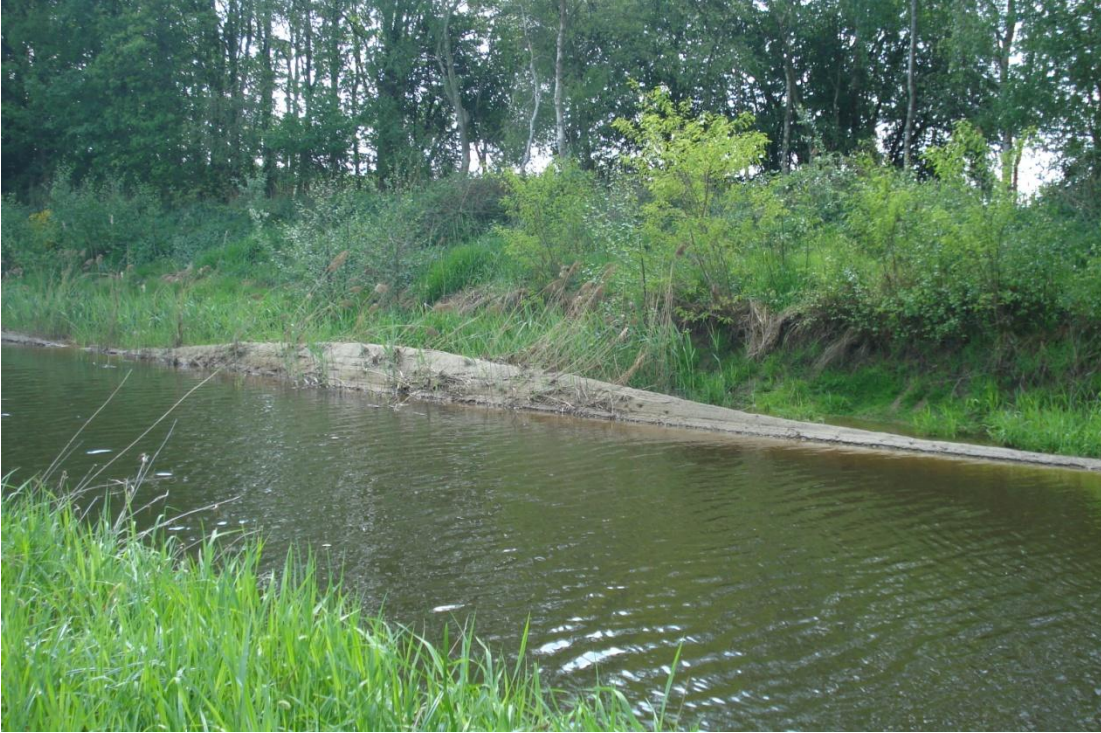
**Figure 15: Scroll bar in the Groenlose Slinge, 2011.**

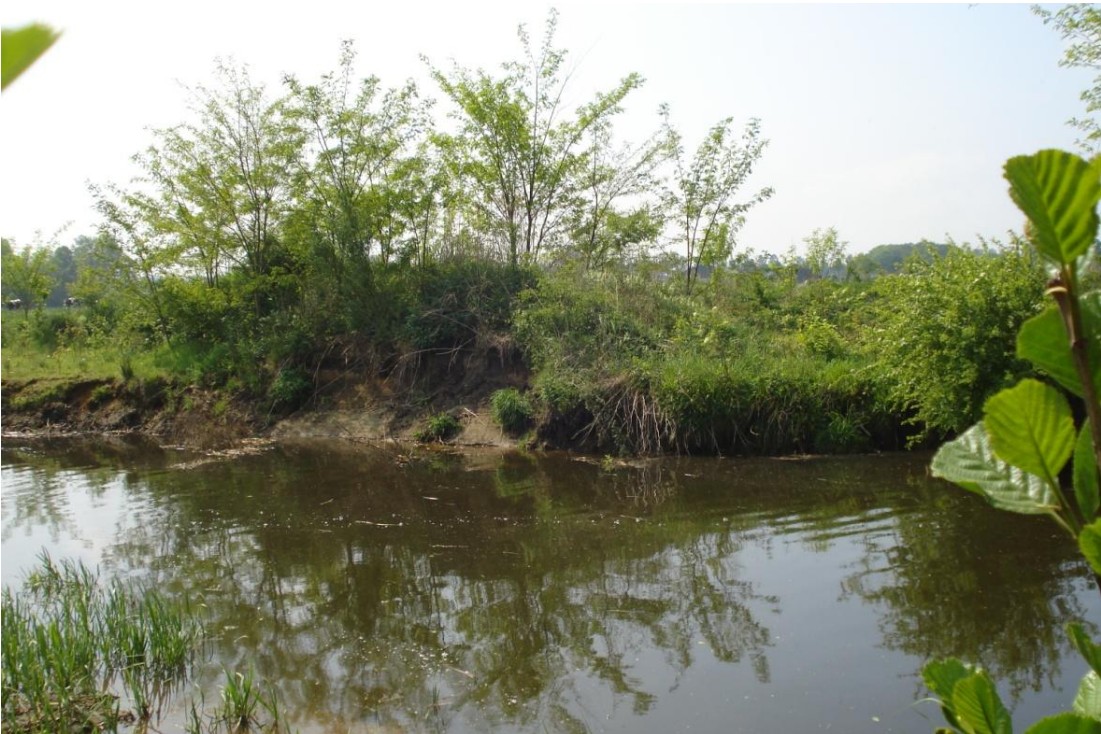
**Figure 16: Bank collapse in outer bend of Groenlose Slinge, 2011.**

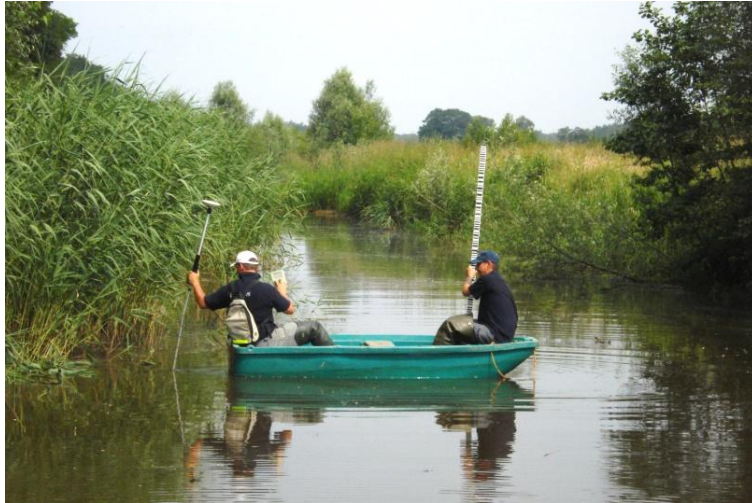
**Figure 18: Measuring of profiles by RPS using a DGPS, a measuring rod and a boat (June, 2011).**

In the fieldwork area twenty cross sections were measured in November 2008, September 2009, April 2010 and June 2011. In *Figure 17* the locations of the cross sections are shown. The length that the crow flies between cross section 1 and cross section 20 is 1530 metres. Between profile 10 and profile 11 the Zeggelinks-Hagbrug is located. In the field, the locations of these cross sections are marked with blue poles, although at some locations the poles have disappeared. In 2011 the twenty profiles were measured by geodetic instance RPS (*Figure 18*), using a surveying agency called a DGPS. In 2008, 2009 and 2010 at the same locations cross sections were measured by Waterschap Rijn en IJssel. In 2008 also three physical geography master students assisted measuring. Also the construction profiles of 2007 are known. The maximal allowed deviation for all measurements is five centimetres in the z-direction and the maximal deviation in the x and y direction is then automatically 3.3 centimetres (a factor of 1.5 smaller). In all years at least all striking nod points were measured. However, the average distance between the measurement points decreases: in 2008 the average distance was equal to 1.4 m and in 2011 the average distance was equal to 1.0 m. This means that the accuracy of the profiles has increased.

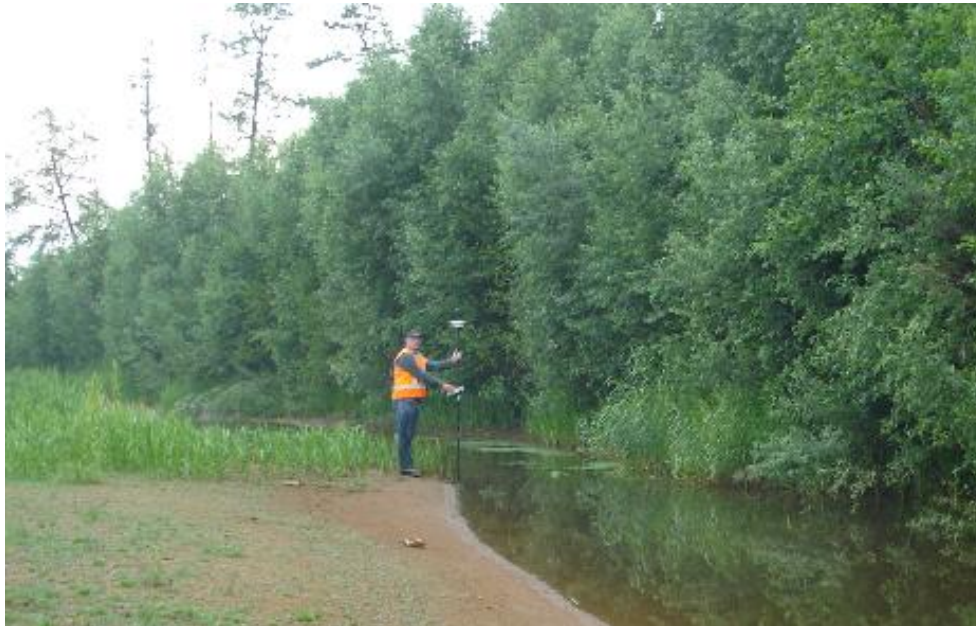
**Figure 20: Measuring the waterline points by a DGPS. Notice that it is not easy to measure the waterline at the other side of the stream because of the dense vegetation.**

Another way to study the migration of the Groenlose Slinge is determining the waterline. Like the bank lines the waterlines are also obtained by connecting points. The waterline represents simply the start of the water. In June 2011 the waterlines were determined by De Winter and De Keijzer at a maximal interval of 20 metres using a DGPS (*Figure 20*). The measuring took place in a period of four days. During this period the water level was low, varying between 15.18 m +NAP and 15.27 m +NAP

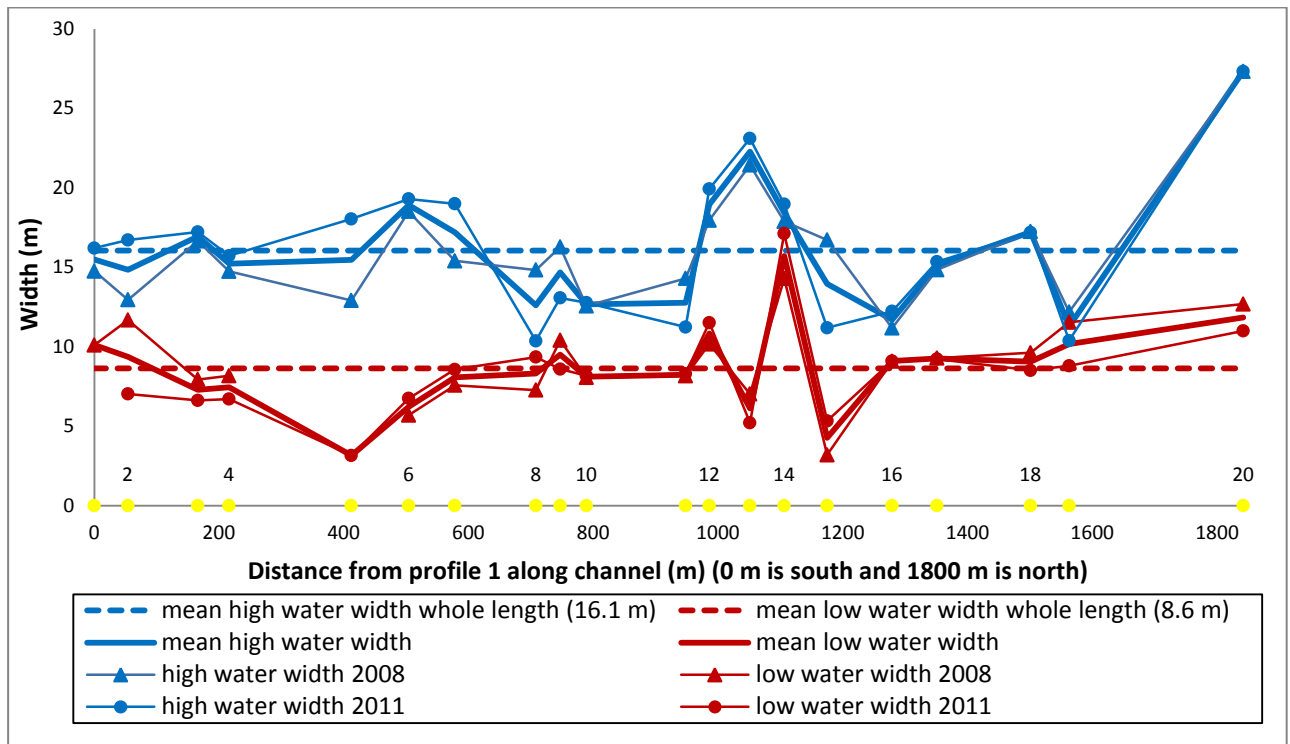
**Figure 24: High water width and low water width at each profile of the Groenlose Slinge, 2008 and 2011. At 14 a sharp bend is located. (See Figure 17 in Section 7.1. for overall locations of profiles.)**

profile 14 are different from the other profiles. More results of profile 14 can be found in *Section 10.4* and *Section 11.1.*

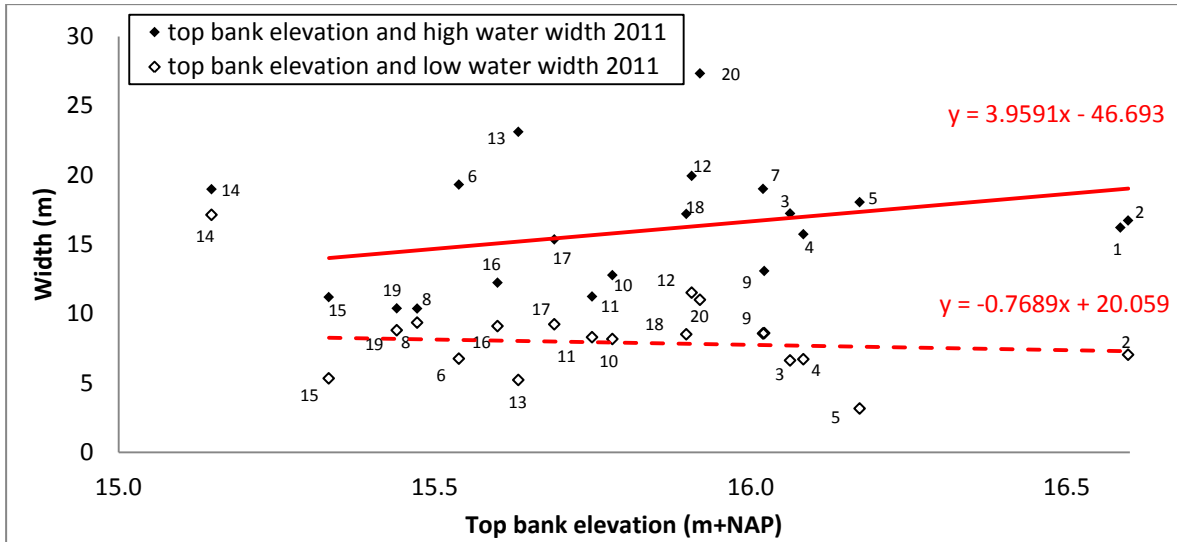
**Figure 28:** Relation between low and high water width and mean top bank elevation, 2011. Both relations are not significant at a 5%-error level. At 14 a sharp bend is located. (See Figure 16 in Section 7.1. for a global view of the profiles.)

In each scatter plot a trend line is fitted. Because of the different characteristics of profile 14, profile 14 was not included when fitting this trend line. Also the equations of the trend lines are given. For each scatter plot it is checked whether the relations are significance at a 5%-error level. When the relation is significance, the trend line is green coloured and when the relation is not significant, the trend line is red coloured. It can be seen that from these relations only the relation between the mean bank elevation and the high water width 2011 and the relation between the lowest point elevation and the high water width 2008 are significant at a 5%-error level. Although most relations are not significant at a 5%-error level, all fitted trend lines show that an increase in elevation correlates to an increase in high water width and to a decrease in low water width.

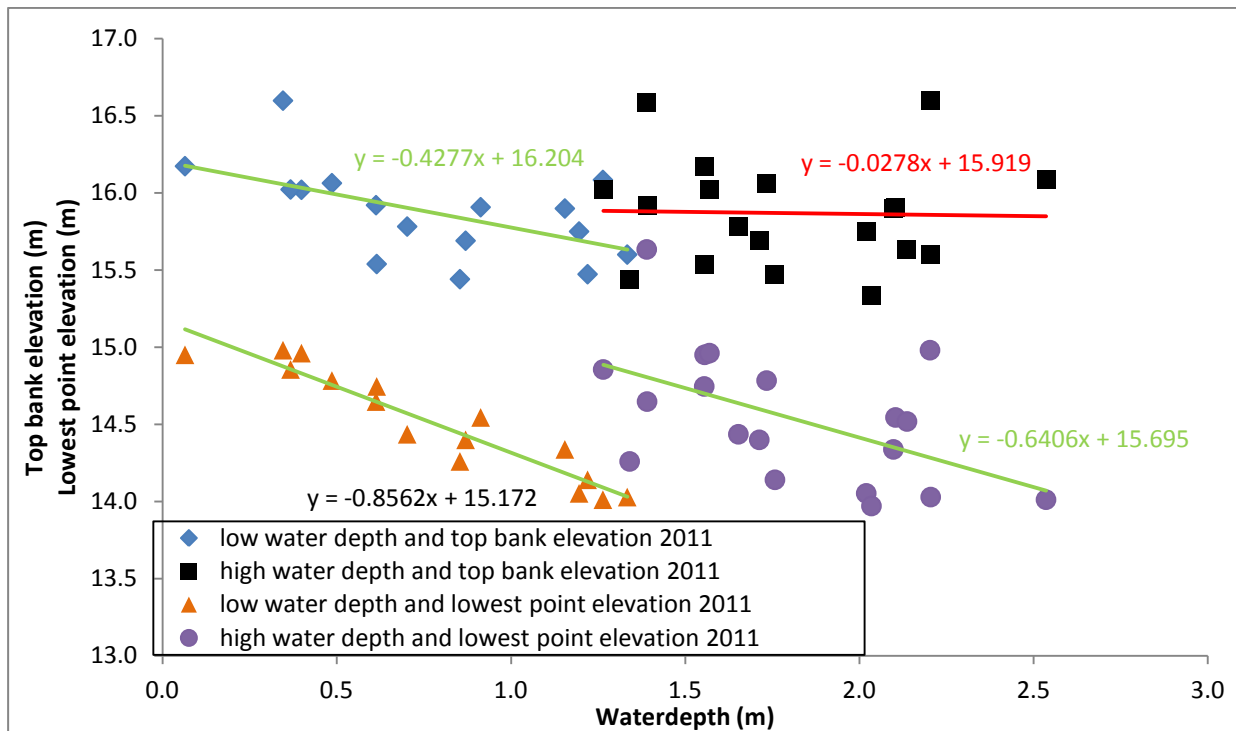
**Figure 36: Relation between elevation and water depth. A larger water low- and high depth correlates to lower elevations. A green coloured trend line indicates a significant relation at a 5%-error level and a red coloured trend line indicates a non-significant relation at a 5%-error level.**

Concerning *Figure 36* it can be concluded that a lower (high and low) water depth correlates to a larger mean top elevation and to a larger deepest point elevation. Thus, a larger water depth correlates to a lower mean top bank elevation and to a lower deepest point elevation. All four relations in *Figure 36*, except the relation between high water depth and top bank elevation, are significant at a 5%-error level.

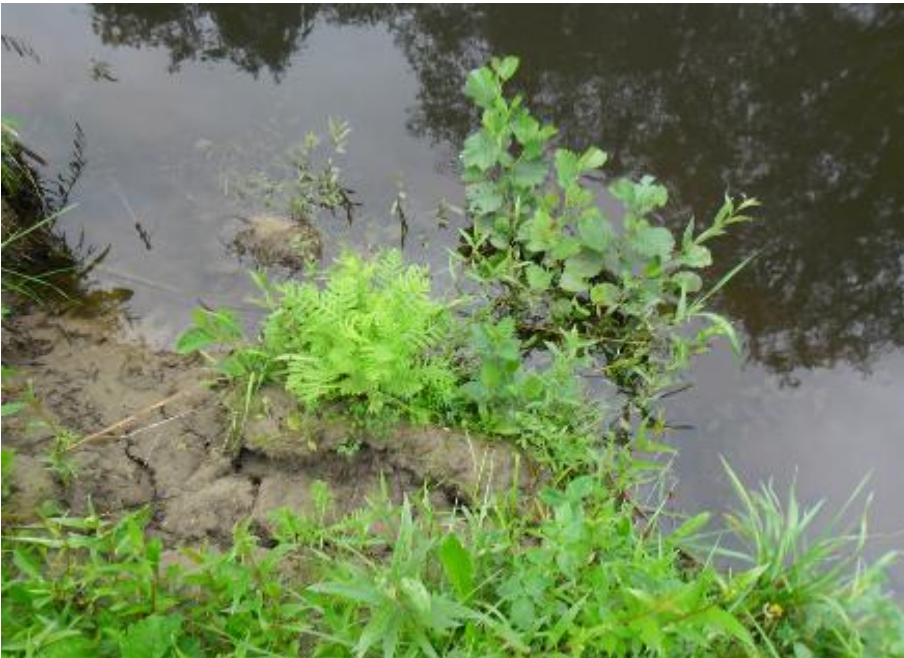
**Figure 53: Active erosion at the east bank of profile 8, slides and tension cracks are visible.**

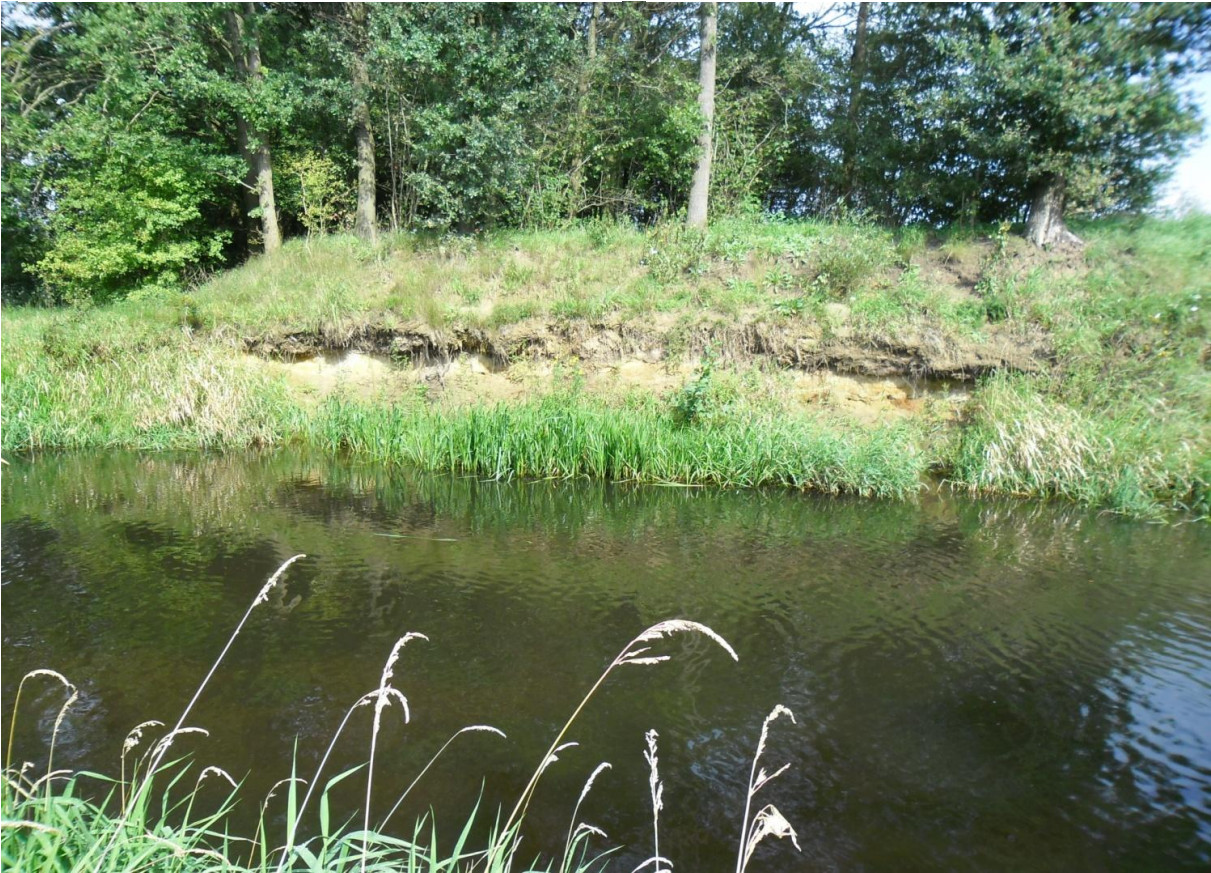
**Figure 58: Erosion to the north of profile 11, east bank.**

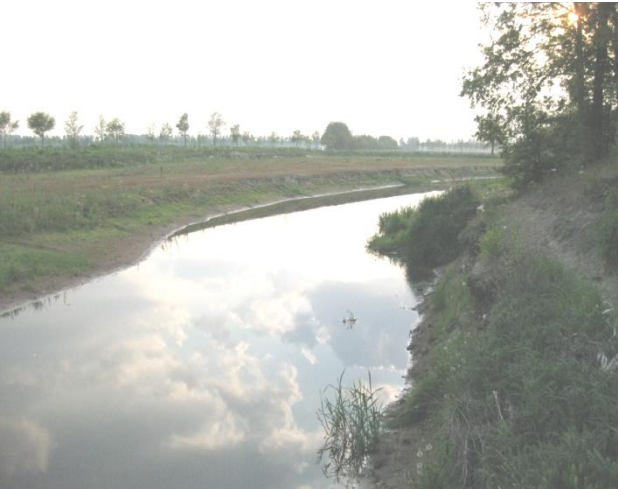
Figure 60: Profile 12 (May 2009).

At the west bank of profile 12 deposition is visible at the upper part of the bank and a little bit erosion is visible at the lower part of the bank (*Figure 60* and *Figure 61*). In the cross sections of profile 12 (*Figure 59*) it can also be seen that at the upper part of the west bank deposition took place and at the lower part of the west bank erosion took place. In *Figure 62* the deposition at the west bank is clearly visible. Also significant overbank deposition is found. The deposited sand is grown by herbs called *Conyza canadensis* (Canadian Horseweed), a pioneering species. Directly at the waterline *Salix alba* (white willow) and *Alnus* (alder) are growing. In the deposited overbank sand

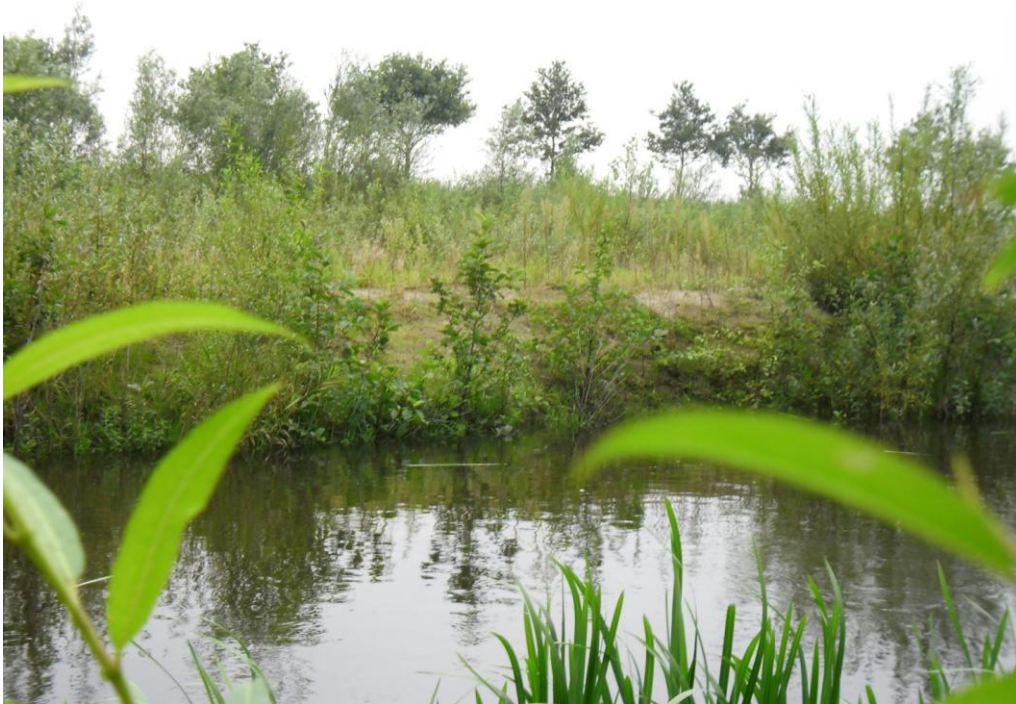
**Figure 62: Deposition at the west bank of profile 12, covered by *Conyza Canadensis* (Canadian horseweed). Some small trees are present at the waterline.**

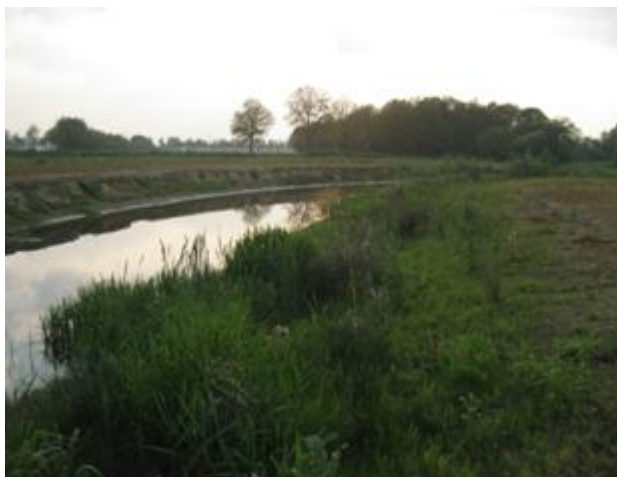
**Figure 65: Profile 13 (May 2009).**

At profile 13 still the same situation as at profile 12 exists (*Figure 65* and *Figure 66*), but more erosion and less deposition is visible. This observation is reflected in the cross sections of *Figure 64* because now over the whole west part of the profile net erosion is visible instead of only at the lower part like in case of profile 12. On the east bank a scroll bar was formed between 2008 and 2011.

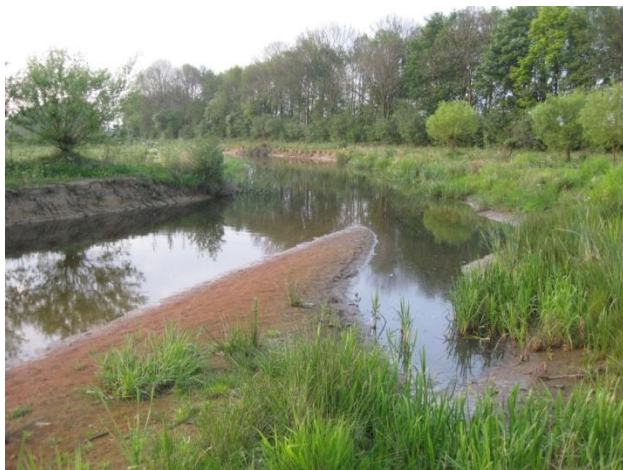
**Figure 76: Few metres north of profile 16 (May 2011), scroll bar.**

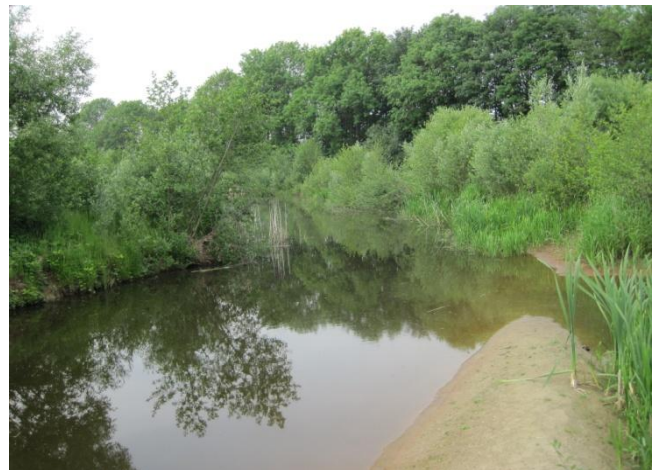
**Figure 77: Few metres north of profile 16 (May 2009), scroll bar.**

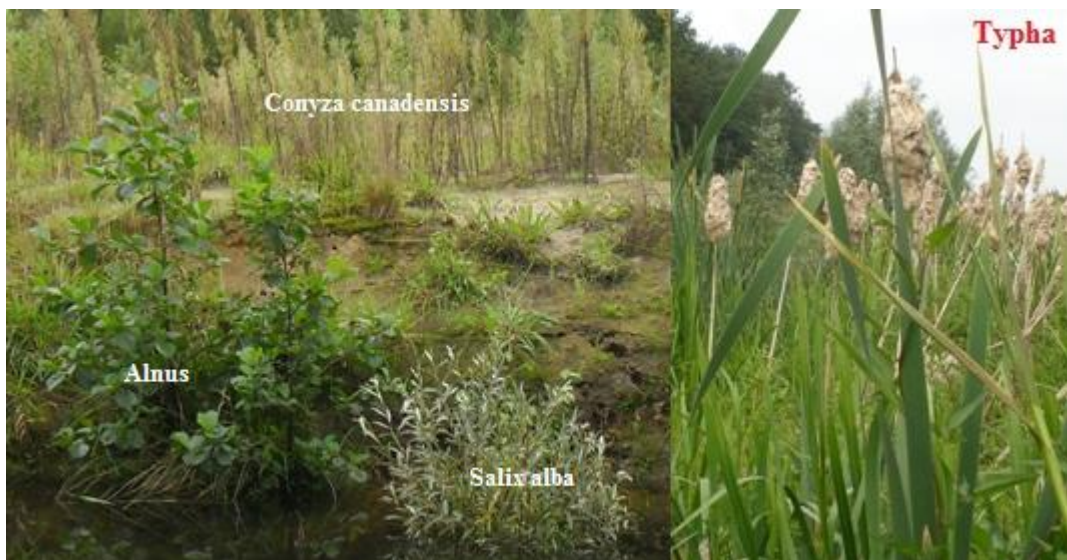
**Figure 85: Common vegetation species in and around the Groenlose Slinge.**

In *Appendix 10* a list of plant species found in the Groenlose Slinge is shown. In this list the vegetation names are in Latin, English and Dutch. In the field several vegetation species were present. Concerning trees, mainly young *Salix alba* (white willow), young *Alnus glutinosa* (black alder) and young *Alnus incana* (grey alder) were found. Also young *Betula Pubescens* (downy birch) and *Salix aurita* (eared willow) were present. The length of the young trees that were found can vary from a few centimetres to about four metres. Also young herbs were found, especially *Tanacetum vulgare* (tancy), *Urtica dioica* (common nettle) and *Conyza Canadensis* (Canadian horseweed) are common. Other herbs that were also found are: *Equisetum fluviatile* (horsetail), *Caltha palustris* (kingcup), *Sparganium erectum* (branched bur-reed), *Mentha aquatic* (water mint), *Rumex hydrolapthum* (great water dock) and *Jacobaea vulgaris* (ragwort). Concerning the grasses, many types were found, but the most common ones are *Phragmites australis* (common reed), *Typha* (bulrush) and *Glyceria maxima* (reed mannagrass). *Phragmites australis* (common reed) grows only near the waterline, not on top of the bank. At some locations mature forest was present. These forests contain besides the same species as the young trees, the young herbs and the young grasses, also *Quercus* (oak) and other tree-, shrub-, herb- and grass species. In *Figure 85* some of the most common vegetation species are shown.

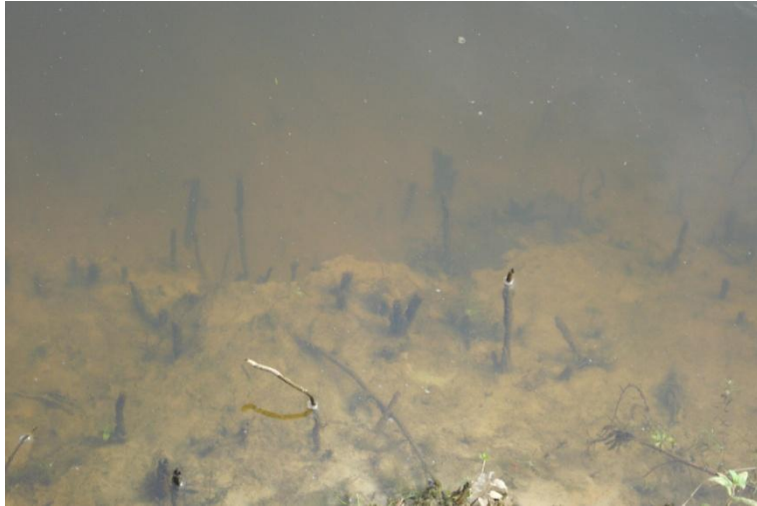
**Figure 86: Old wood stems in the Groenlose Slinge.**

Interesting features found at several locations in shallow water are old, short root stems (*Figure 86*). It is not possible to pull out those root stems because they break immediately. These root stems were also found during the fieldwork of 2008.

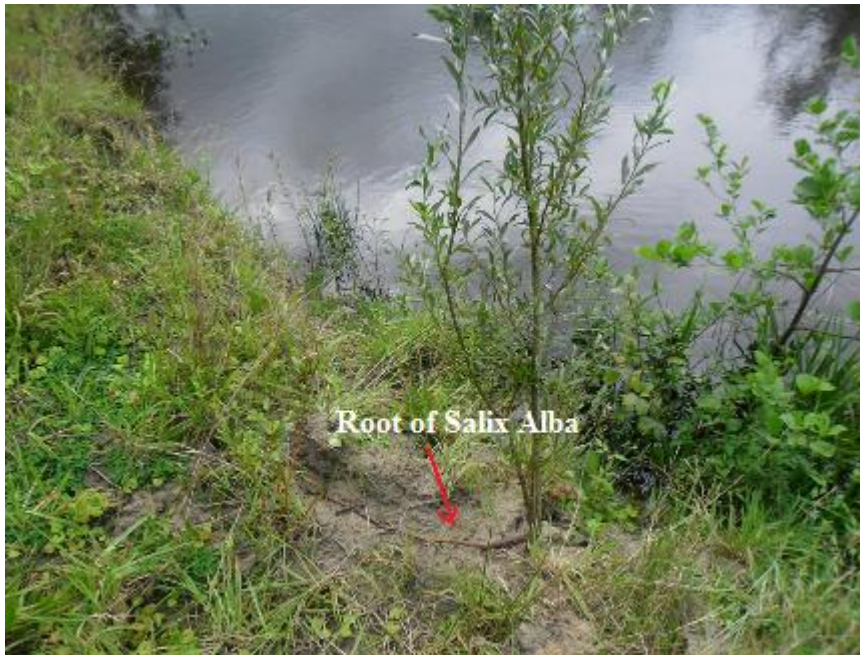
**Figure 91: Long root of *Salix alba* (white willow).**

All young trees were rooted very shallow, about ten centimetres under the surface. Their longest roots have a length of at least four metres. The young trees have about five of these long roots. In *Figure 91* such a long root can be found. These long roots often contain runners of smaller roots. From the about five long roots, often one or two roots are thicker and longer than the other ones (*Figure 92*). When a long root is followed, it can be seen that it crosses other roots of other vegetation and it can be seen that a tangle of roots below the ground surface exists.

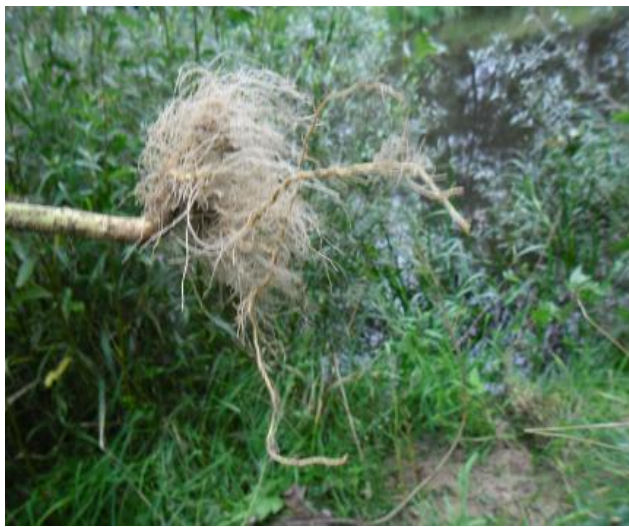
**Figure 94: Grass species with one wreath of many short, thin hair roots.**

The roots of herbs and grasses are shorter, denser and have a smaller diameter than the roots of small trees. The way of rooting of reed is different from most other herb- and grass species. In case of reed, root stems below the surface are present and thus the single reed stems that are above the surface are connected under the ground (*Figure 93*). The root stems can have hairy small roots in wreaths around the root stems. Other grass species contain one wreath of many short, thin hair roots (*Figure 94*).

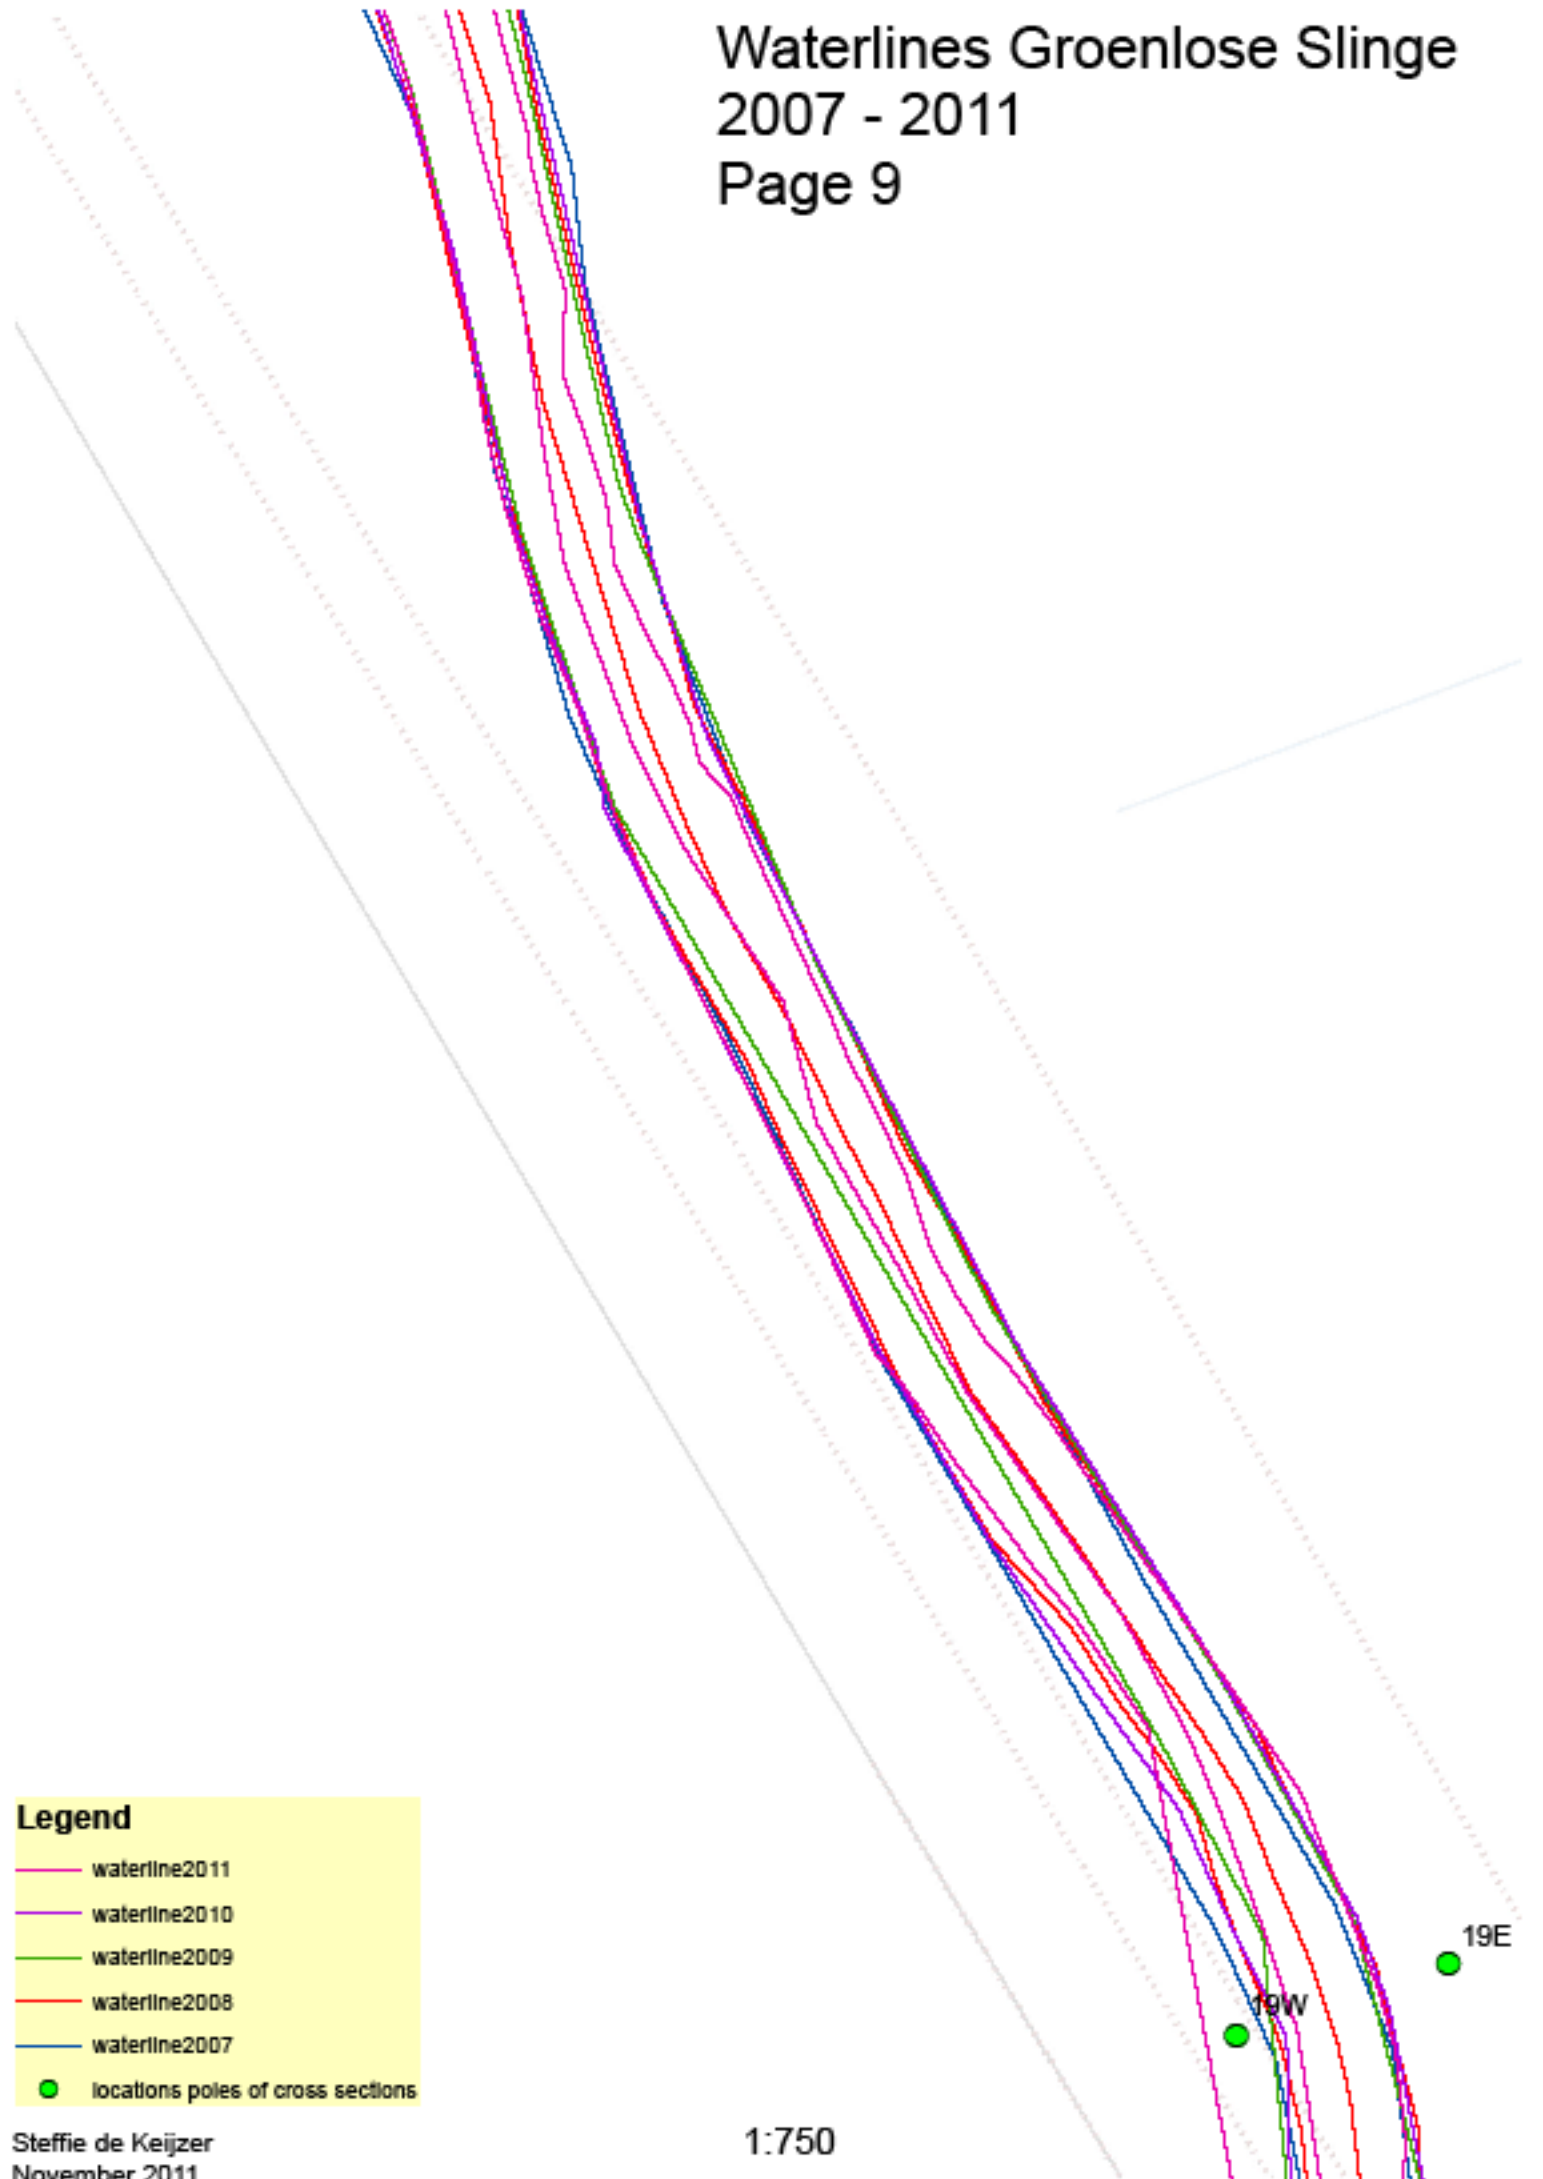
Page 9

# Waterlines Groenlose Slinge 2007 - 2011
