# The effect of vegetation on the bank erosion pattern and the lateral migration rate of the Groenlose Slinge, the Netherlands

## MSc Thesis Physical Geography

S.H.A.M. De Keijzer (3221598)  
Supervisor: Dr. M.G. Kleinhans  
Second corrector: F. Schuurman  
27 January 2012

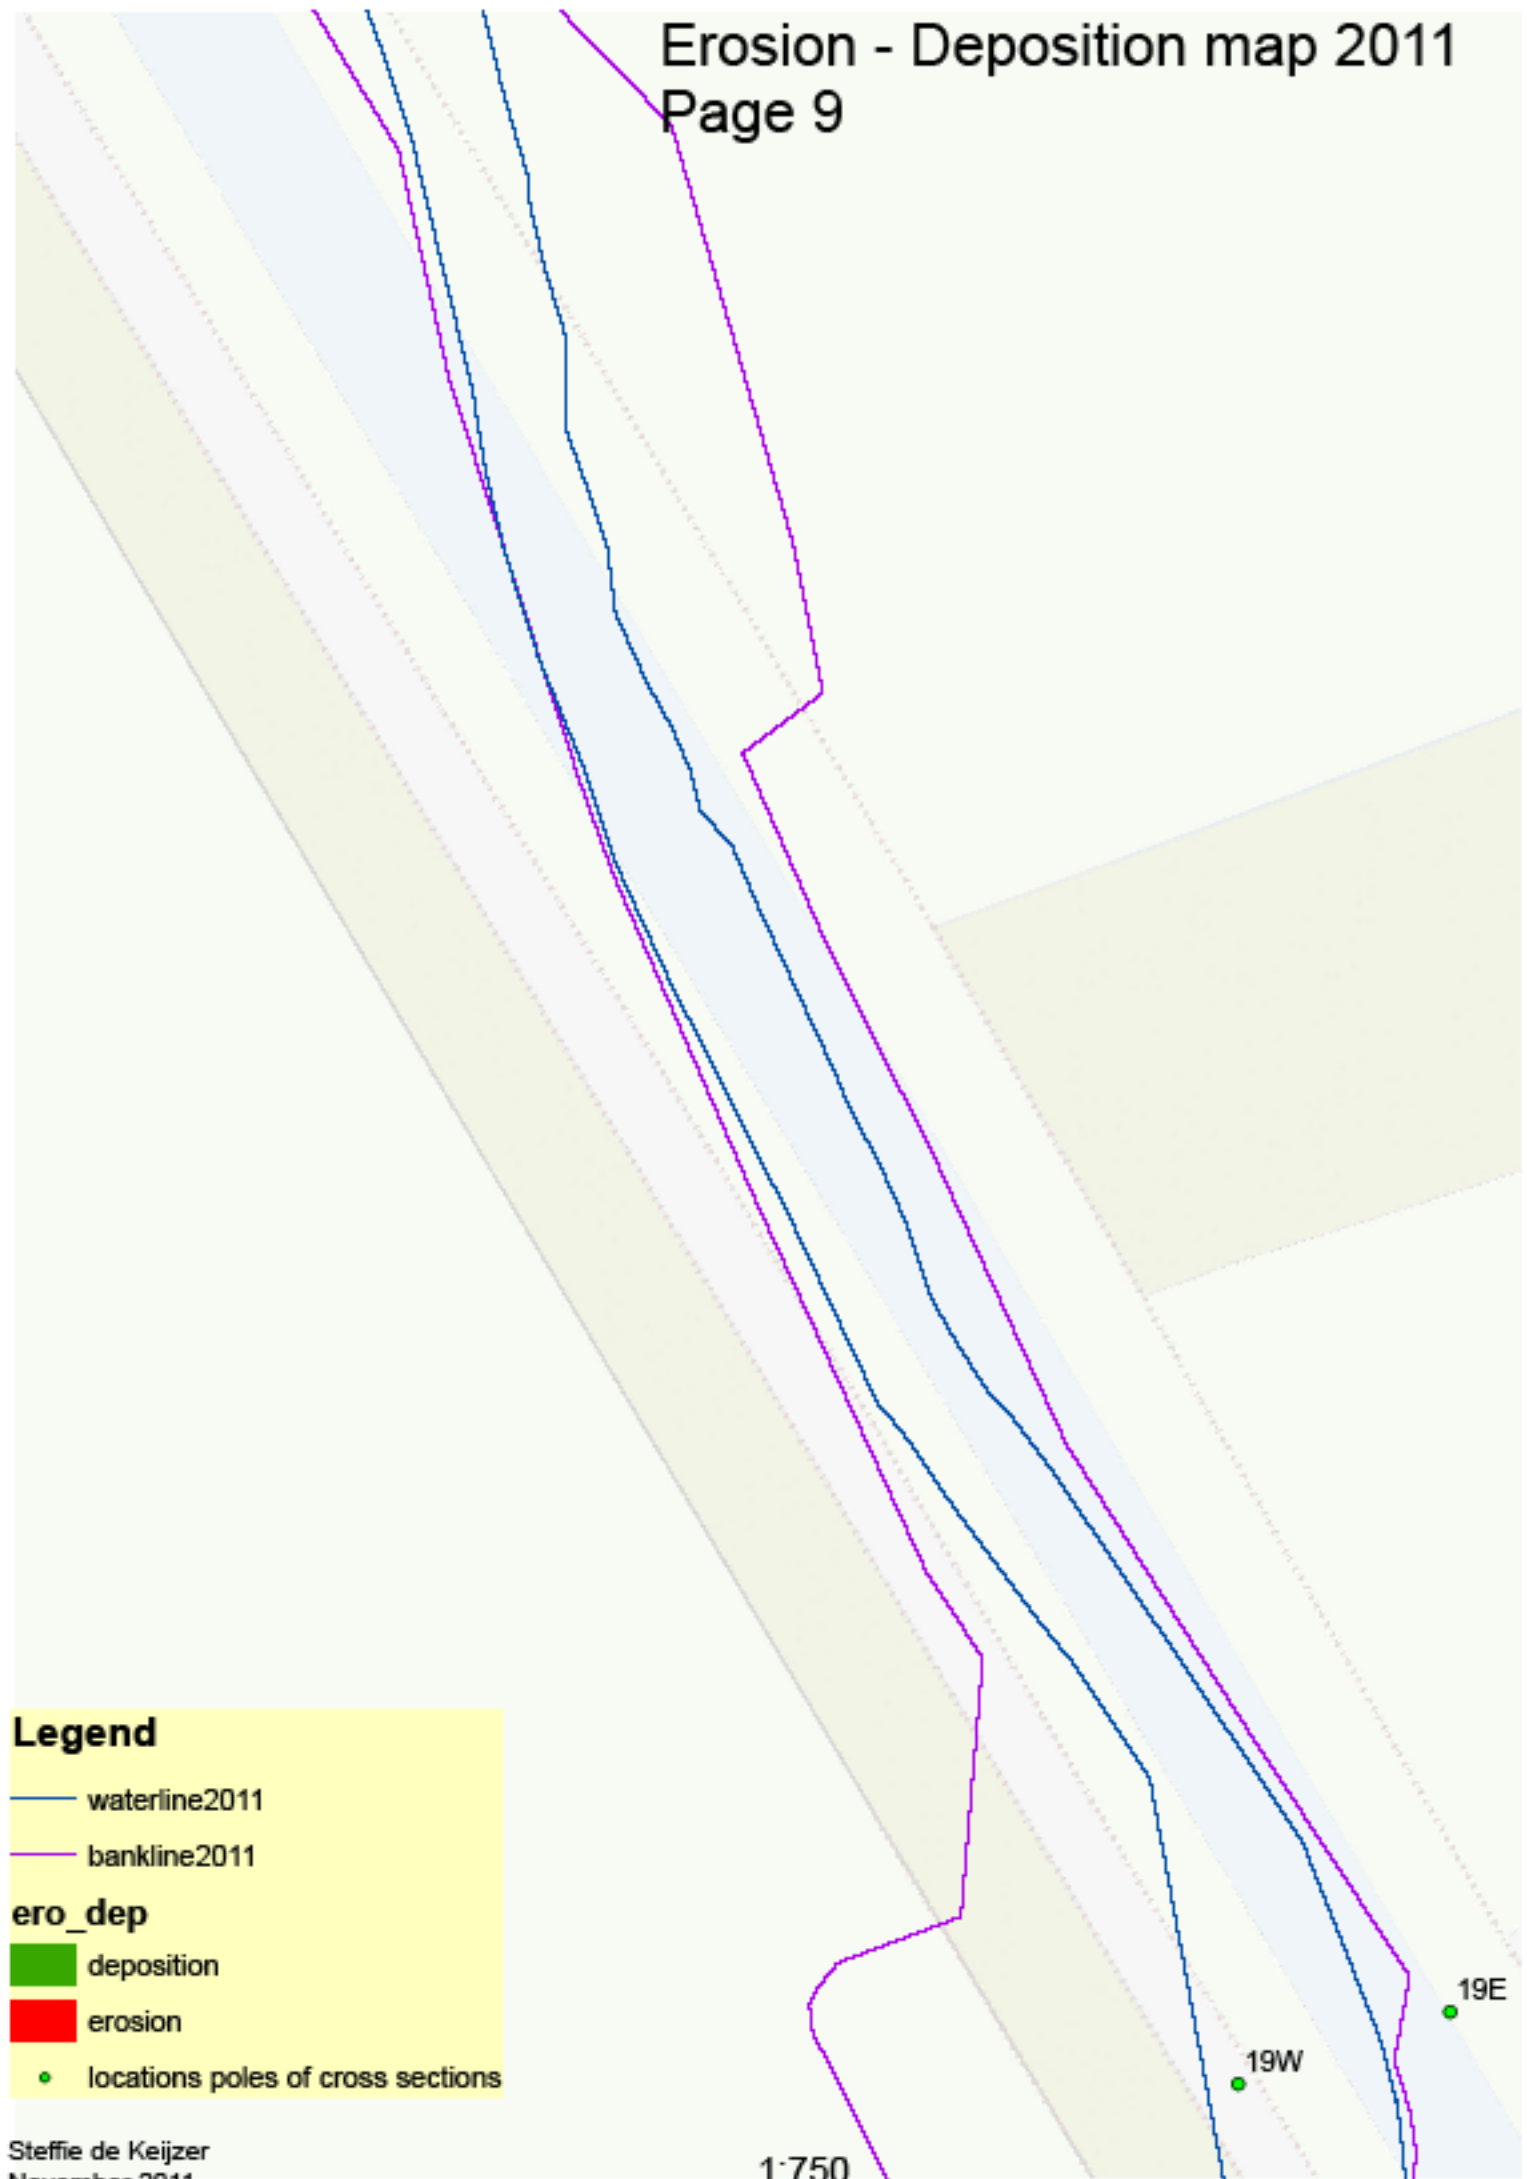
## Page 9

# Erosion - Deposition map 2011
