Master's Thesis
Water Science and Management

Thesis at Ingenieursbureau Gemeente Haarlemmermeer
In corporation with
Utrecht University
Graduate School of Geosciences

Solutions for a resilient urban water system: the case study of Hoofddorp park

Master Thesis

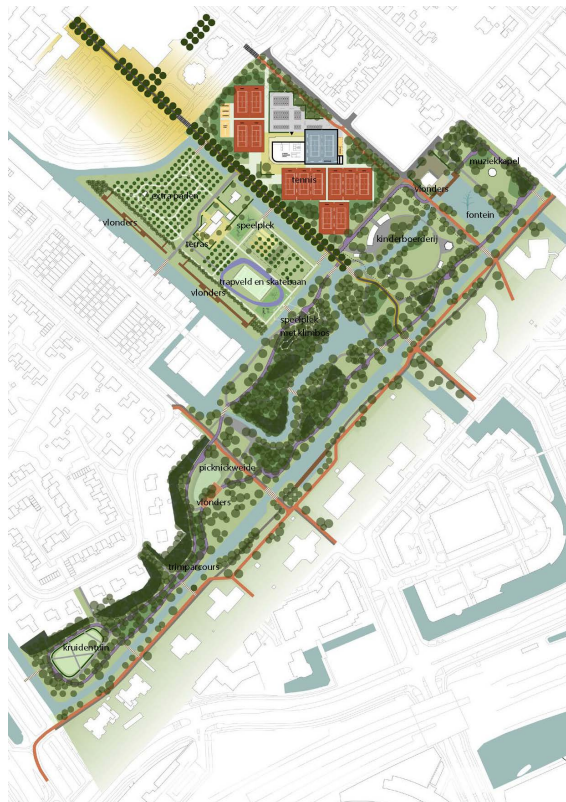
Figure 1.2.: A detailed map of Hoofddorp park (Gemeente Haarlemmermeer, 2016)

The municipality Haarlemmermeer, is increasingly focusing on sustainability ([Gemeente Haarlemmermeer, 2014](#)). They identified Hoofddorp park (see figure 1.2) as a place where they can improve the urban water system along with the developments around the park. Improvement is required for very practical reasons as smelly water and enhancing recreation but also for climate adaptation and sustainability ([Gemeente Haarlemmermeer, 2016](#)).

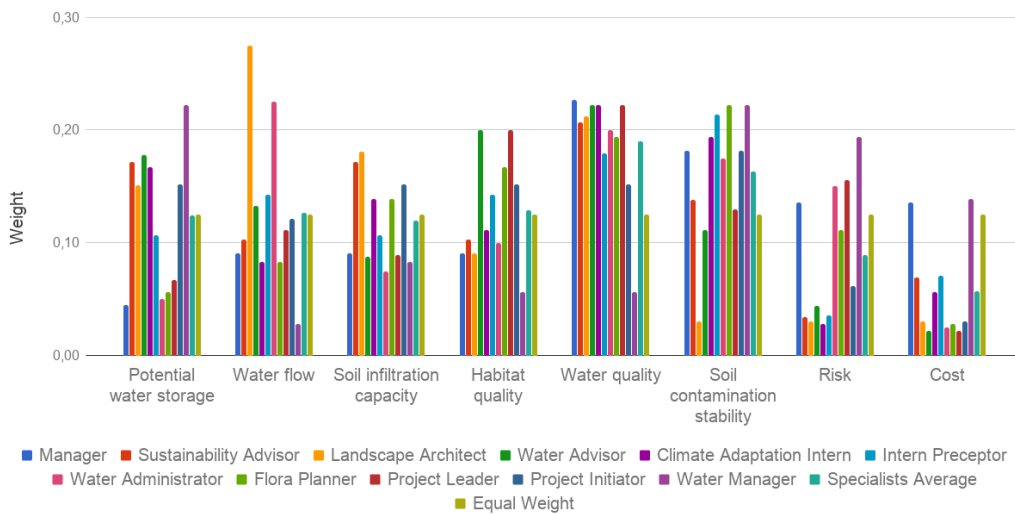
Figure 4.3.: Criteria weights of the SIMOS and equal weights method

The experts did not assign high weights to cost and risk, which might not be congruent with actual decision making on this topic. The water manager and the manager were the only two that assigned higher scores to risk and cost, which represents their function. Remarkably, the project leader and administrator assigned low weights which does not represent their function.

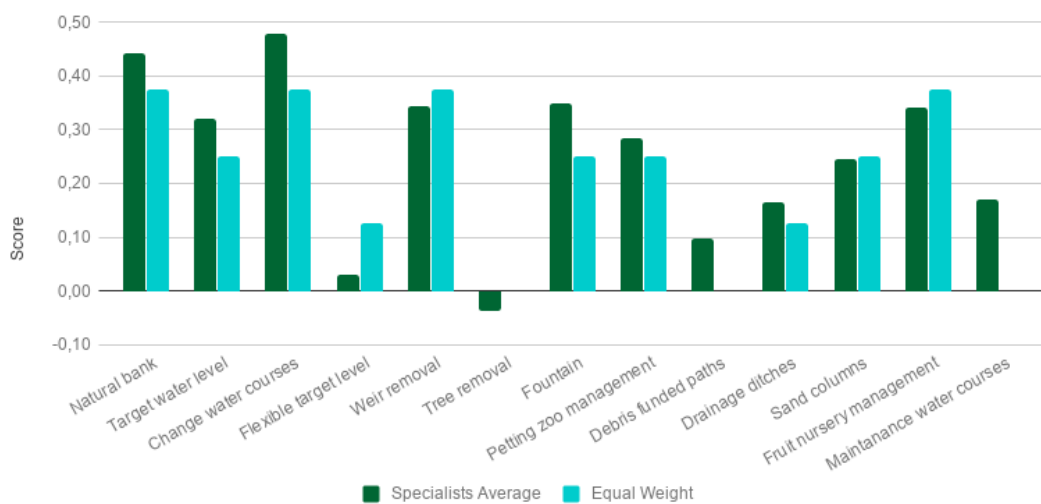
Figure 4.6.: Scores of measurements for the average of the specialists and equal weight method without soil contamination stability

Because all of the measurements scored the same on the soil contamination stability, the evaluations is also performed without this criterion. The results are shown by figure 4.6. The scores of all measurements are lower, but the high scoring measurements remain the same. The measurements that scored low are now close to zero or negative.

For the detailed figure without the criterion on soil contamination stability, similar effects are shown as figure 4.6 compared to figure 4.5. All the measurements score lower, but the relative high scoring measurements remain the same. The negative scores are less compensated by the positive influence of the soil contamination stability criterion.
