Effects of dredging and dumping in laboratory scale experiments of estuaries

March 2018 – final version

Master: Earth Surface and Water

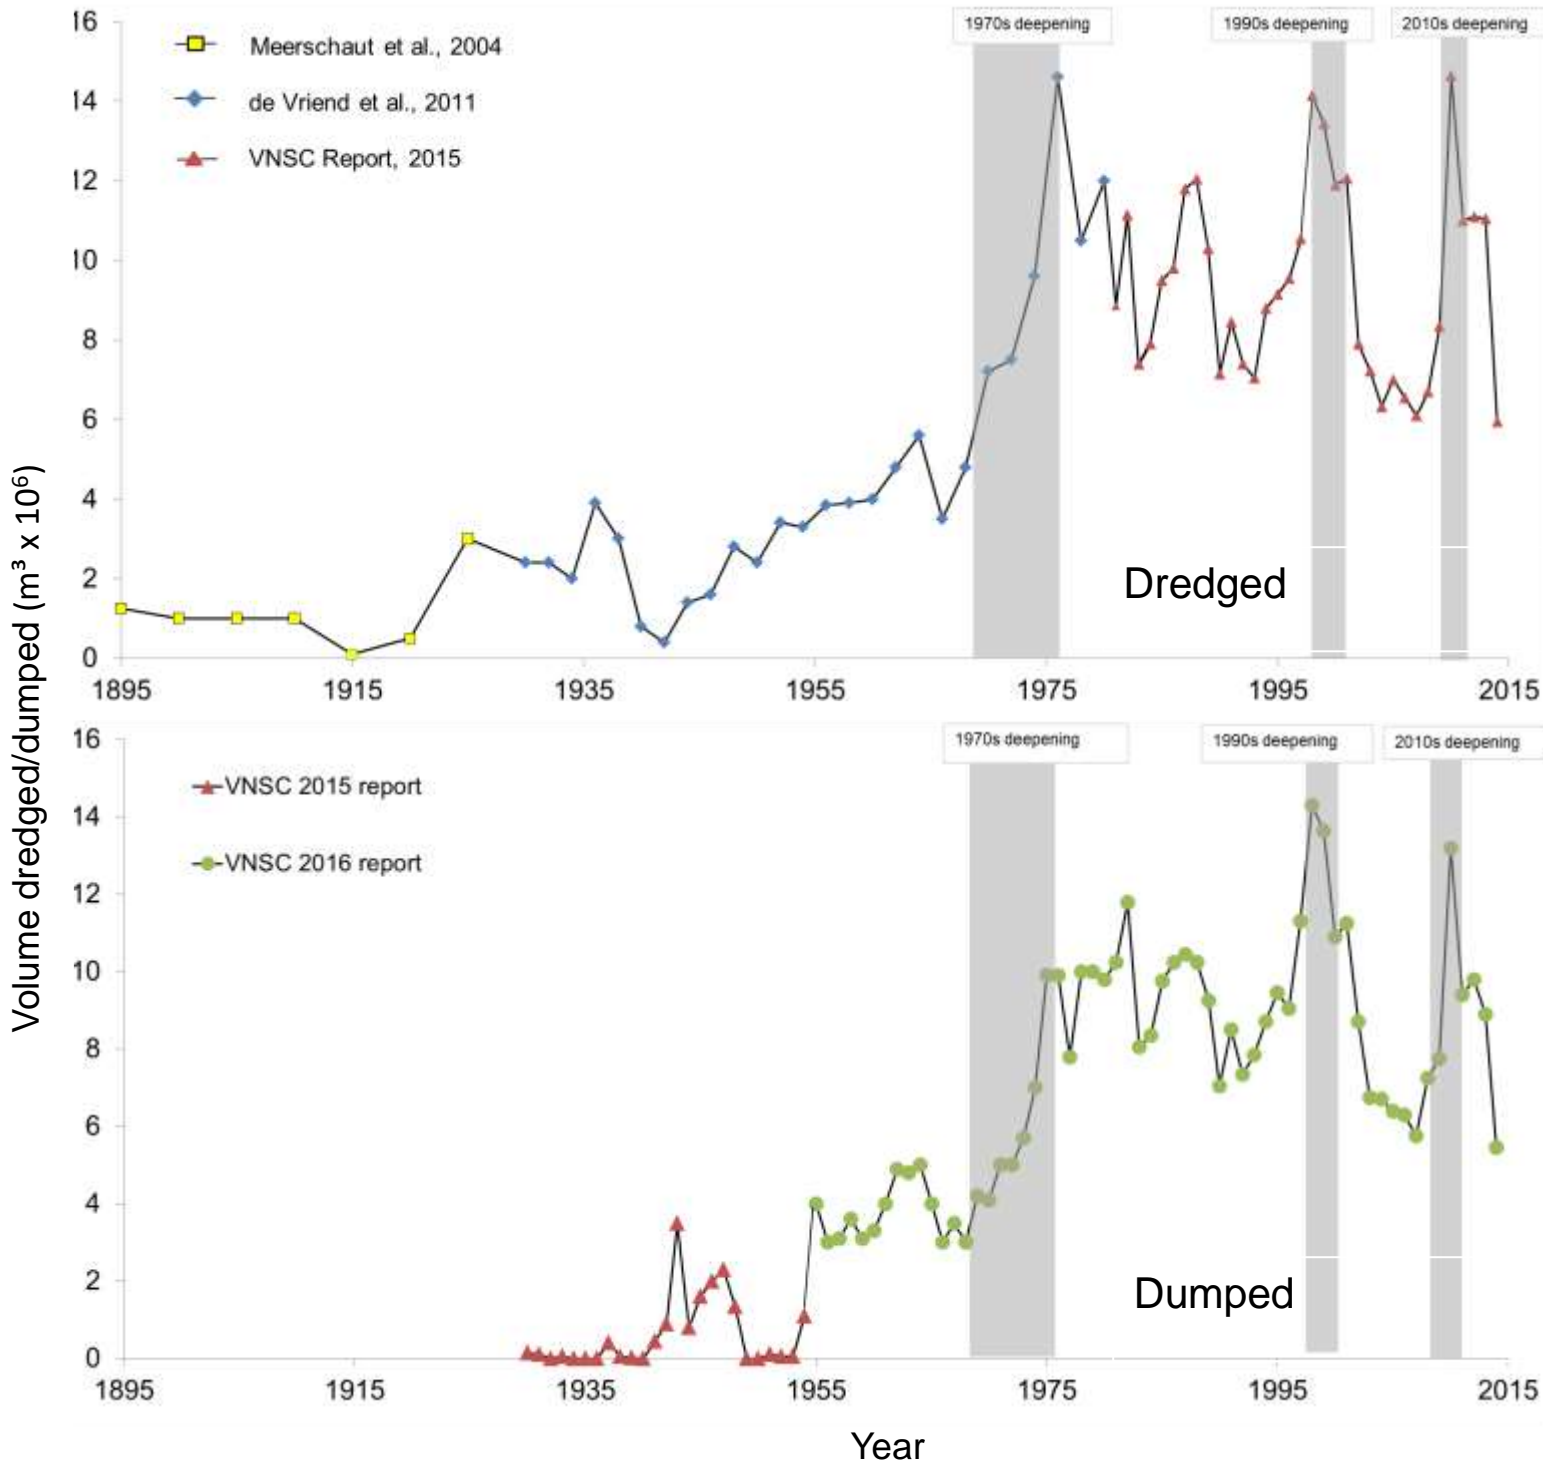
Figure 5: Volumes of dredged and dumped sediment in the Western Scheldt 1895-2014 (including data sources), grey boxes indicate channel deepening events.

The amount of sediment dredged has varied over time as seen in Figure 5. When the deepening events occur, the largest overall volume of sediment is removed from the system (and consequently relocated within the estuary). Certain locations have had very high volumes of sediment removed from the system over time; these are sill areas such as Drempeel van Bath, Drempeel van Valkenisse and Drempeel van Borssele. As seen in Figure 6, the most dredged area since the 1980s is Drempeel van Hansweert.

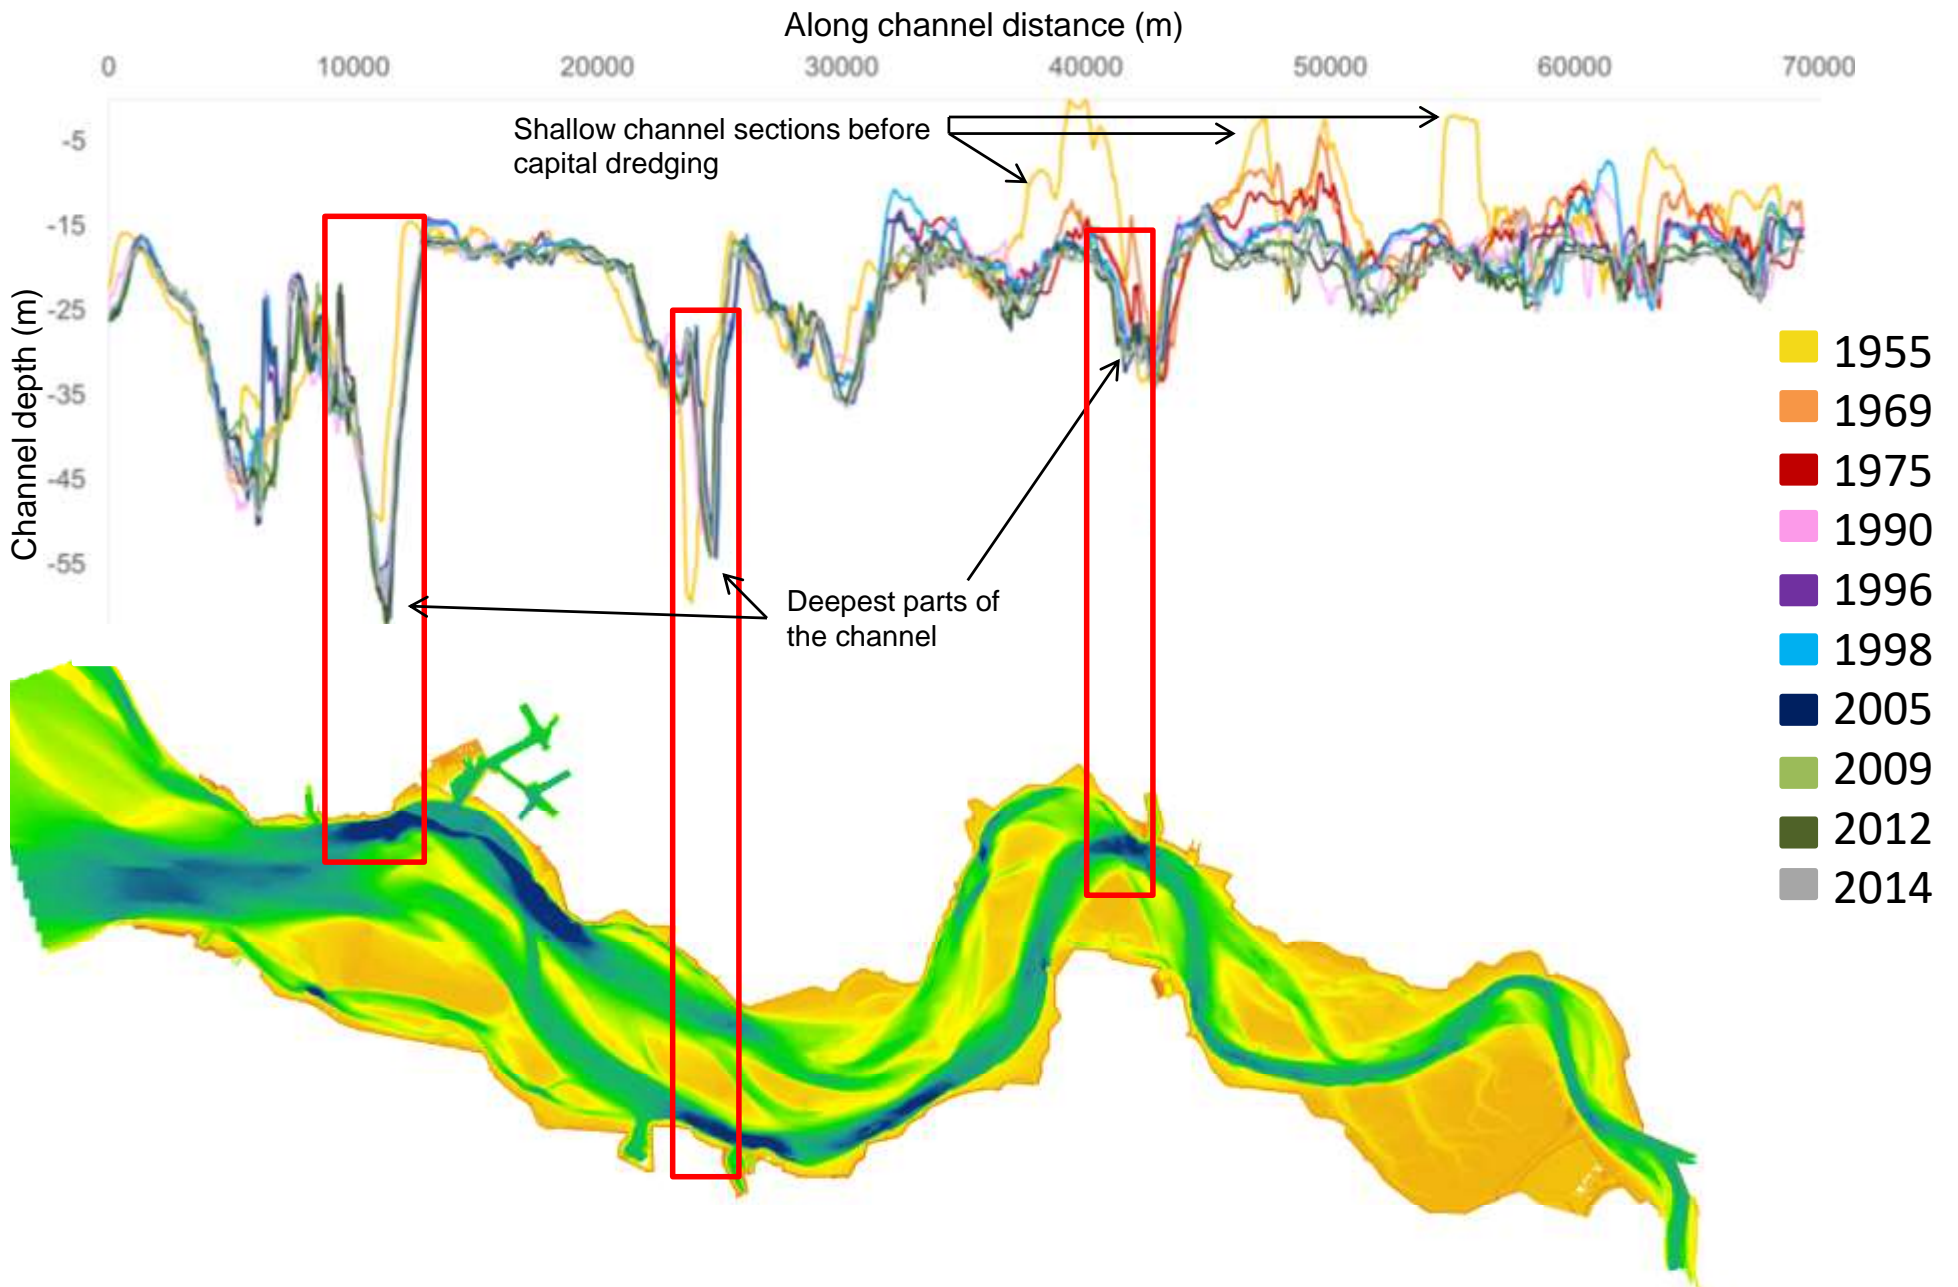
Figure 8: Elevation of the shipping fairway of the Western Scheldt over time.

Dredging in the Western Scheldt has caused deepening of the entire main channel over time. Figure 8 shows the change in depth of the main channel/shipping fairway over time. Some sections have become much deeper than others and all shallow sections have been removed. Several side channels and shortcuts have also been dredged and deepened for navigation focused on the seaward end of the estuary. However, most of the side channels have silted up and shallowed significantly including the side channel from Biezelingsche Ham to Eendragt (see Figure 10). For the three different capital dredging events the response of the system varies.

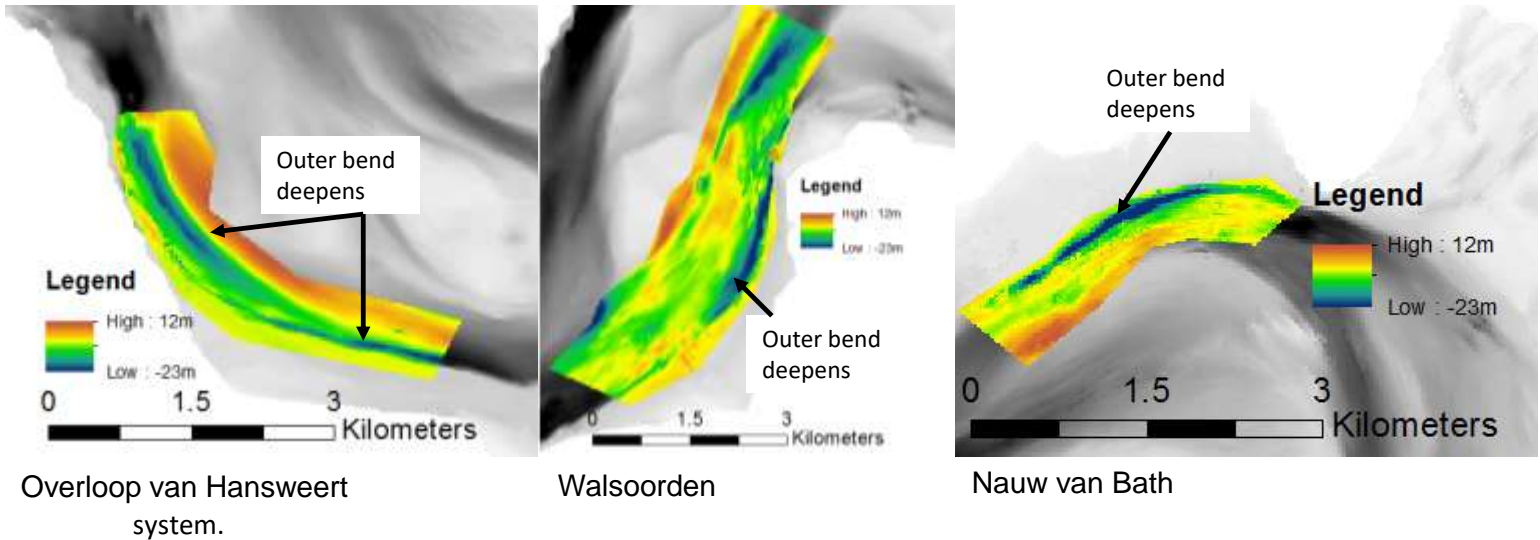
Figure 9: DEMs of difference between 1955 and 1970 (pre-capital dredging) for three main channel dredging sites in the Western Scheldt estuary, where red = increase in elevation, blue = decrease in elevation.

Prior to the first channel deepening (1955-1970) the main channel deepened in response to dredging with the focus on the outer edges of bends (Figure 9). Side channels also deepened leading to a larger vertical difference between water levels and shoal edges. This led to the erosion of several shoals in the

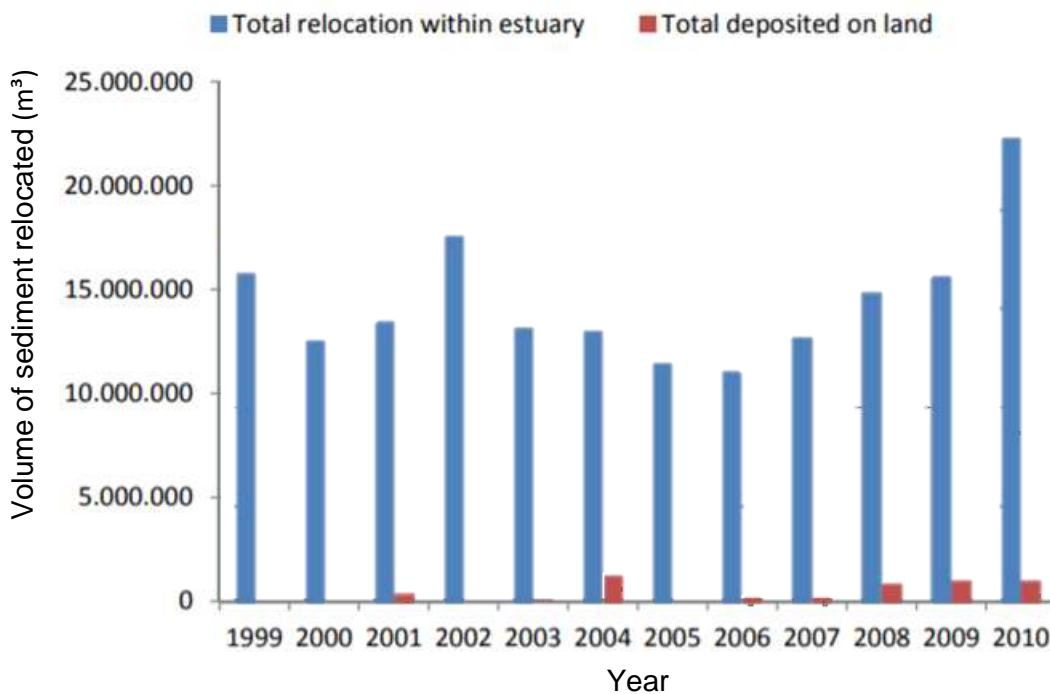
Figure 13: Volumes of sediment relocated within the Western Scheldt and their destinations. Altered from Mow (2013).

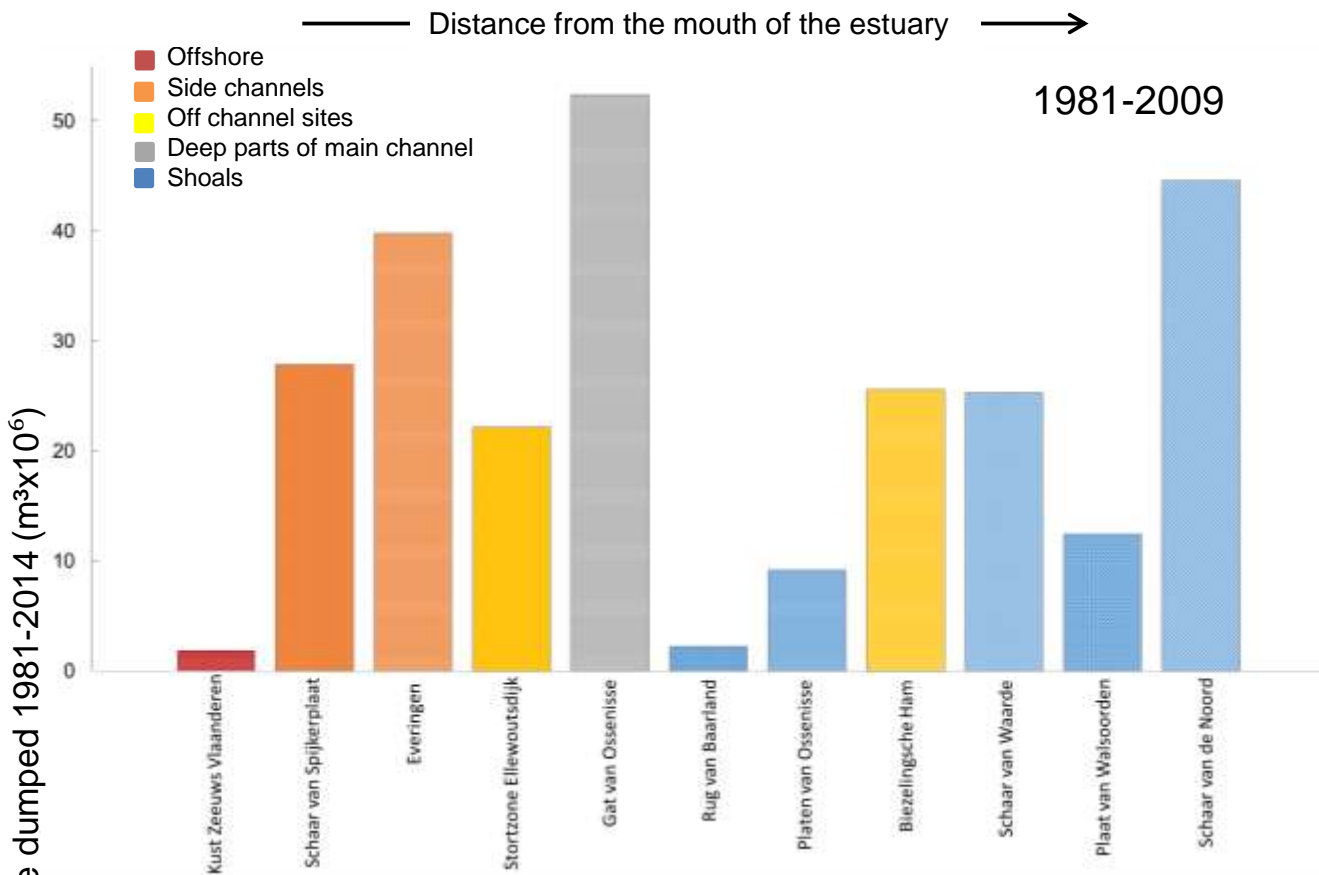
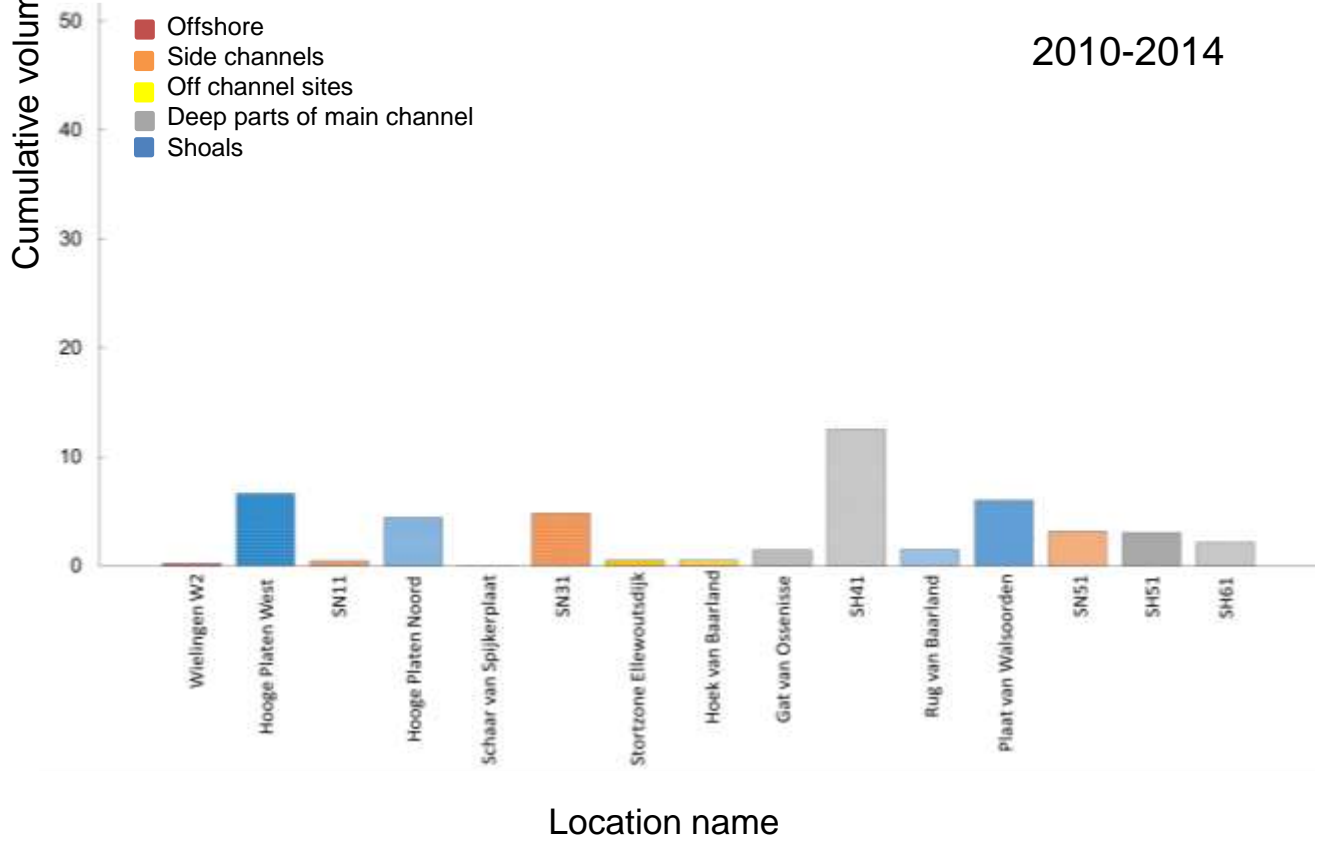
Figure 14: Cumulative amount of sediment dumped per location in the Western Scheldt for 1981-2009 (before flexible dumping) and 2010-2014 (with advent of flexible dumping) with volume figures from VNSC report (2015). Locations correspond with the map shown in

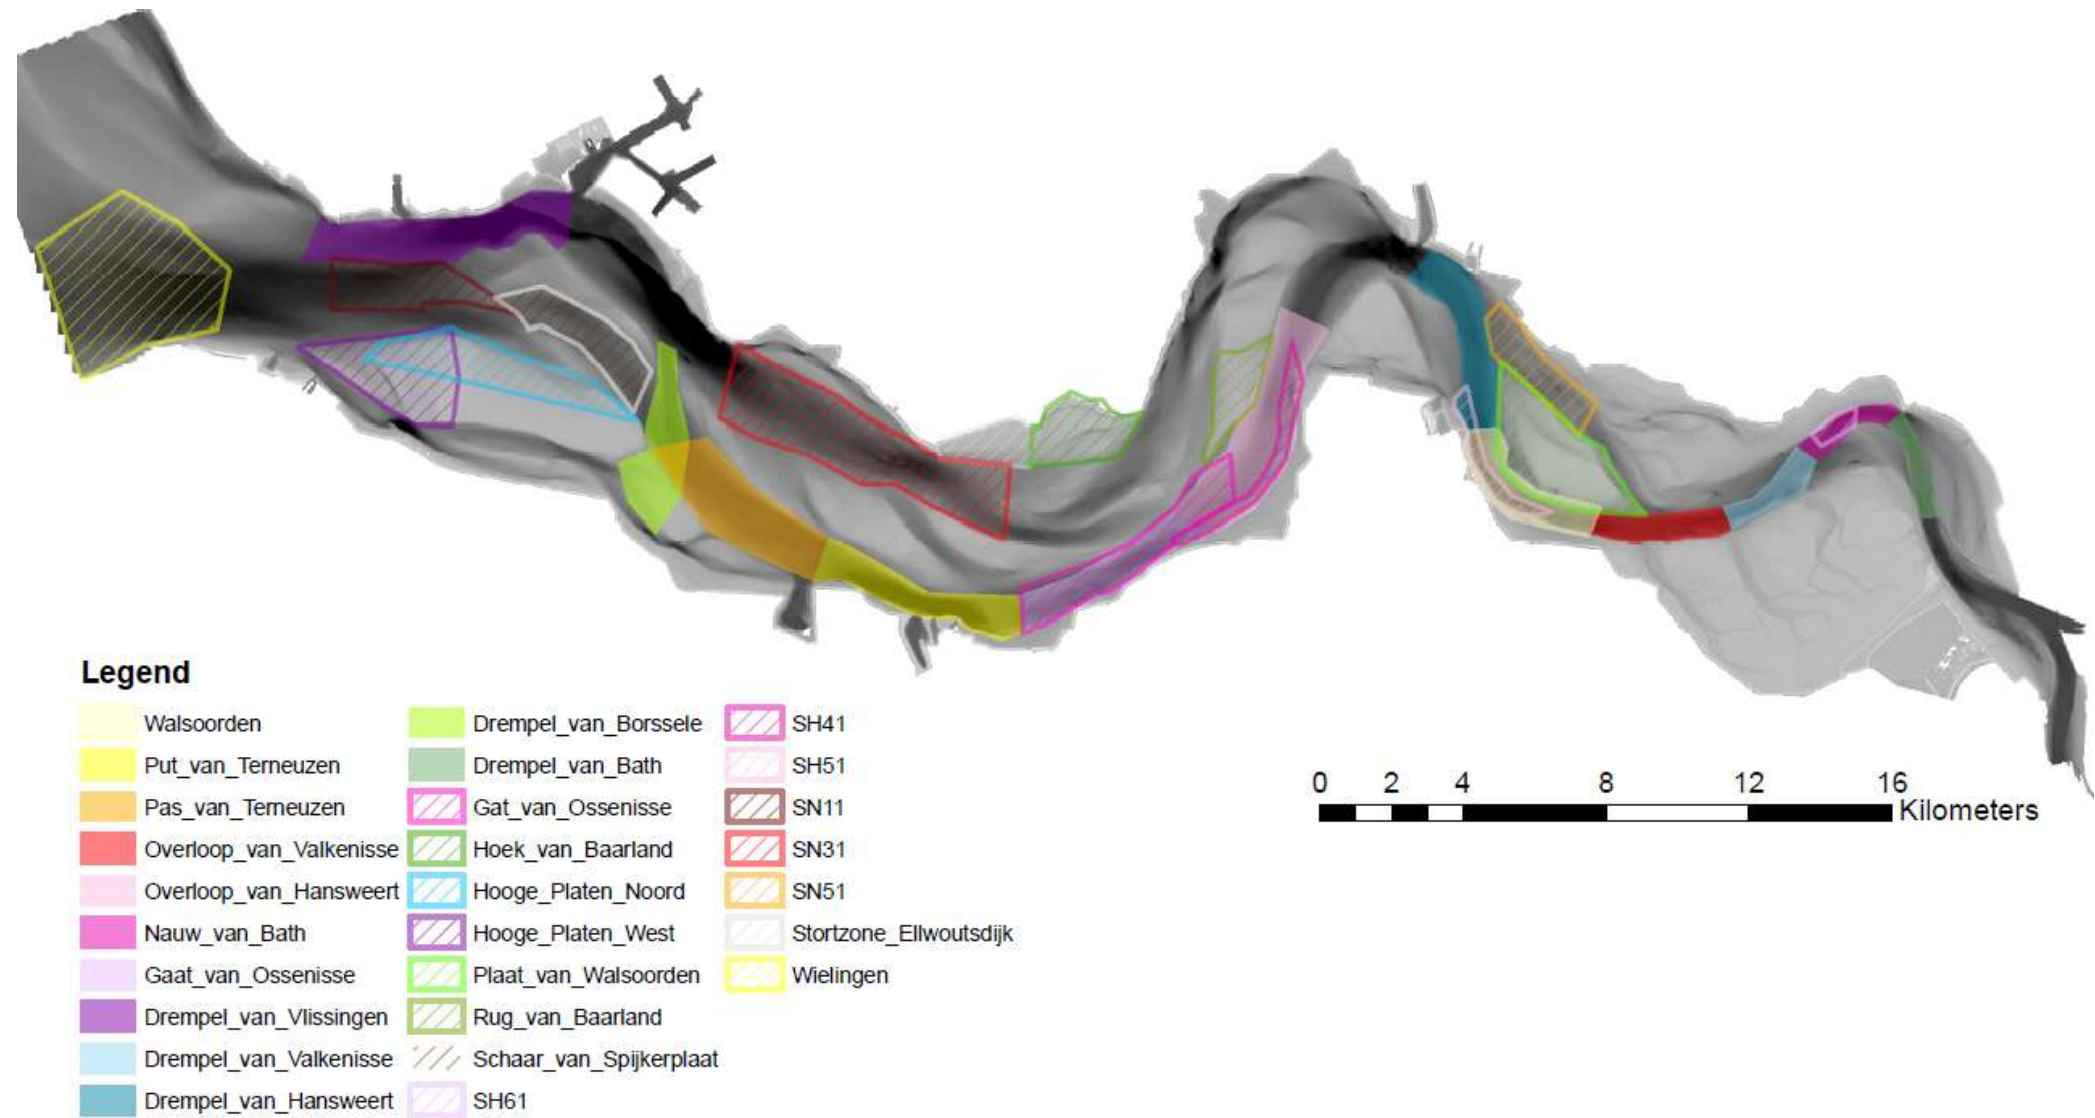
Figure 16: Locations of all dredging sites (plain colour) and new flexible dumping sites (hashed) in the Western Scheldt since 2010 based on VNSC reports (2015 & 2016).

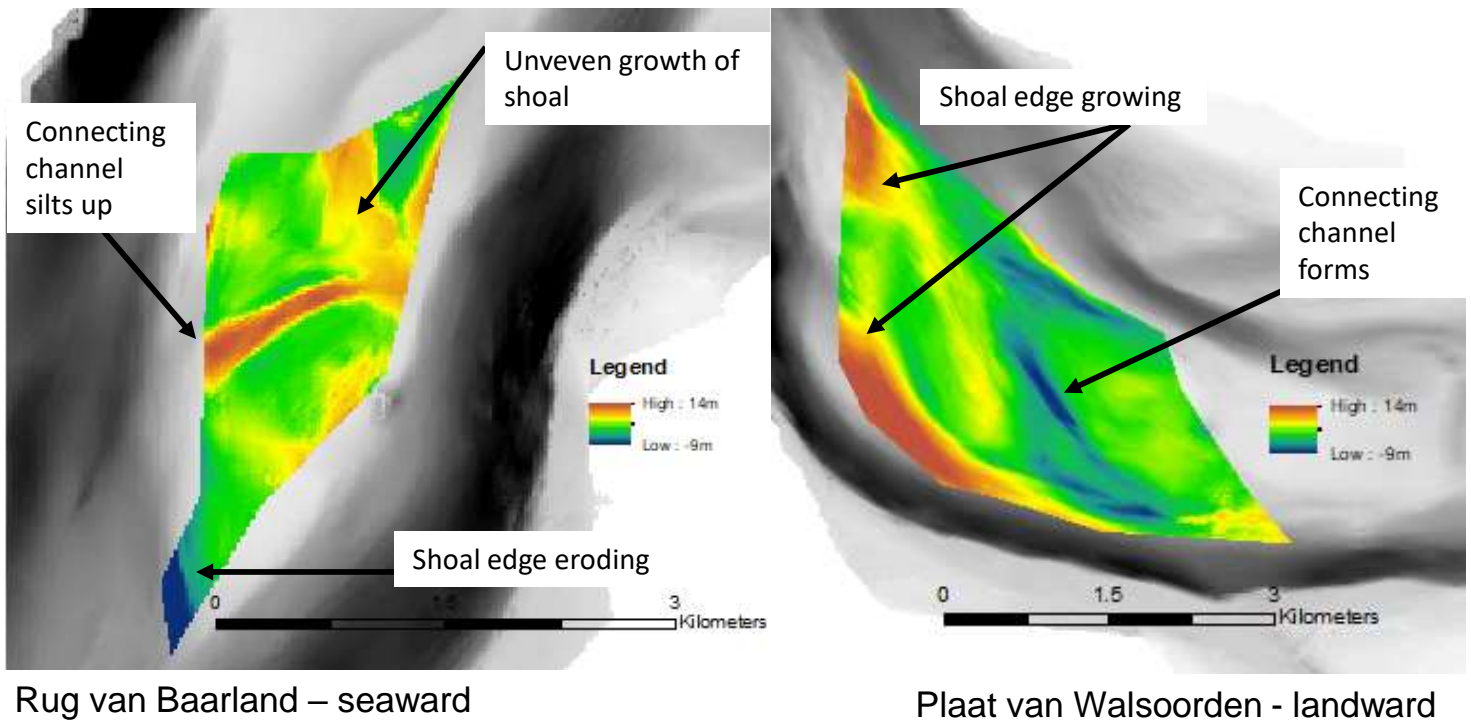
Figure 17: DEMs of difference between 1955 and 1969 (pre-capital dredging events) for two shoals in the Western Scheldt estuary, where red = increase in elevation, blue = decrease in elevation.

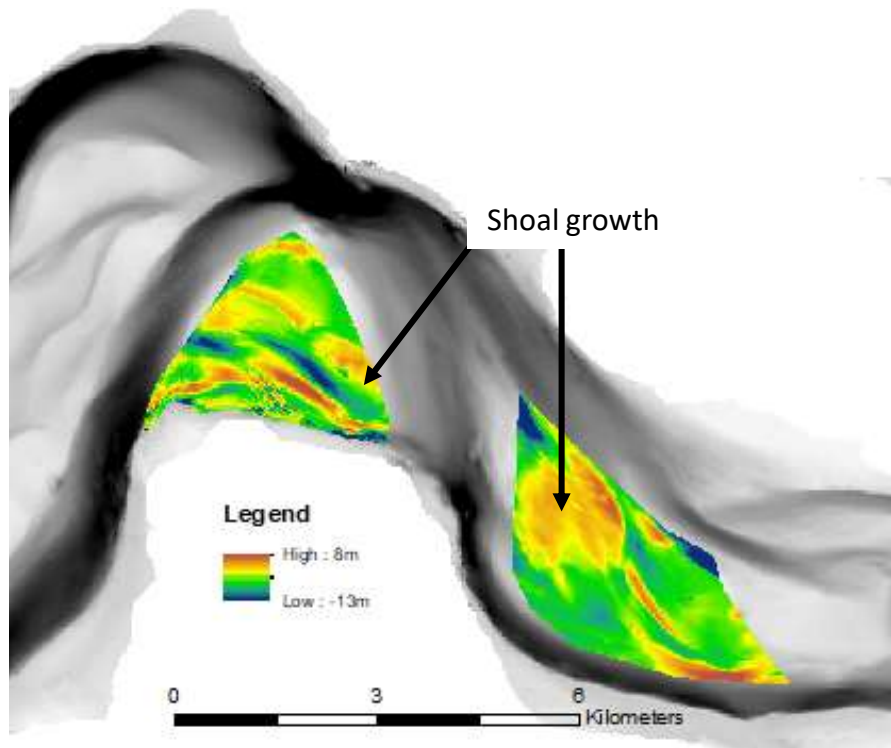
Figure 18: DEMs of difference between 1969 and 1975 (before and after first capital dredging event) for shoals between Waarde and Valkenisse in the middle of the Western Scheldt estuary, where red = increase in elevation, blue = decrease in elevation.

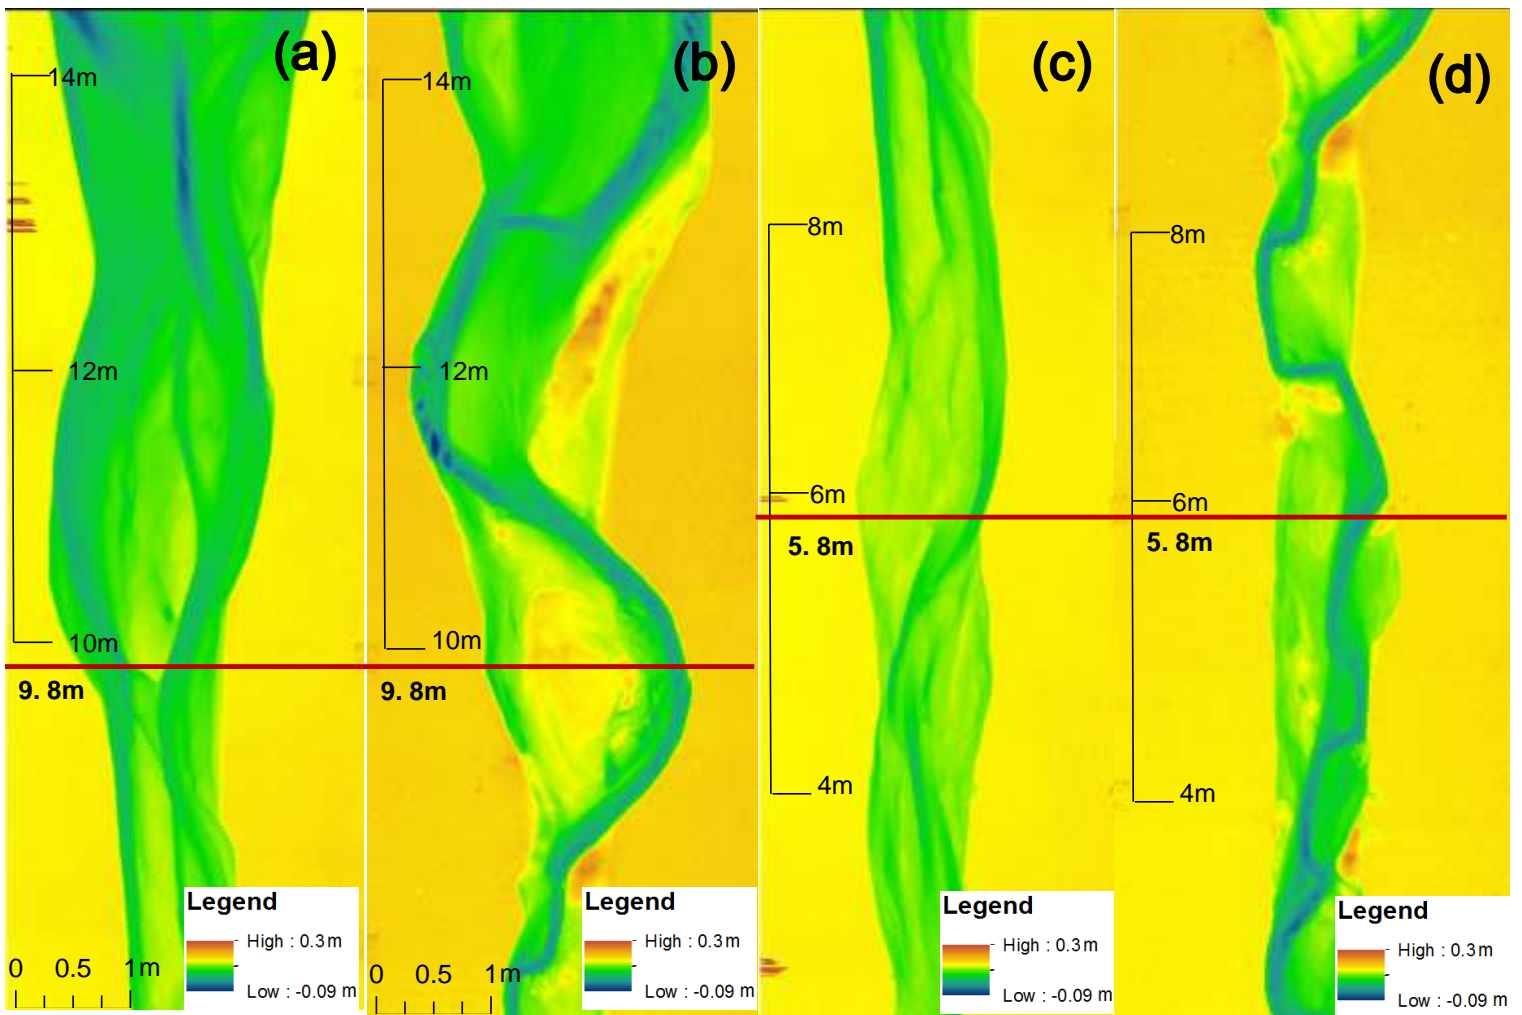
Figure 30: DEMs showing estuary width at (a) 10-14m for the non-dredged situation (b) 10-14m for the dredged situation (c) 4-8m for the non-dredged situation and (d) 4-8m for the dredged situation (Cycle 4899 for the non-dredged experiment and cycle 4900 for the dredged experiment).

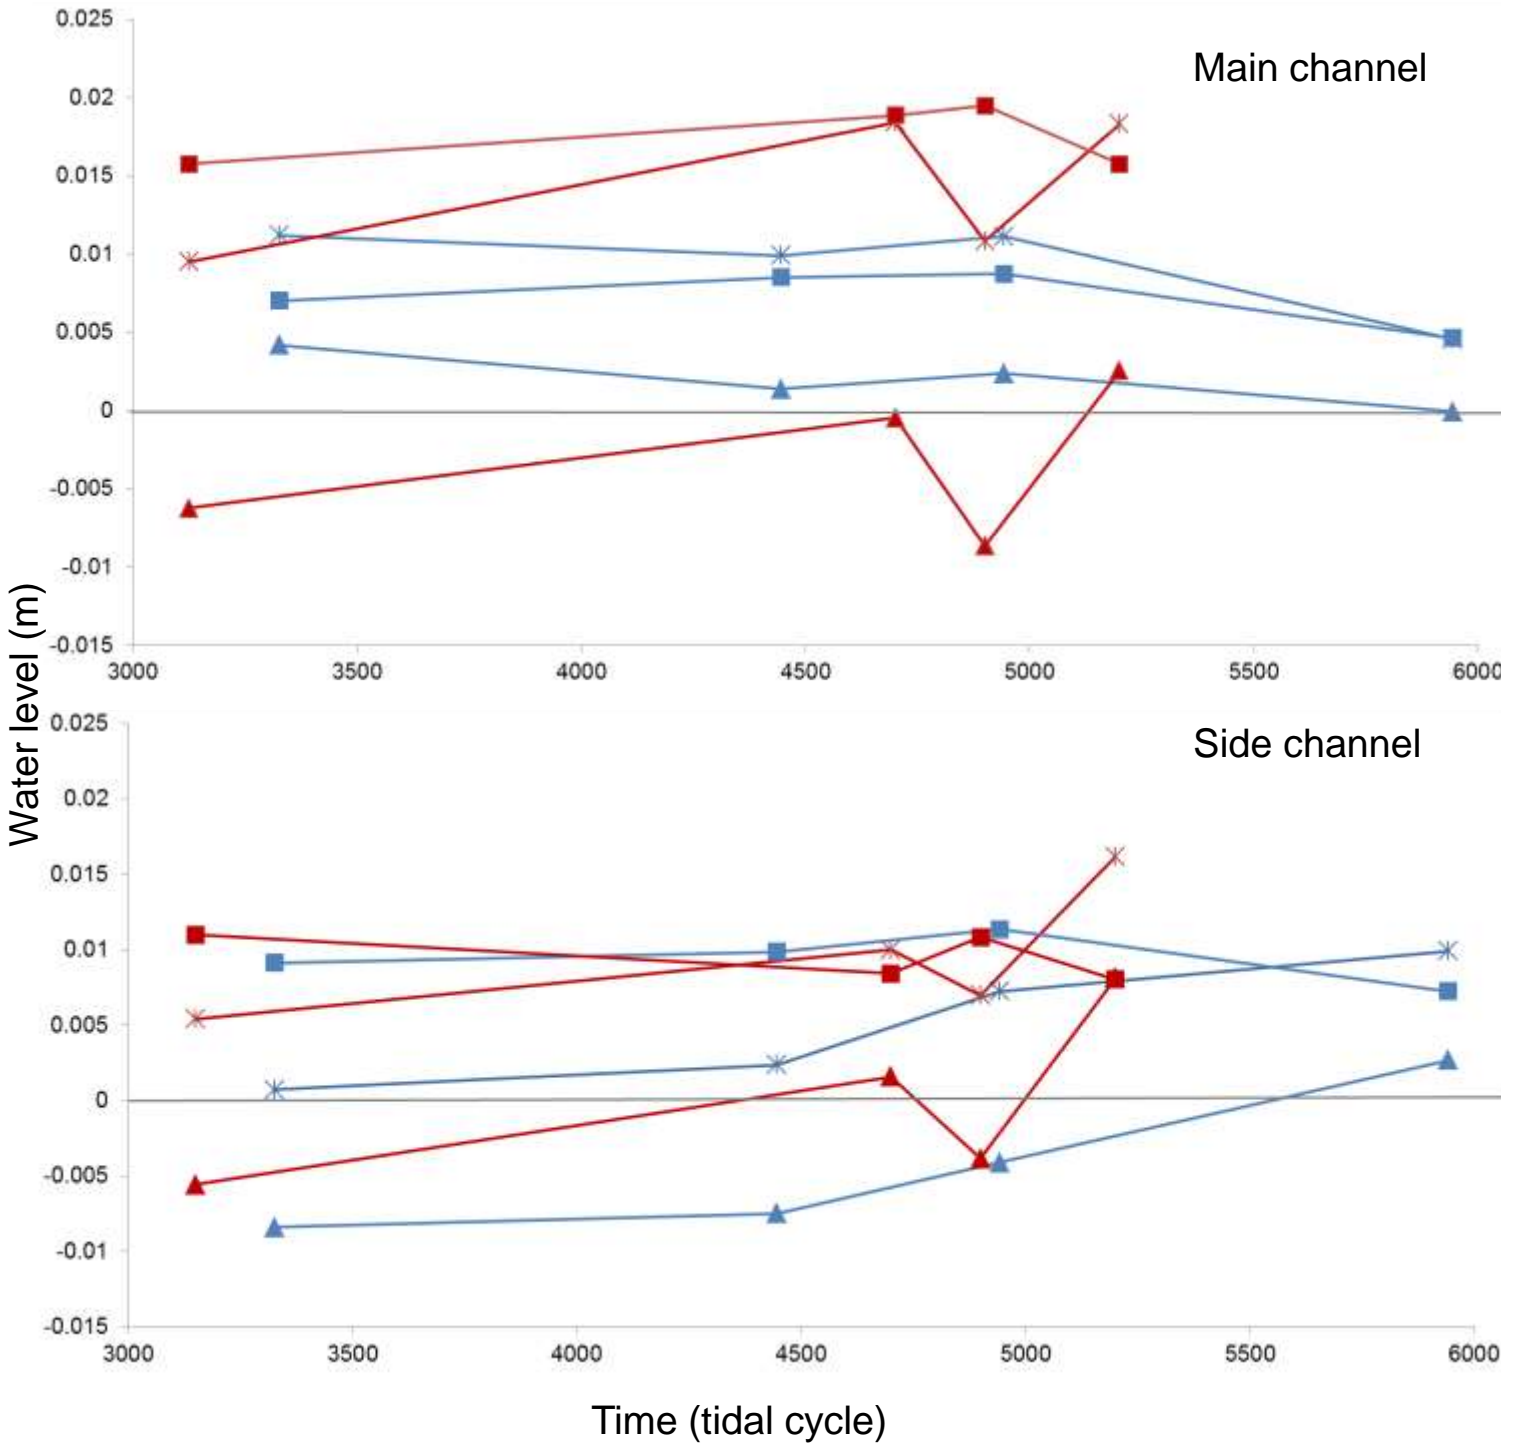
Figure 40: High water, low water and tidal range data for main channel (top) and side channels (bottom) for the non-dredged and dredged experiments.

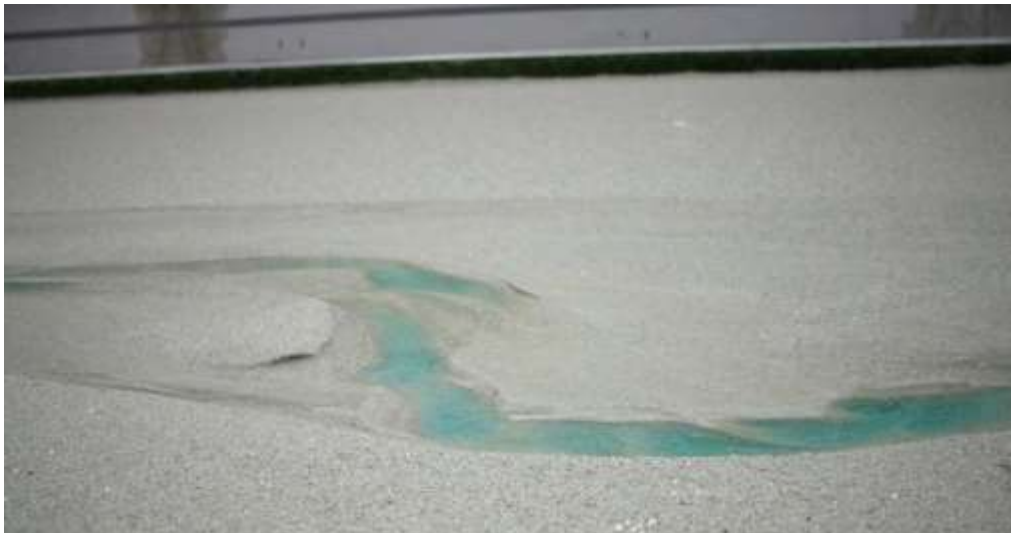
Figure 42: Supratidal shoal elevated above high-water level upstream.

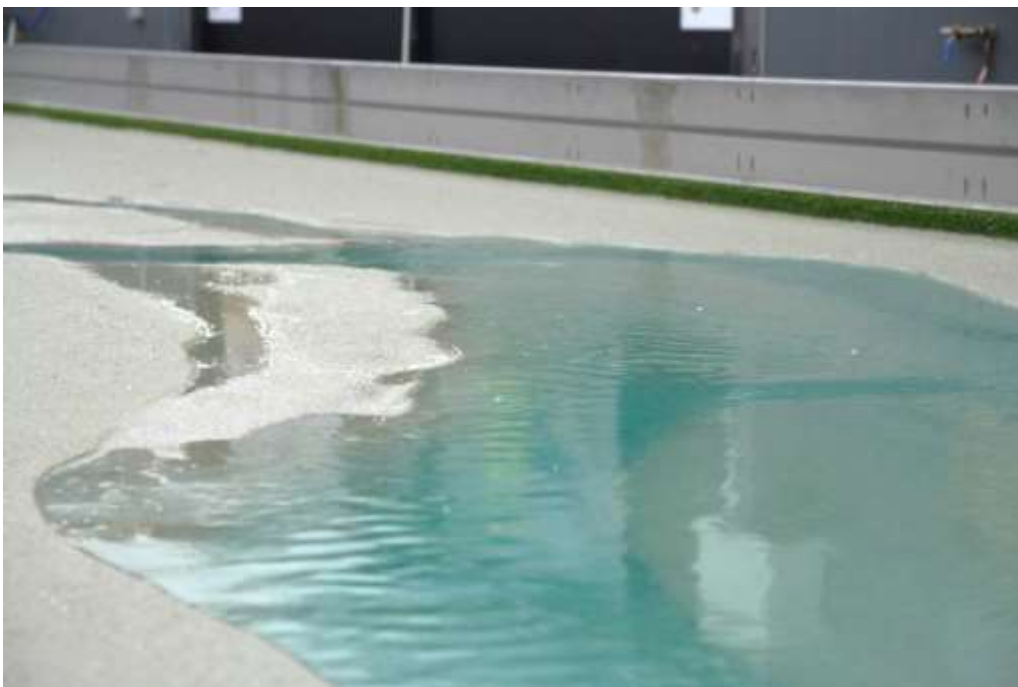
Figure 43: Intertidal shoal located at the seaward end.
