Mapping and quantifying the rate of soil and gully erosion in the dry areas of Jordan

MSc Thesis

08-2020

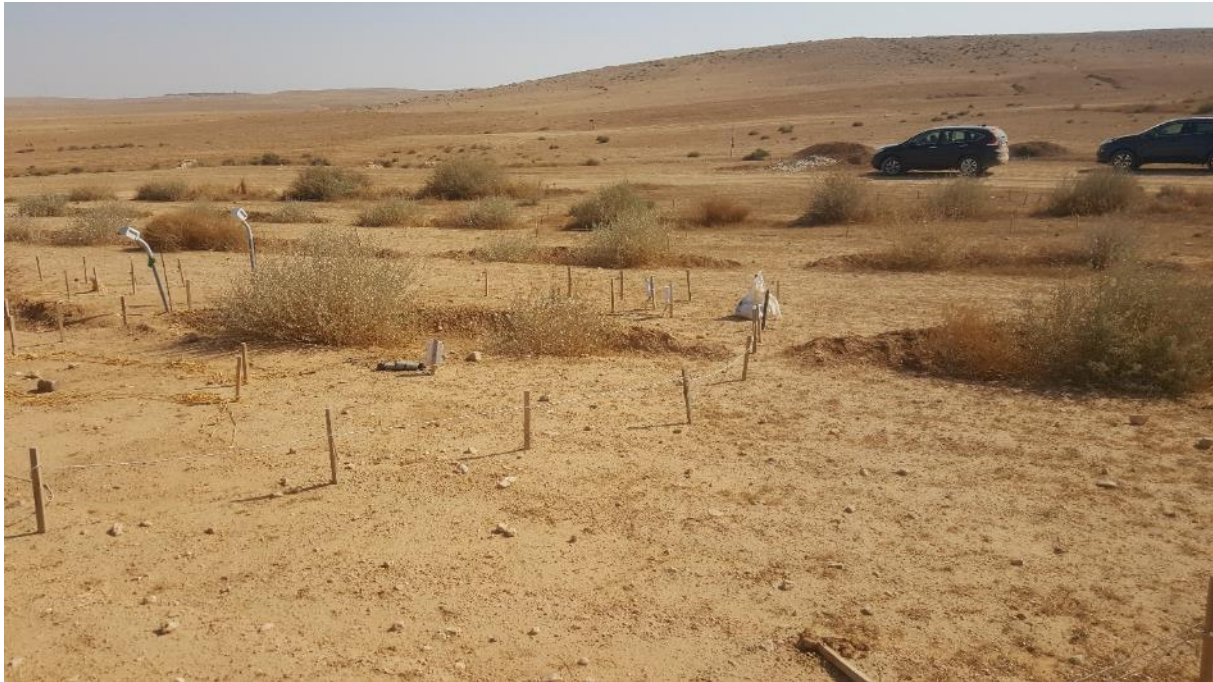
Figure 6: Vallerani structures as implemented in the treated watershed.

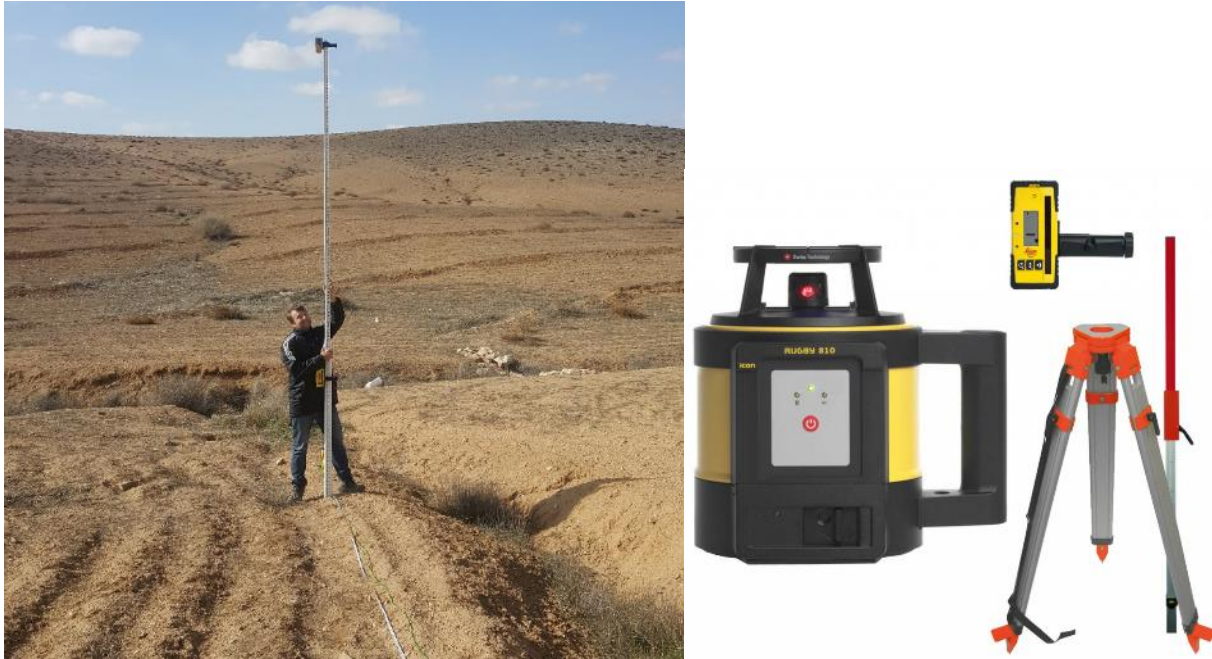
Figure 9: The measurement bar (left) and the Leica Rugby 810 laser level altitude meter and receiver (right).

The slope in the watershed was measured with a Leica Rugby 810 laser level altitude meter (figure 9). A tripod with the altitude meter was placed 15 meters upslope the gully head in the drainage area. The laser altitude meter measured the elevation inside every drainage catchment. It measured the elevation by capturing the light of the rotating laser with a receiver. The receiver was placed on top of a measurement bar and made a beeping noise when the laser was found. At this time, the height measurement was read on the bar.

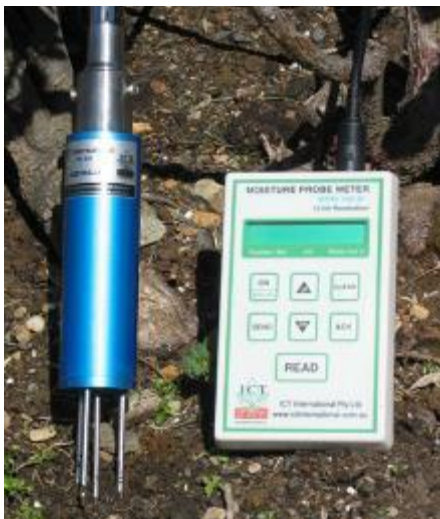
Figure 11: The handheld MP306 ICT TDR used to measure soil moisture content in the soil.

Values of soil moisture in the side banks of the gully system were measured directly after a rainfall event to validate the Hydrus 2D model. The amount of soil moisture was measured using a handheld MP306 ICT Time Domain Reflectometer (TDR) (figure 11). A handheld TDR is a soil moisture meter that can directly measure the amount of water content in the soil using electric and dielectric properties of materials. This apparatus approximated water content once at 12 gully cross-sections in the RWH treated watershed and 6 cross-sections in the untreated watershed. The measurements were located at the bottom, in the middle and on top of the gully side banks.

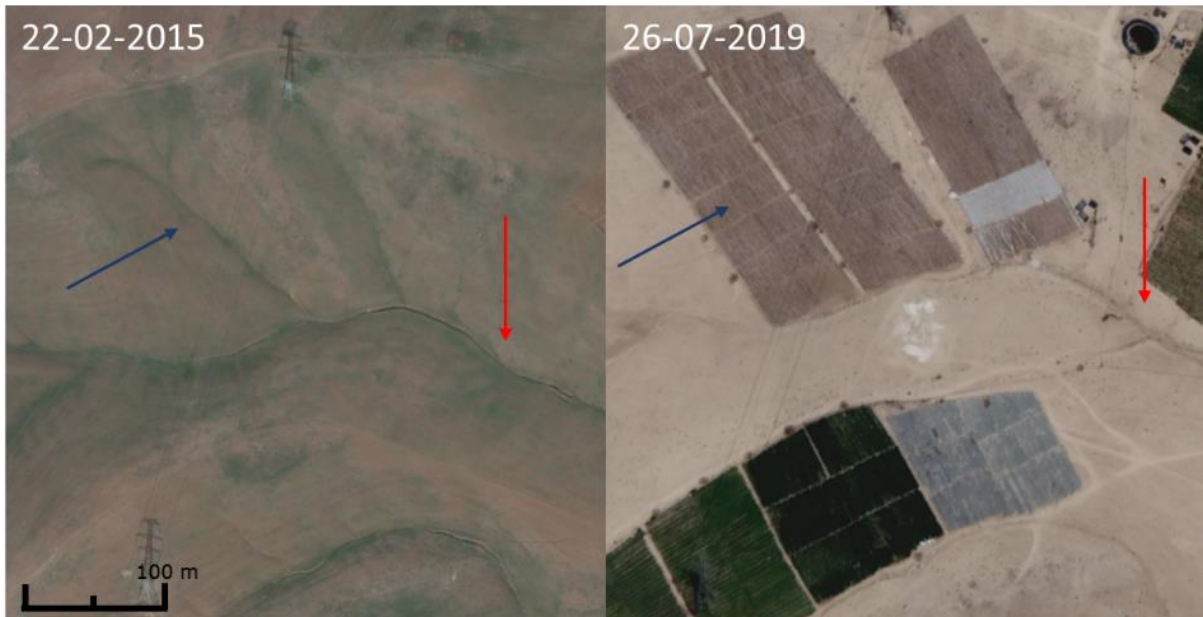
Figure 18: Examples of removal (blue arrow) and initiation (red arrow) of gullies in combination with agricultural practices.

Gullies were locally flattened for agriculture, which means that entire gullies were removed. At the same time, agricultural land use can initiate gullies as well. The initiation of new gullies was observed in lower areas next to newly constructed fields in higher areas (figure 18). While most gully growth was similar throughout the selected areas of the middle catchment, enhanced growth was found at the construction site.

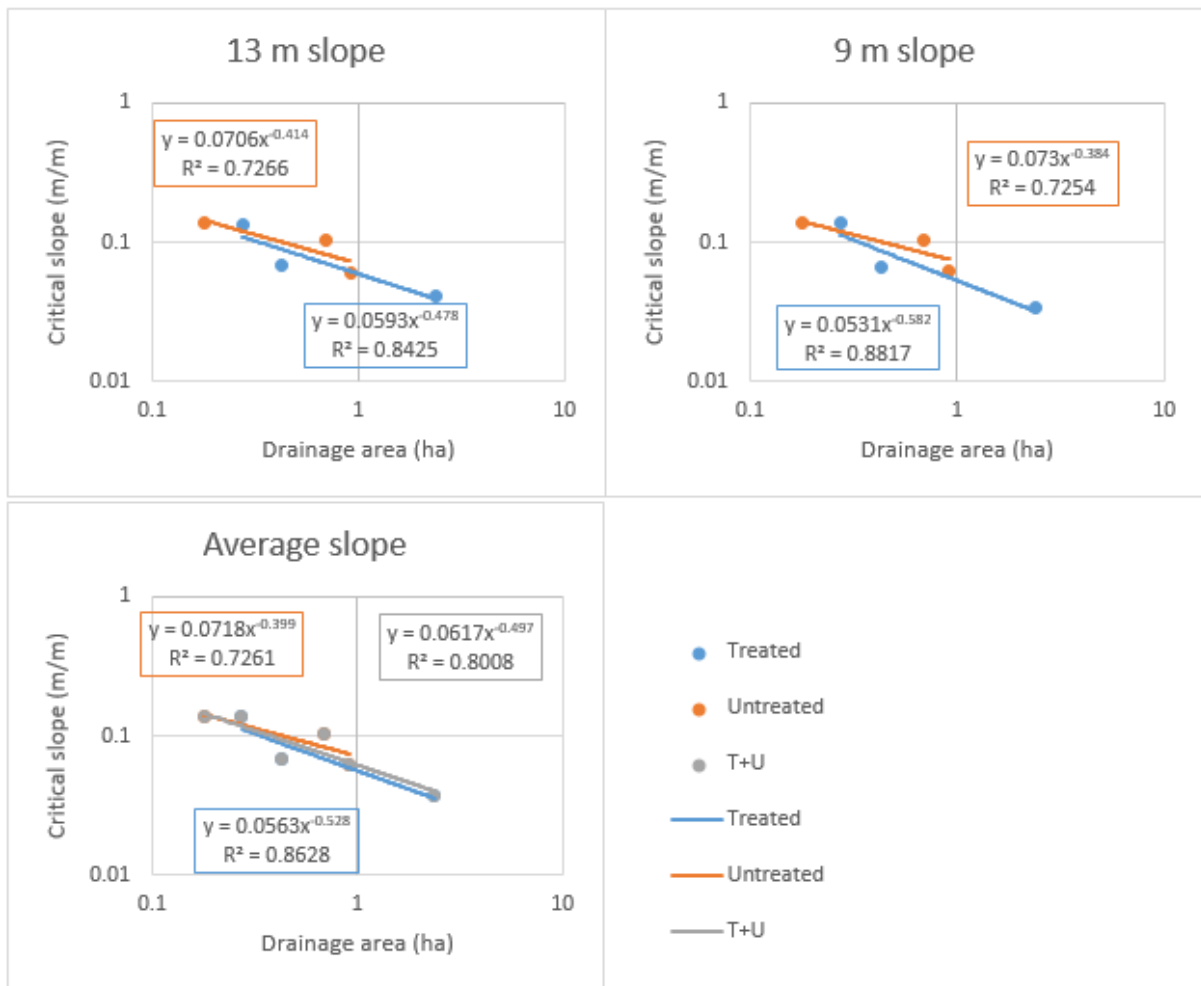
Figure 22: Relation between the critical slope and drainage area for the 13-meter slope, the 9-meter slope and the average of these slopes on the Al-Majdiyya watersheds. Blue colors represent the treated site, orange colors the untreated site and gray the average of all observation points.

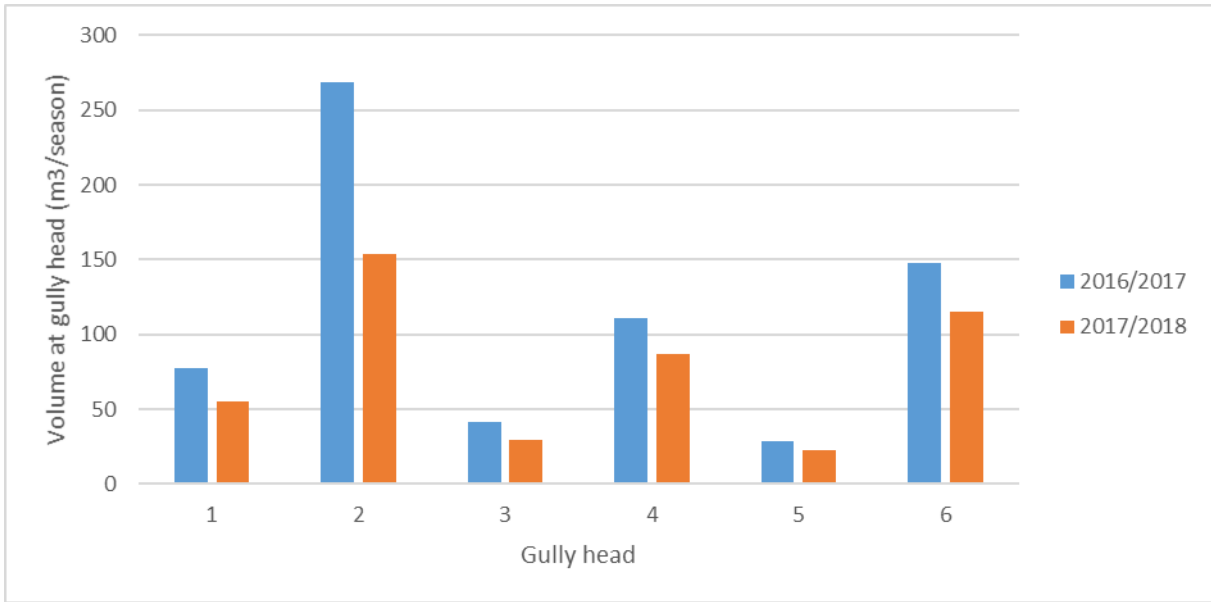
Figure 23: Total runoff at gully heads in m^3 /season. Gully head 1,2 and 3 are in the RWH treated watershed and 4, 5 and 6 are in the untreated watershed.

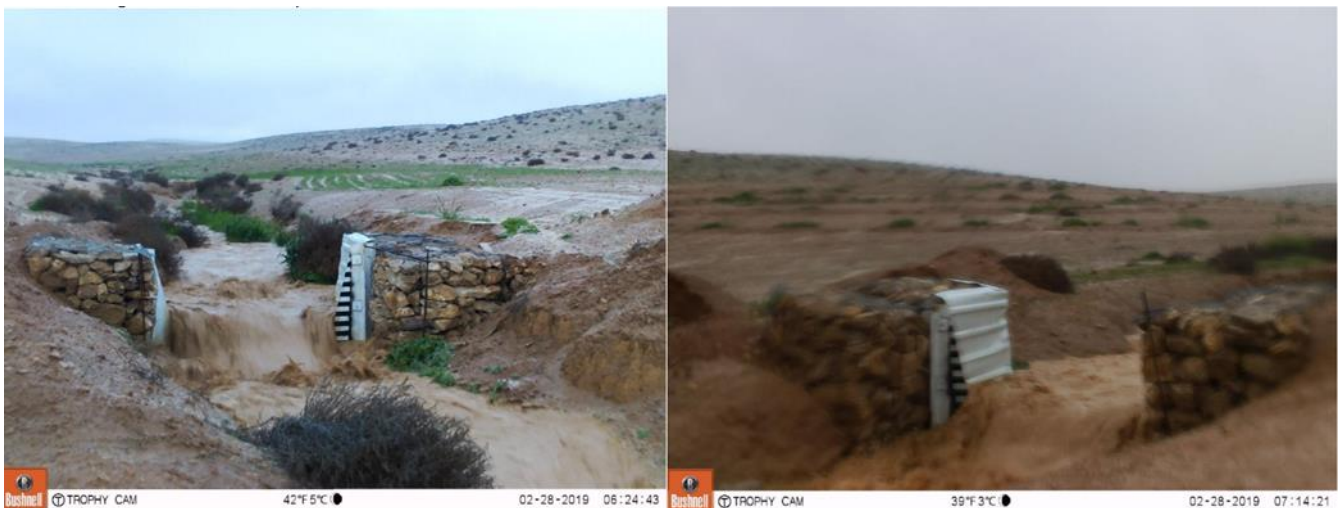
Figure 27: Peak discharge event in the untreated (left) and treated (right) watersheds at 28-02-2019.

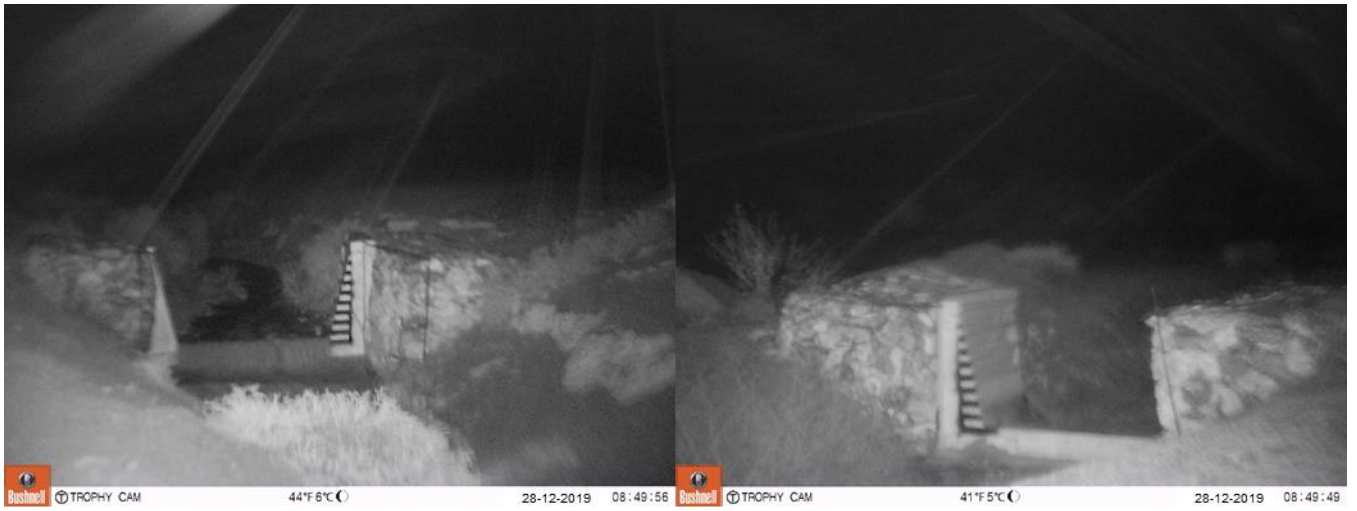
Figure 28: Peak discharge event in the untreated (left) and treated (right) watersheds at 28-12-2019.

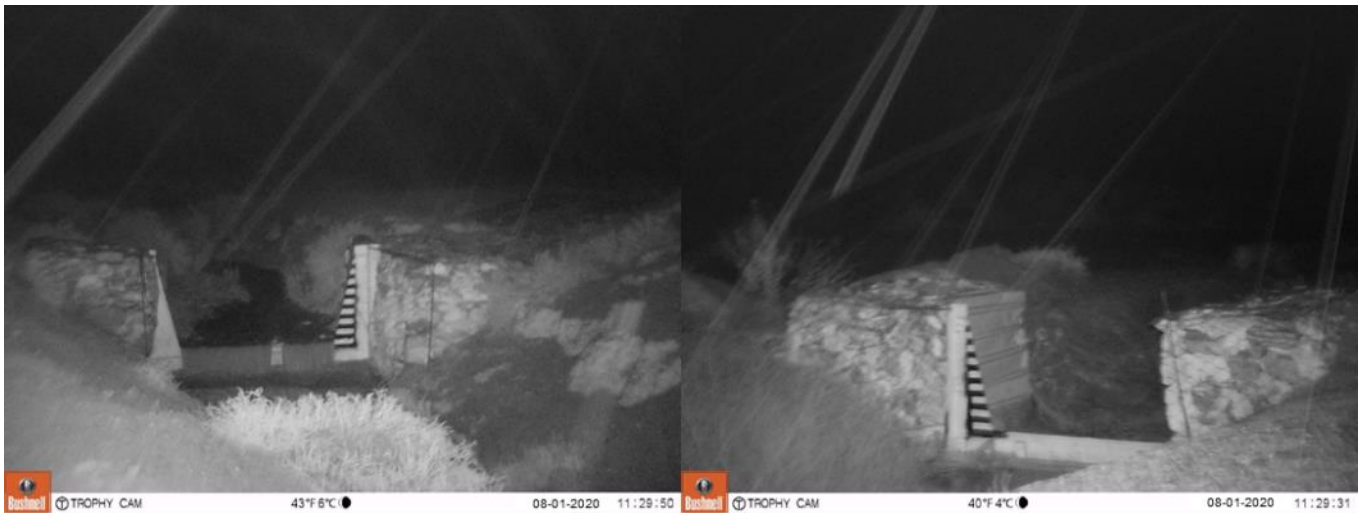
Figure 29: Peak discharge event in the untreated (left) and treated (right) watersheds at 08-01-2020.

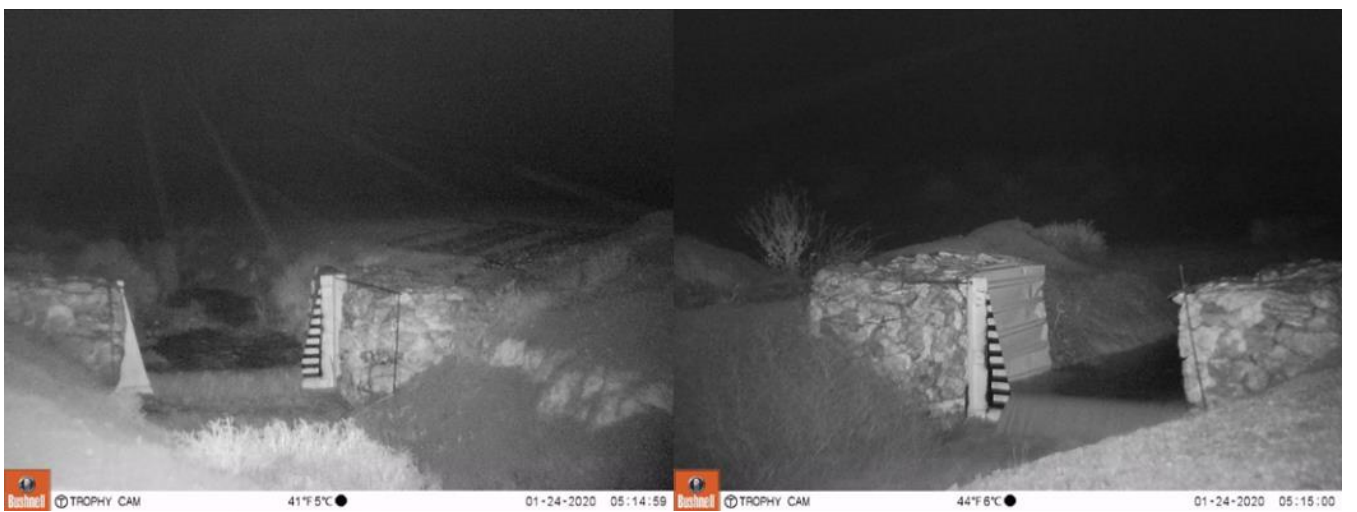
Figure 30: Peak discharge event in the untreated (left) and treated (right) watersheds at 24-01-2020.

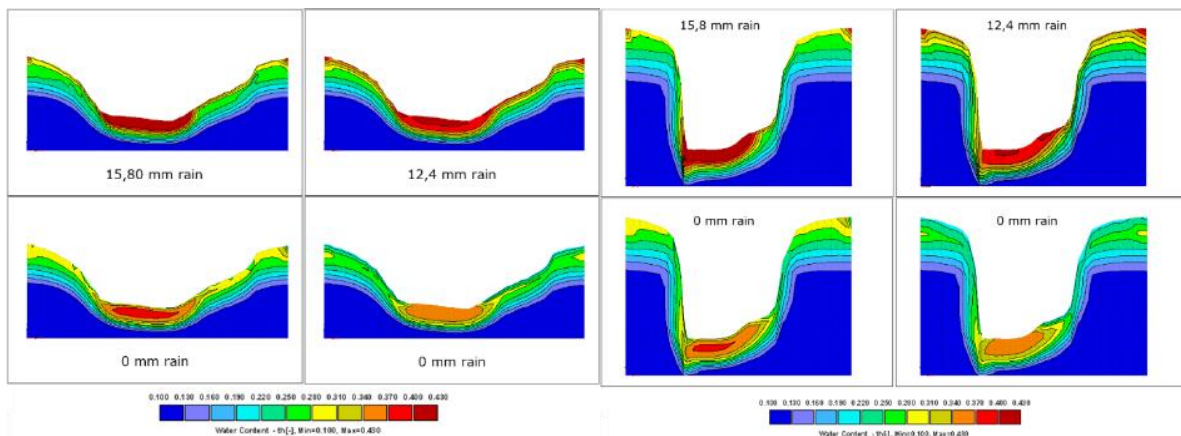
Figure 31: The soil moisture content patterns along a gully cross section of the treated watershed (left) and the untreated watershed (right) during the period between 28-01-2017 and 31-01-2017. Modelling was done with the Hydrus 2D model. Rain fell on the first two days and was followed by two dry days (see appendix 1a).

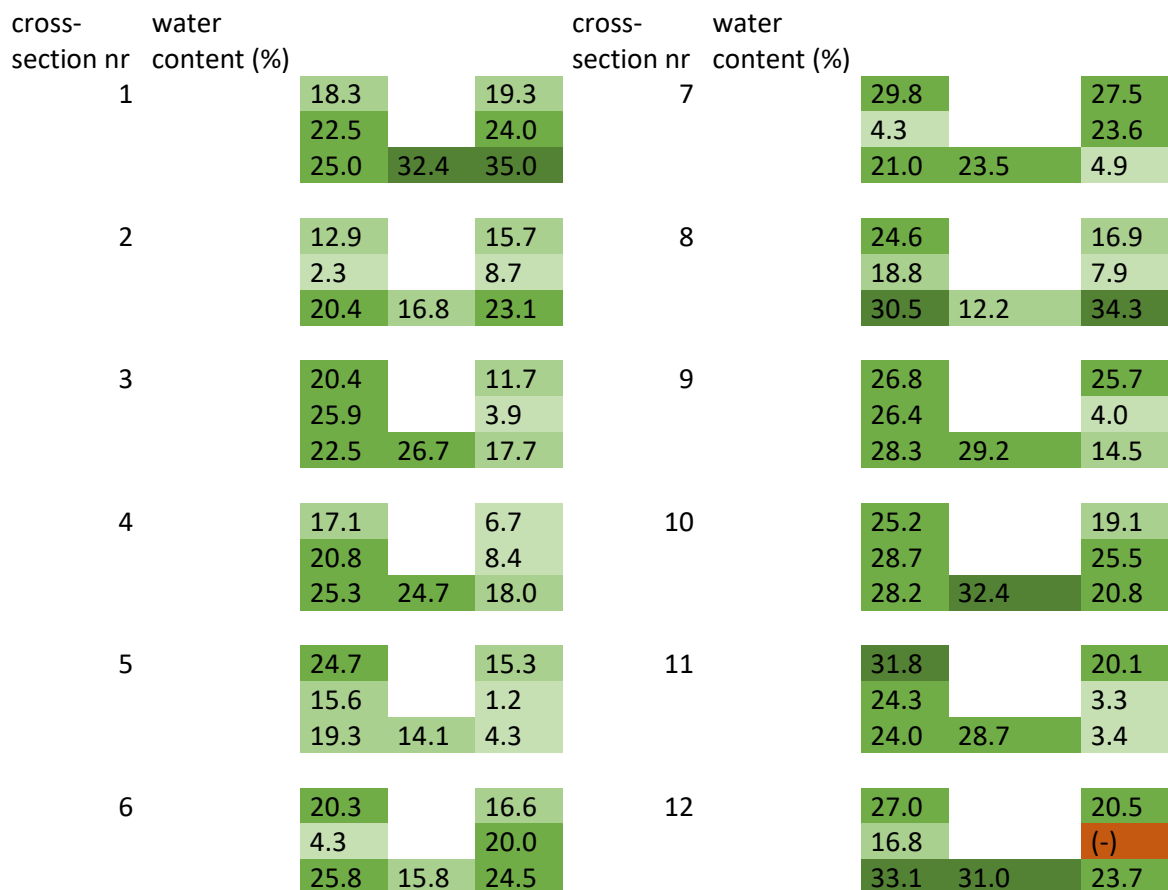
Figure 34: The soil moisture content in the cross sections of the gully in the treated watershed as measured by the TDR. The increase of water content is indicated by a darker green intensity. The brown color indicates either impermeable wall or bad measurement.

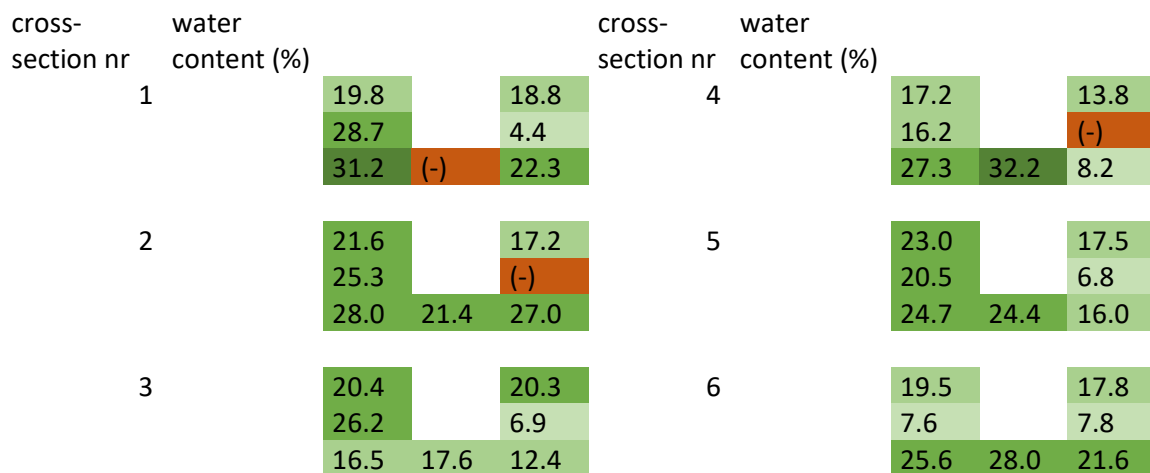
Figure 35: The soil moisture content in the cross sections of the gully in the untreated watershed as measured by the TDR. The increase of water content is indicated by a darker green intensity. The brown color indicates either impermeable wall or bad measurement.

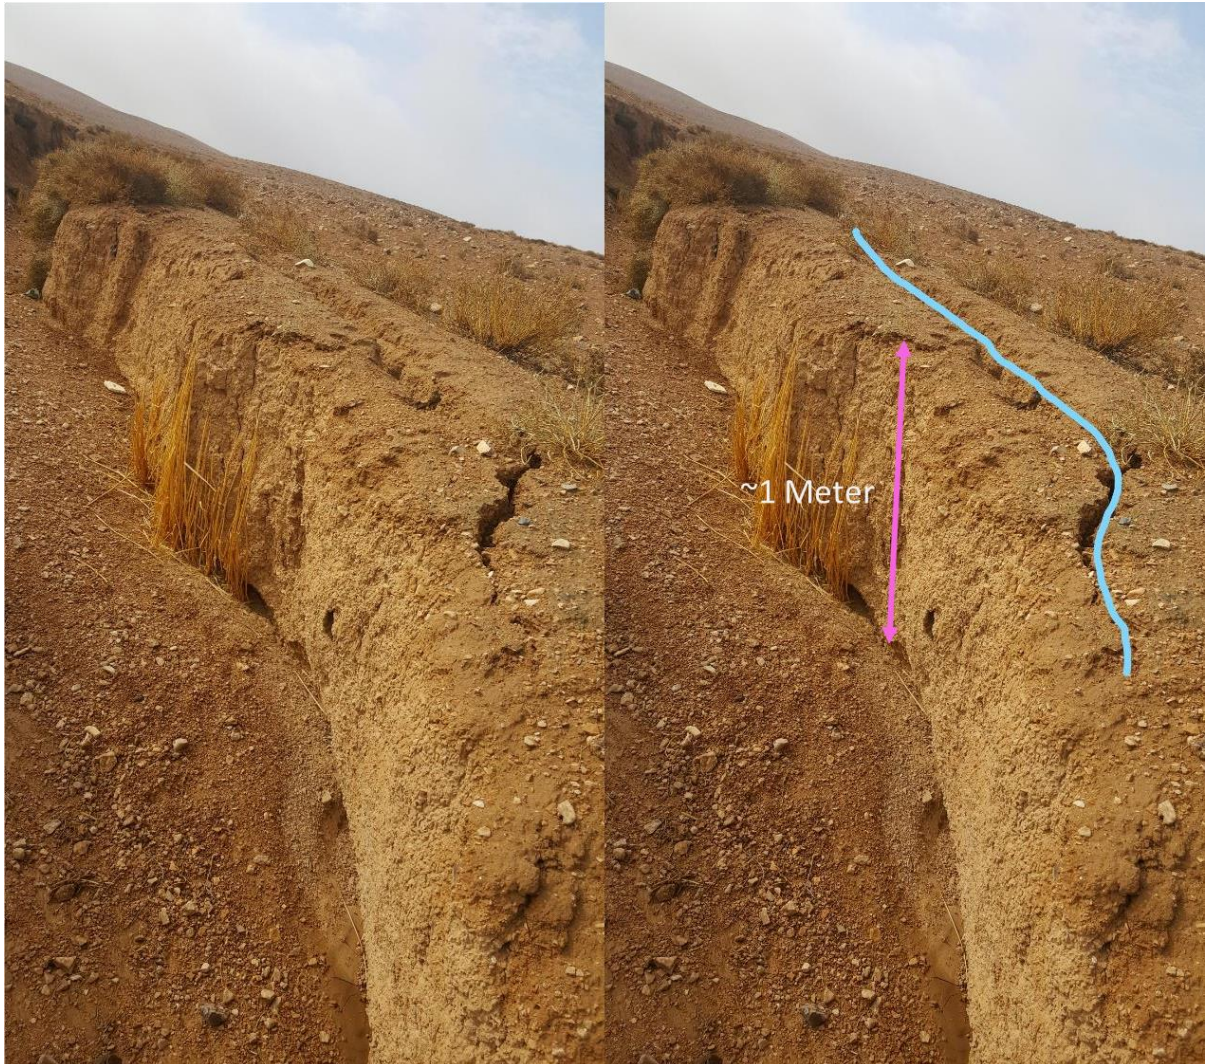
Figure 37: Spliced earth as seen in the gully (blue line). The side bank can collapse after undermining by scouring.

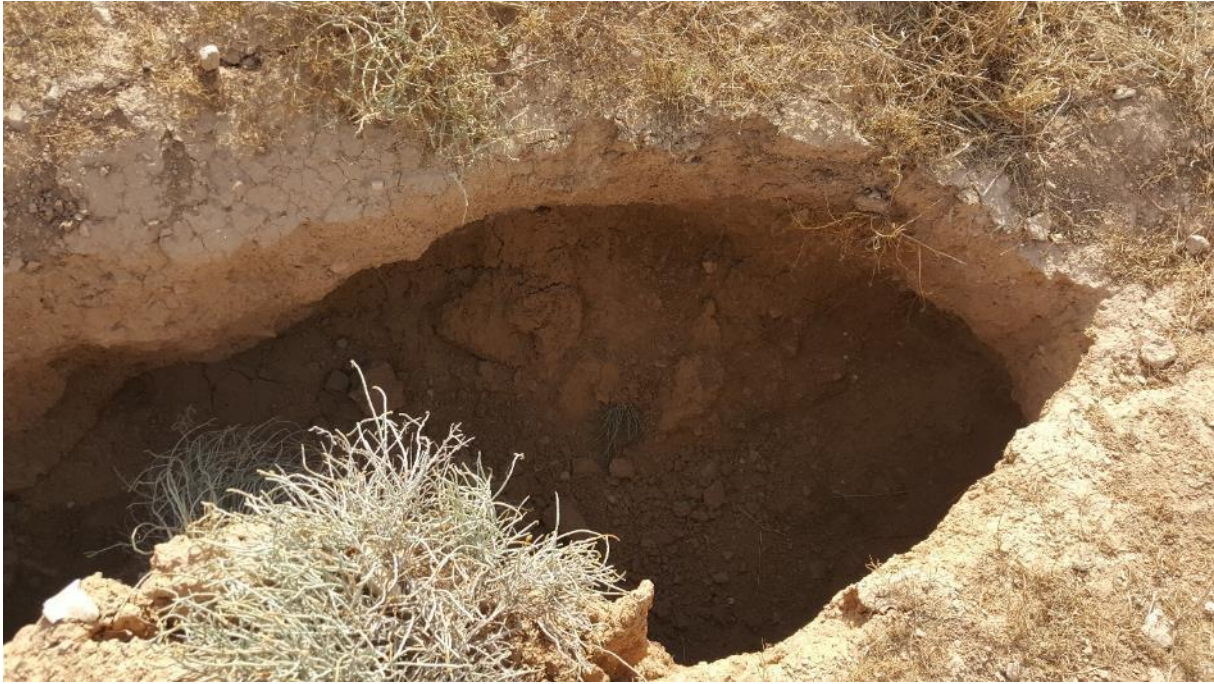
Figure 39: Headward erosion and undercutting in the side banks of the gully. Just right of the plunge pool an erosion rill is visible.

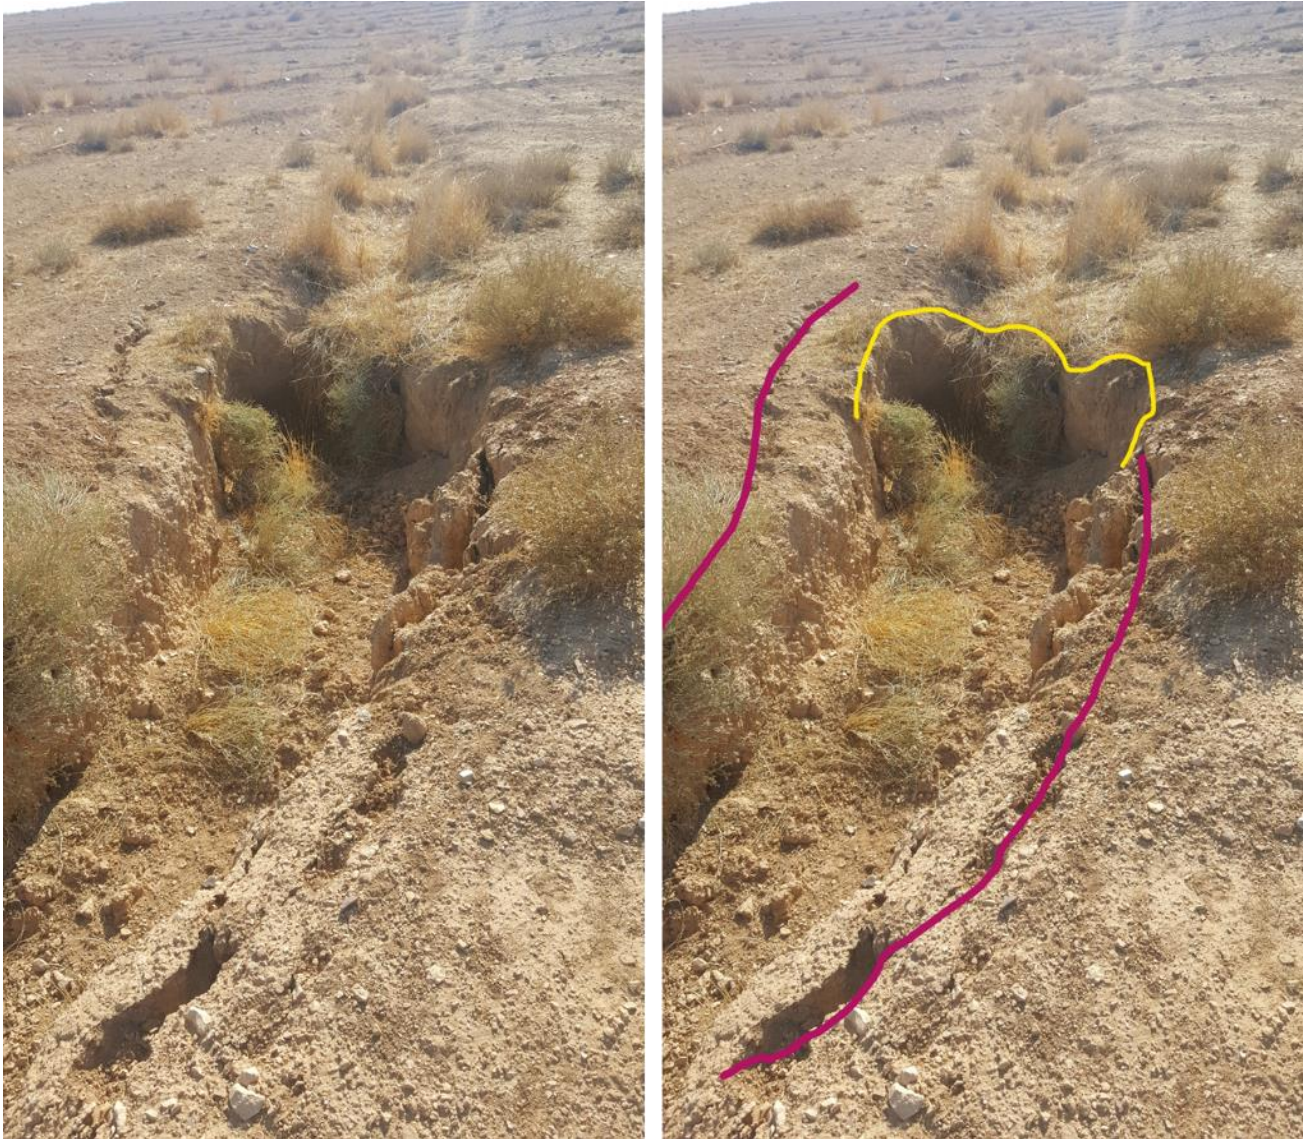
Figure 40: The starting point of the gully and headward erosion as observed in the field. Undercutting takes place at the yellow line, the purple line depicts spliced earth.

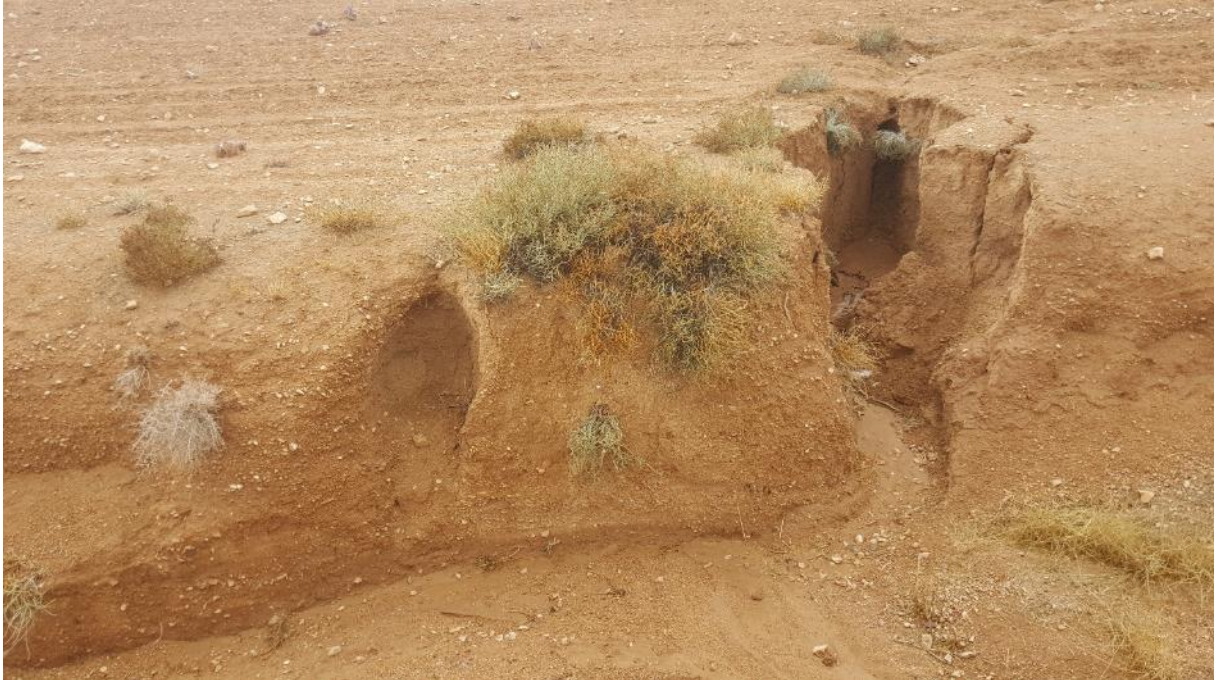
Figure 43: Plunge pool and headward erosion next to vegetation. The vegetation stabilized the side wall, but enhanced erosion around the vegetation due to flow concentration on both sides.

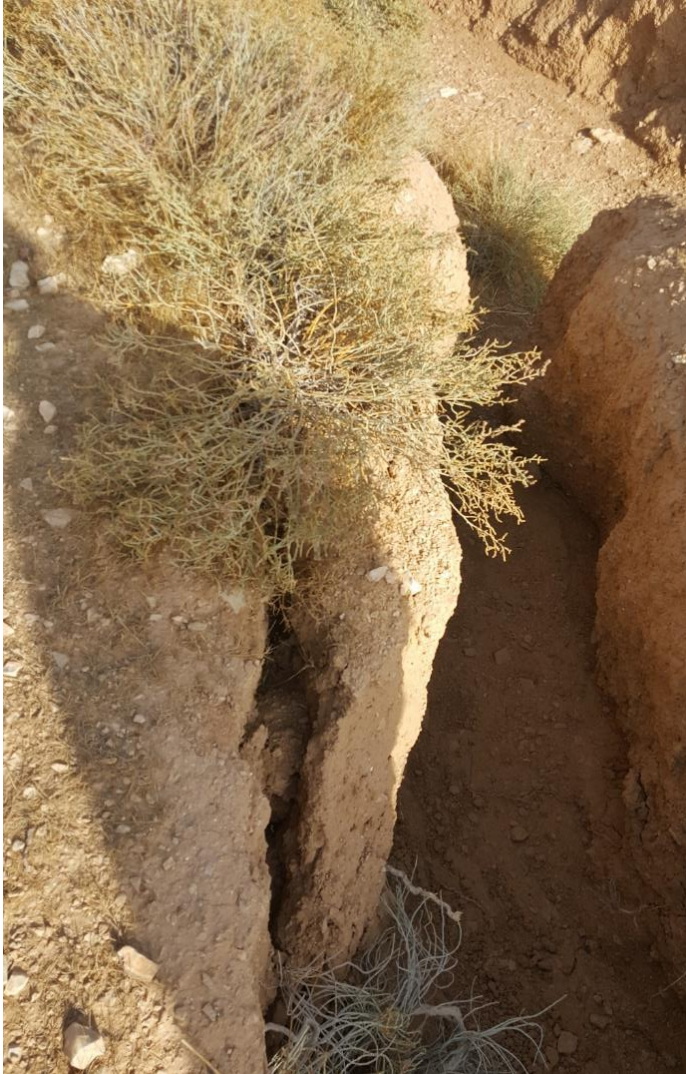
Figure 44: Earth splicing at the roots of vegetation.

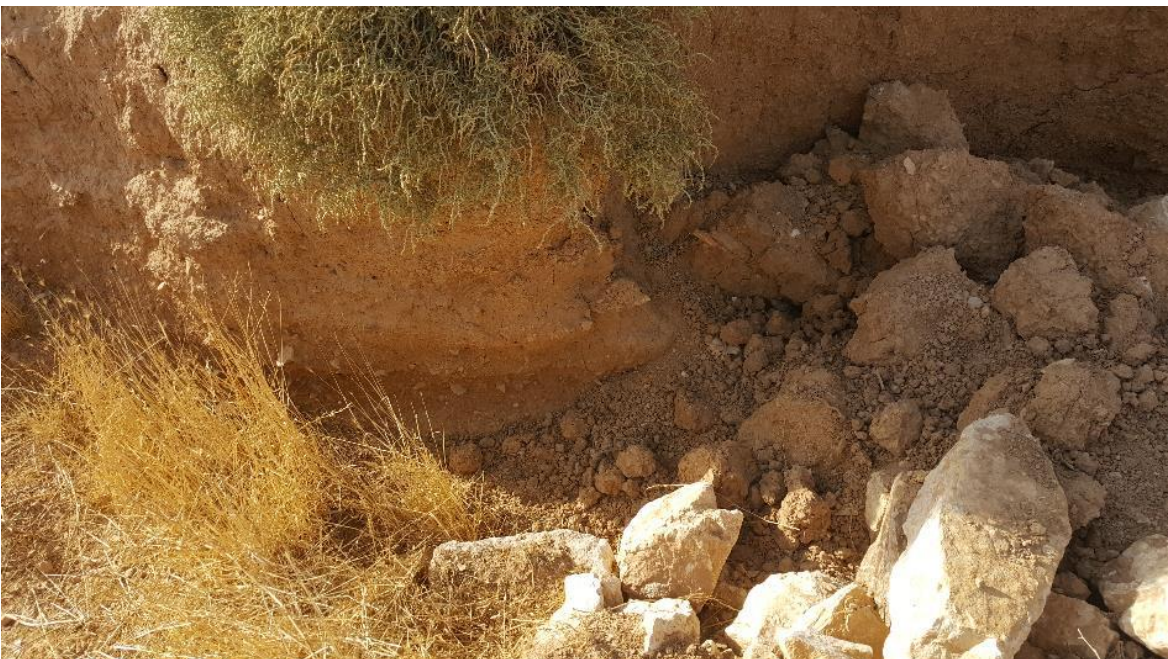
Figure 45: Vegetation holding soil together while the side collapses.

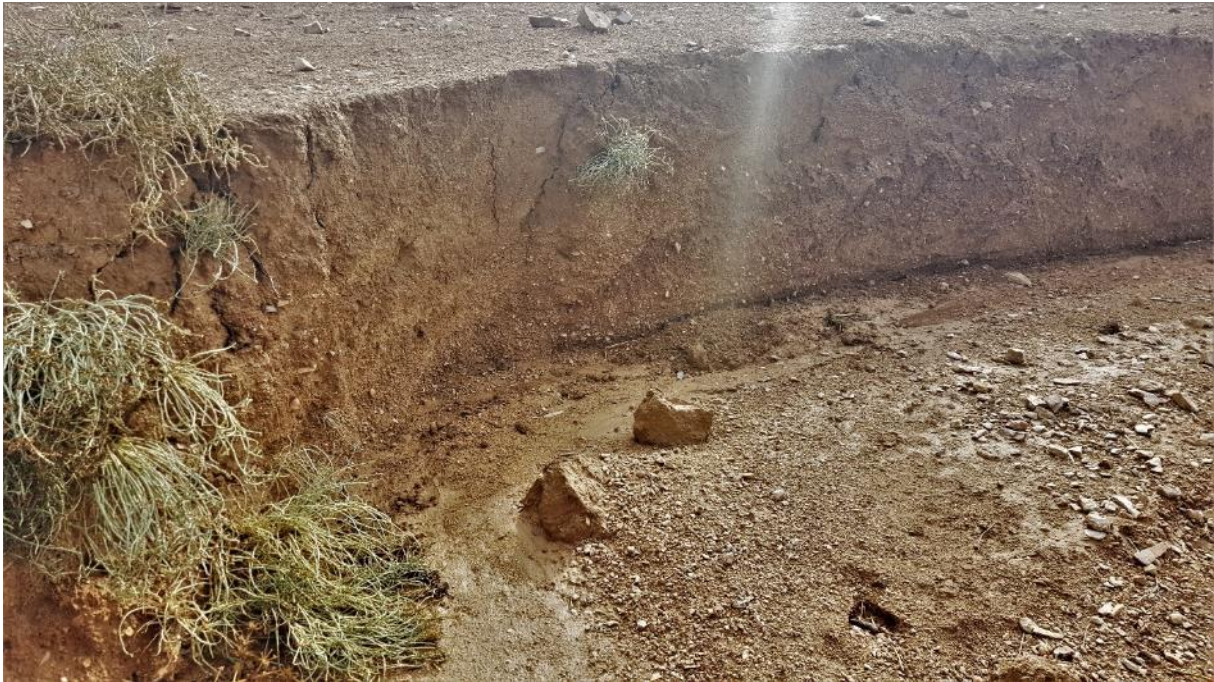
Figure 46: Soil stability and vegetation. The side wall with vegetation has collapsed due to erosional forces exceeding the stability forces.

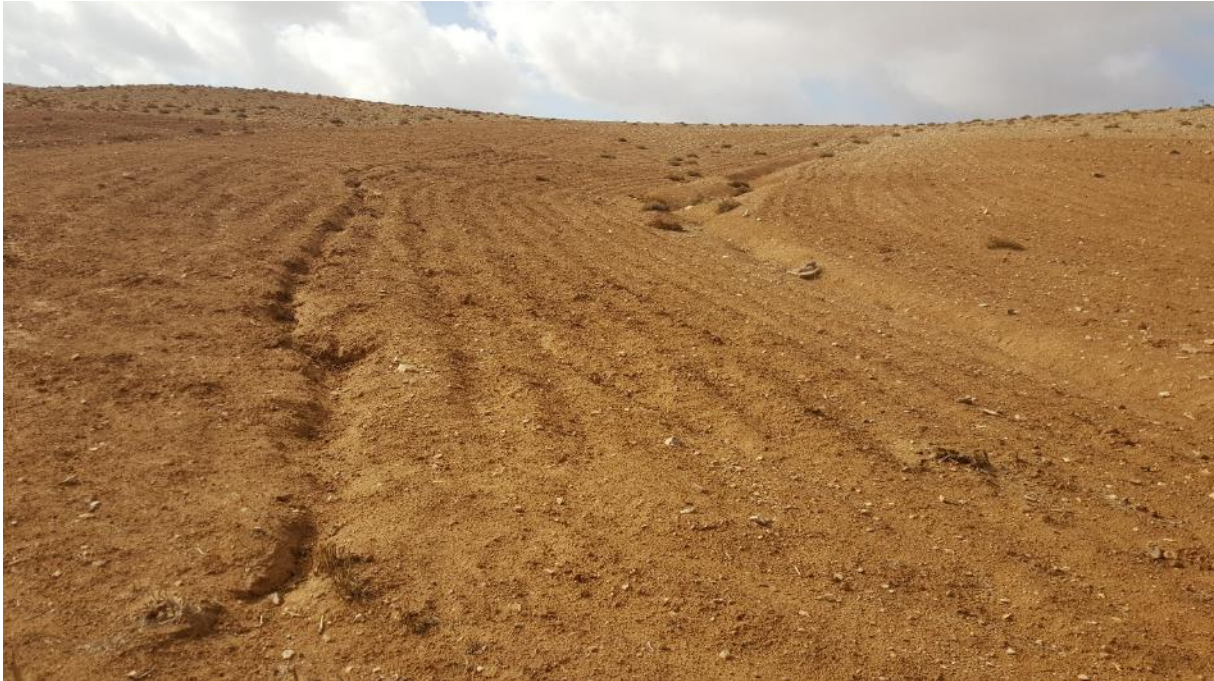
Figure 47: Forming of rill erosion by contour plowing parallel to a gully tributary.

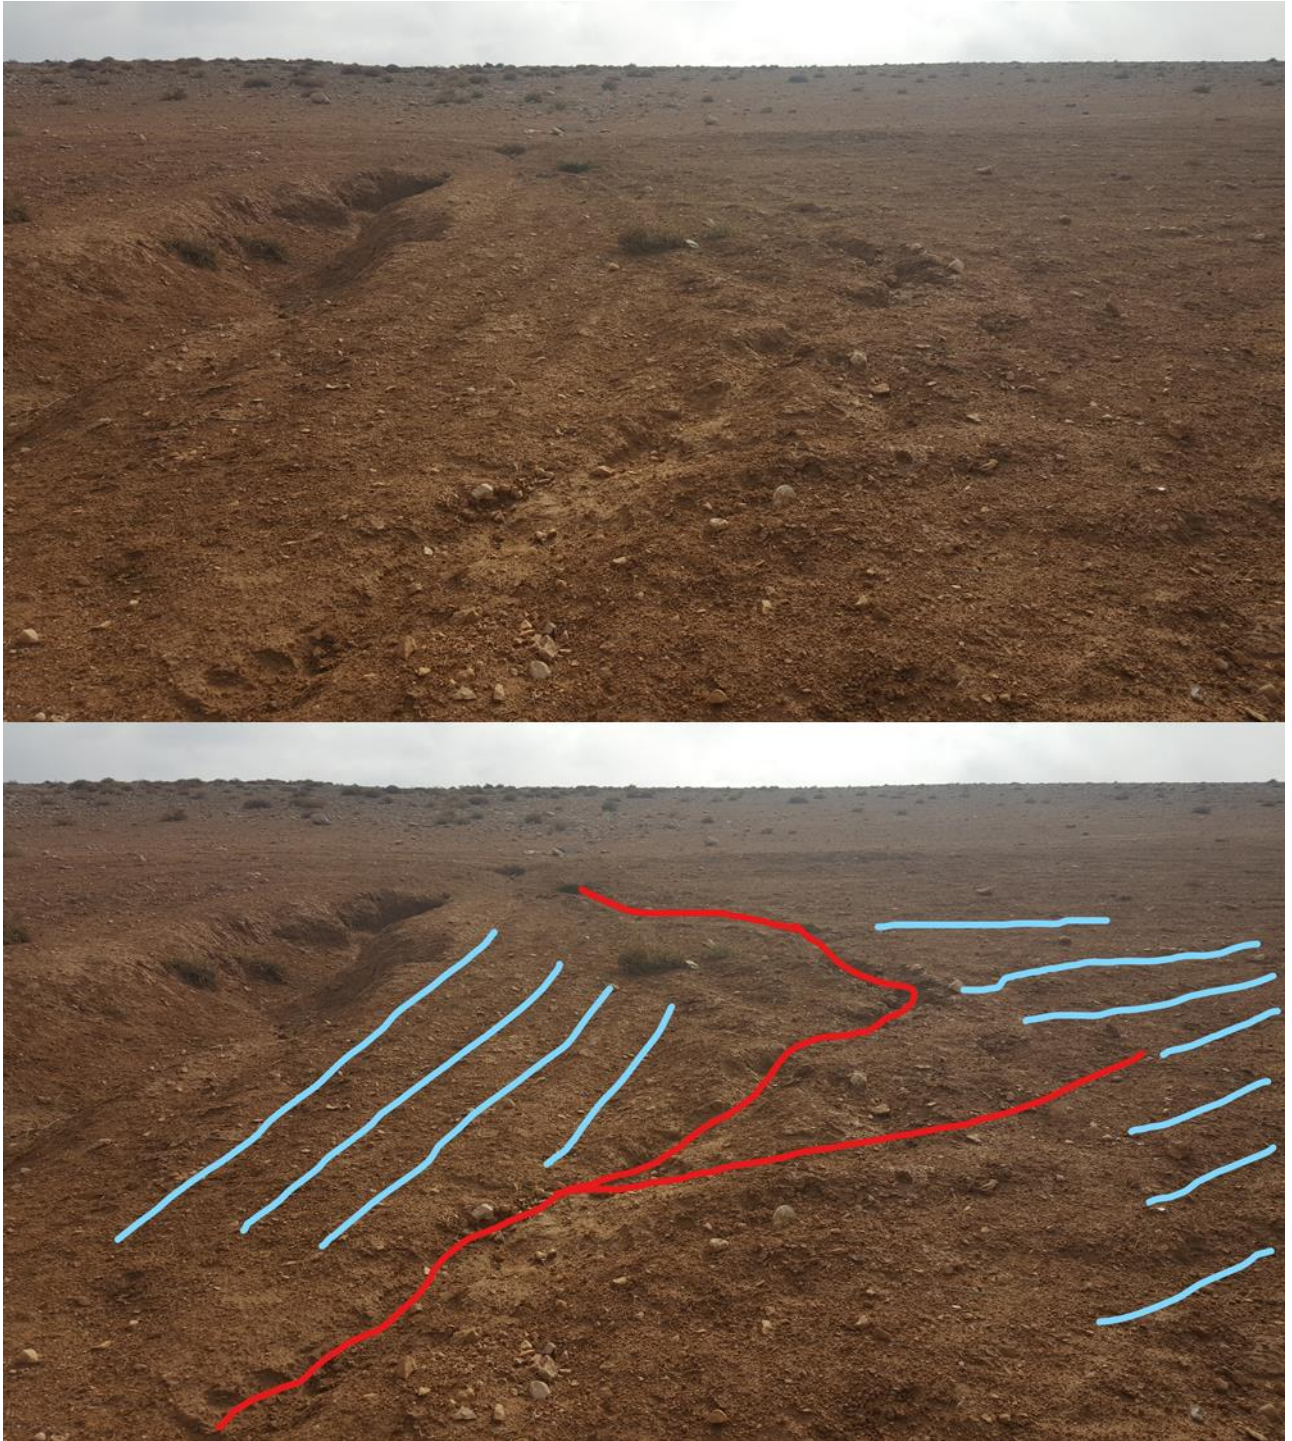
Figure 48: Rill erosion at the boundary of perpendicular contour plowing lines. Blue lines represent contour plowing and the red line represents rill erosion.

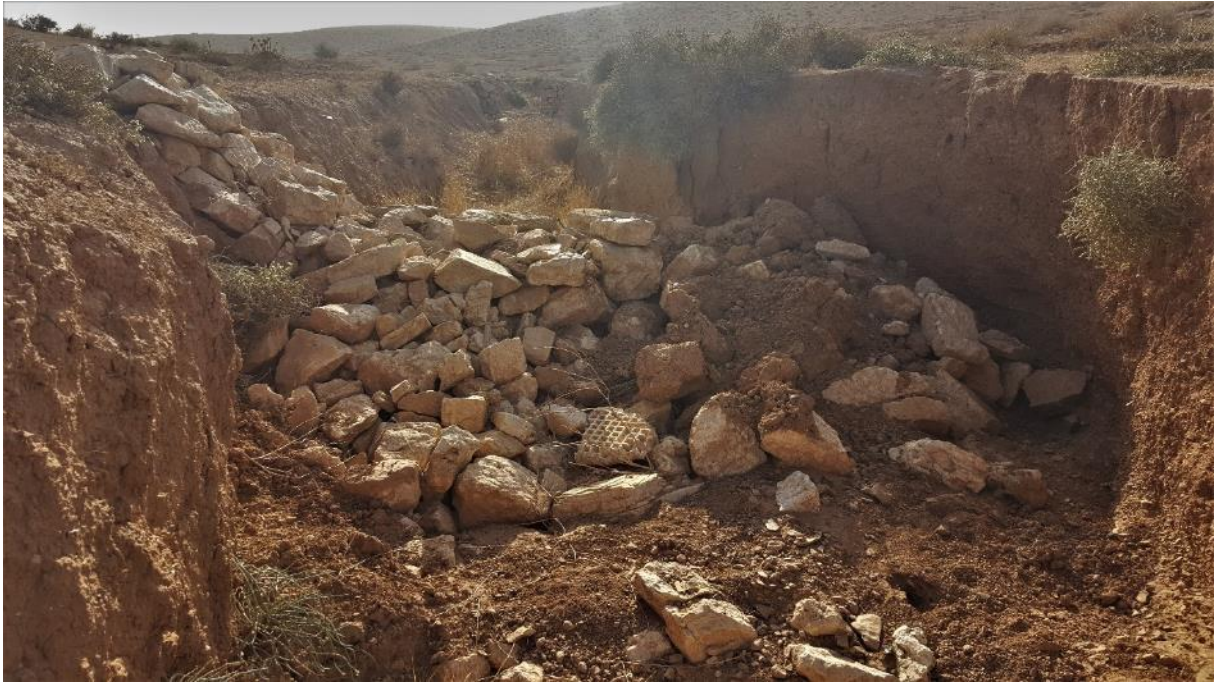
Figure 49: Failed gully plug located in the treated watershed. Increased erosion was seen on the right where the side bank collapsed.

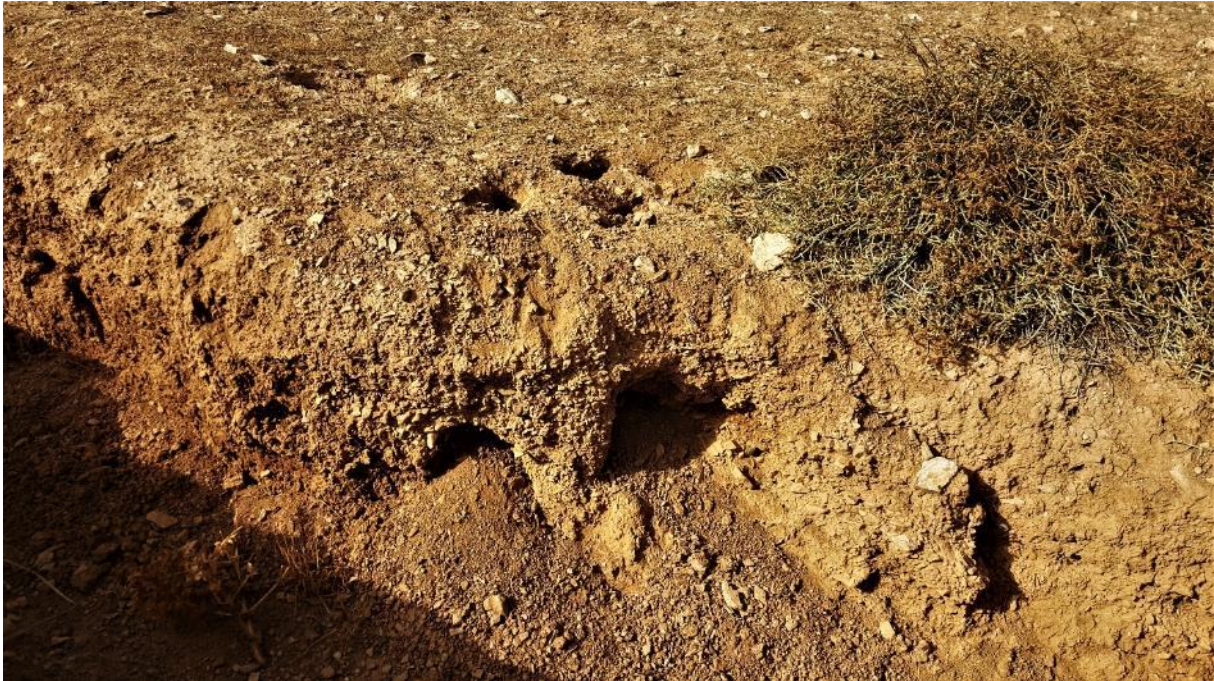
Figure 50: Animal perturbation as observed in the field.
