Mapping and quantifying the rate of soil and gully erosion in the dry areas of Jordan

MSc Thesis

08-2020

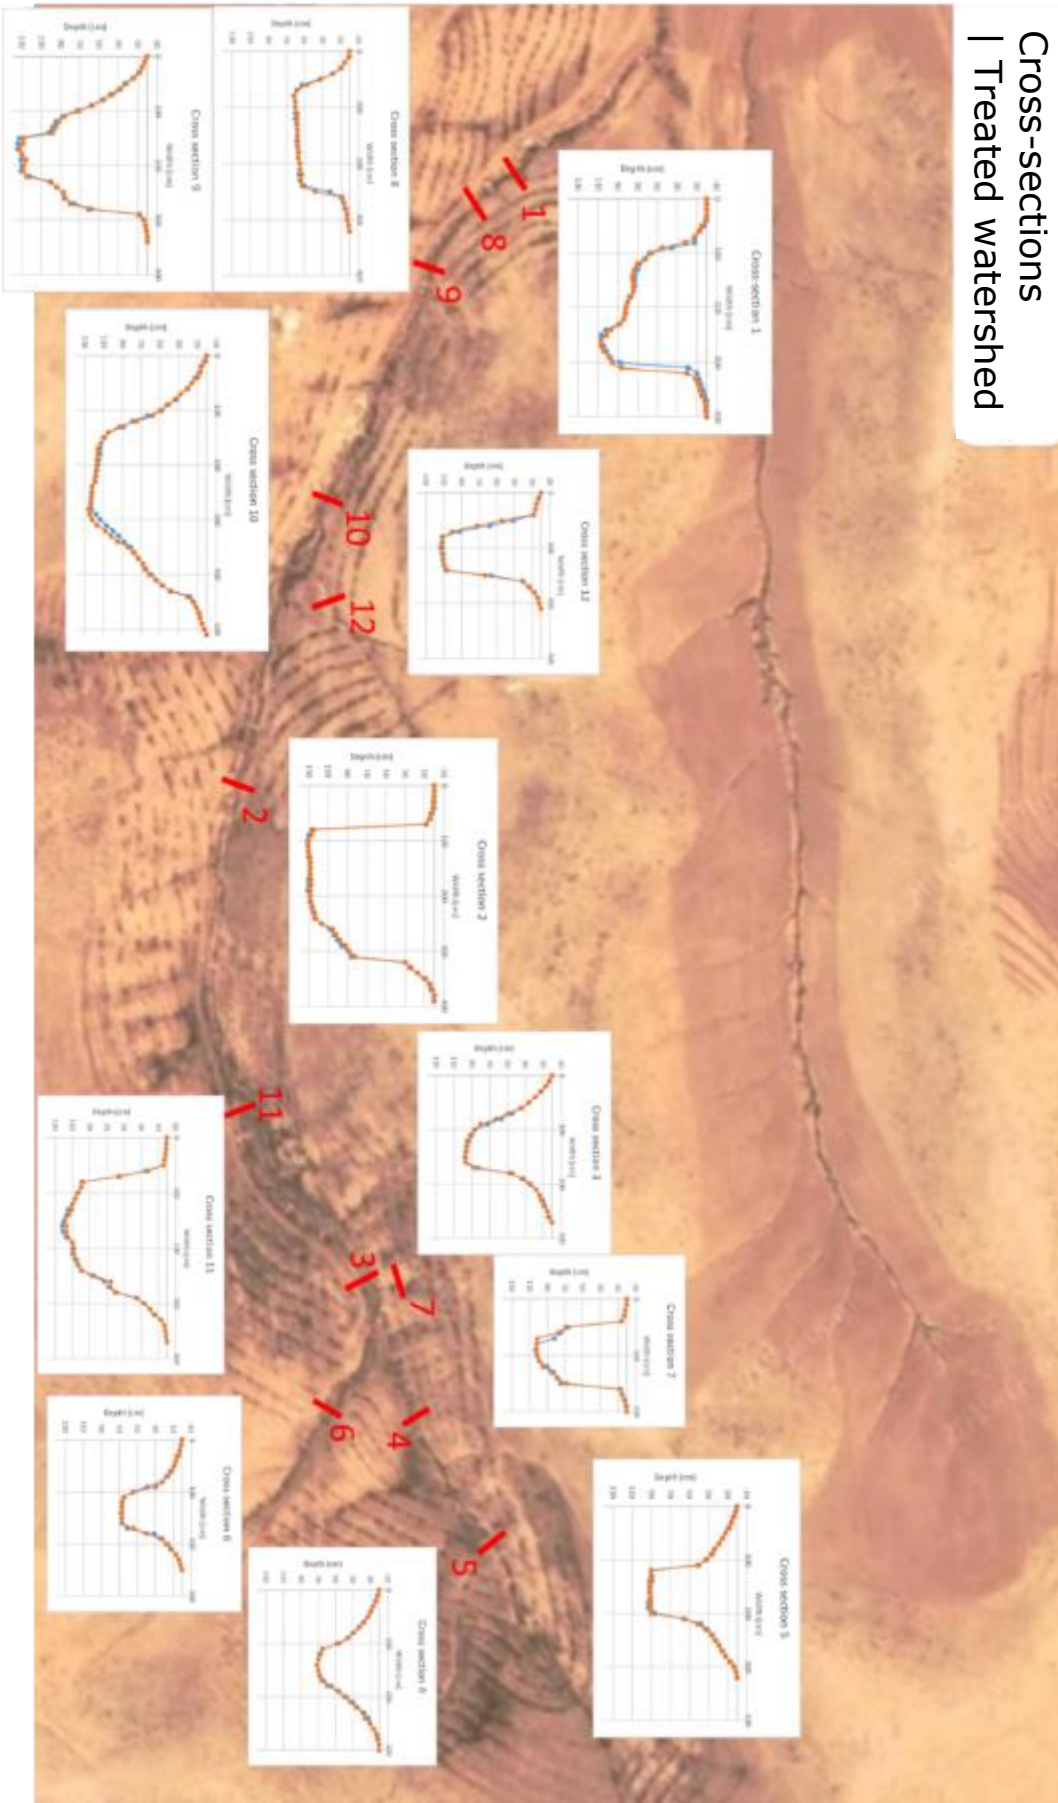
Cross-sections | Treated watershed

Figure 51: Cross sections in the treated gully watershed (see appendix 3). Blue lines represent measurements before rainfall events, orange lines represent measurements after rainfall events.
