SPATIAL VARIATION AT THE SURINAME COAST:

Deriving alongshore and cross-shore patterns in tidal channel geometry, elevation and vegetation from UAV imagery

Tessa Deggeller (5655374)
Utrecht University

February 2021

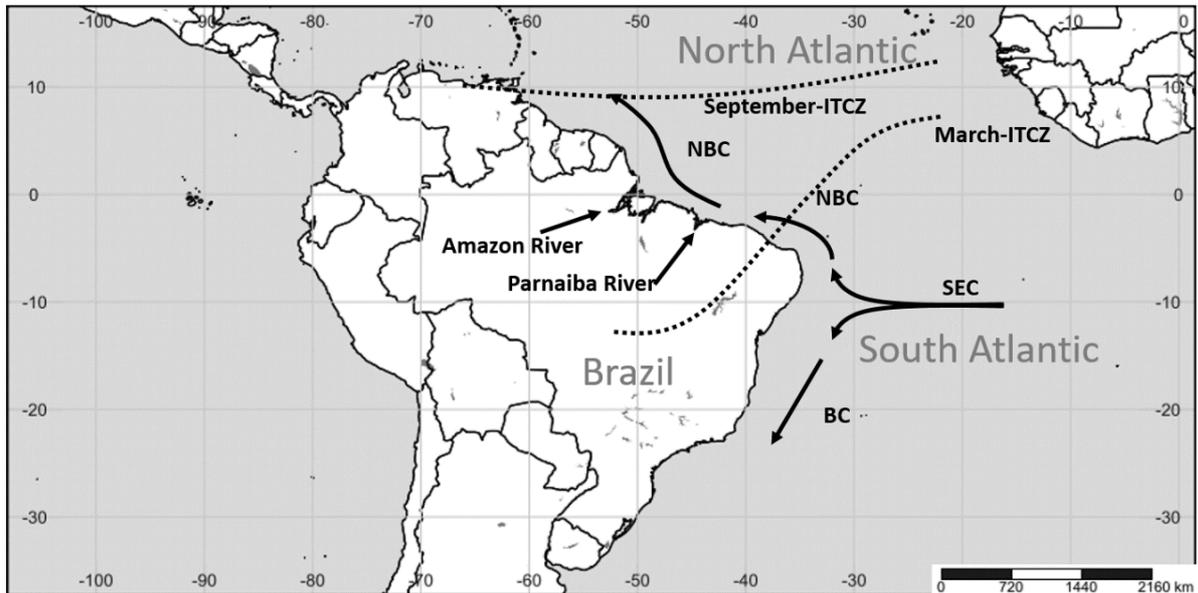
Figure 1. Schematic map showing the major ocean currents in the Atlantic. The Southern Equatorial Current (SEC) flows west, splitting into the Brazilian Current (BC) and the North Brazilian Current (NBC) (Roberts, 2017).

The main oceanic forcing mechanism is the South Equatorial current, which flows west from the Southern Atlantic Ocean to Brazil and then splits into the North Brazil Current (NBC) or Guiana current, flowing along the Guiana coast, and the Brazil Current going southward from Brazil (Figure 1). Because of the NBC, the Guiana coast is continuously under influence of a north-westward current, flowing over the outer shelf (Chevalier et al., 2004).

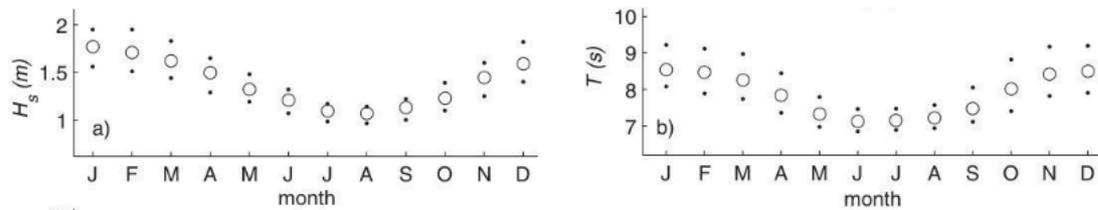
Figure 2. Wave climate at the Suriname coast from a 44-year record of ERA-40 (European ReAnalysis). Left shows significant wave height H_s , and right shows significant wave period T_s . Dots represent the first and third inter-quartiles, circles are the median values (Anthony, 2016)

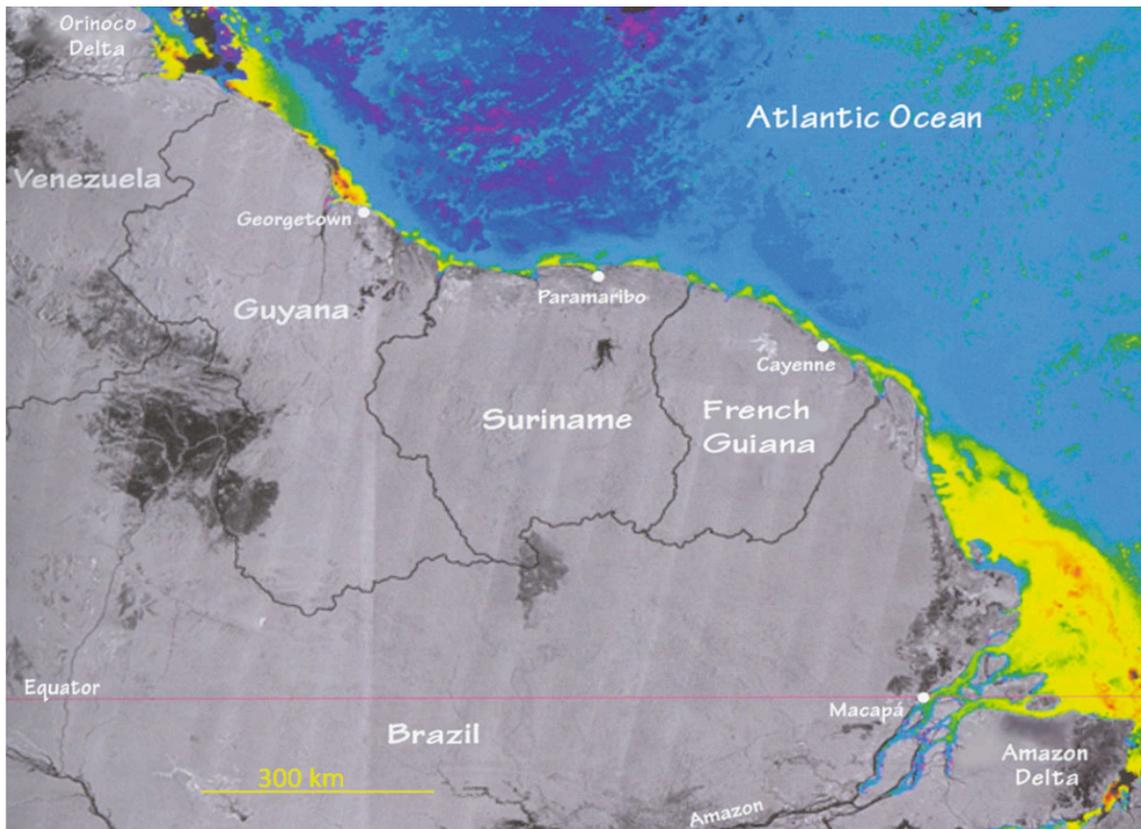
Figure 3. Turbidity along the Amazon delta and the north-eastern coastline of South America derived from NOAA satellite images (Toorman et al., 2018).

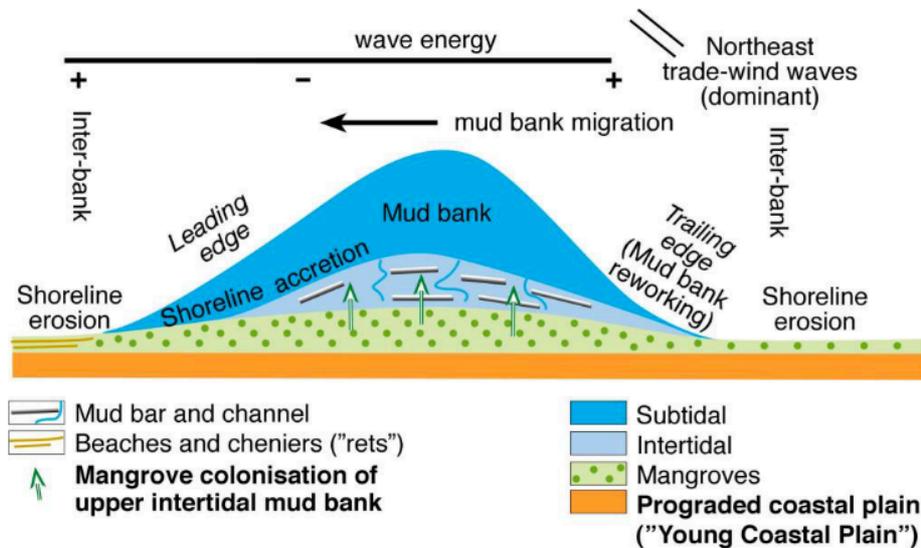
Figure 4. Mudbank migration and dynamics (Anthony, 2016).

Near the mouth of the Amazon river, around 15-20% of the muddy discharge forms highly turbid suspensions ($>1\text{g}/\text{L}$). This causes mud banks to form that traverse from east to west, causing a multi-year cycle of erosion and accretion. There can be around 15 mudbanks simultaneously migrating along the Amazon coast, each with a length of 10-60 km. They migrate westward with speeds of $2\text{km}/\text{yr}$, and they can contain the multiple times the equivalent mass of the yearly sediment discharge of the Amazon river (Anthony et al., 2010, 2019; Toorman et al., 2018). They are traversing over a mud wedges that are deposited by earlier mud banks, at water depths of $<5 \text{ m}$ (Mead A. Allison et al., 2000) or $<5 \text{ to } 20 \text{ m}$ (Anthony et al., 2010). The cycle of mudbanks is generated by sediment transport through longshore currents and wave hydrodynamics. Westward migration happens by erosion on the east side (trailing edge) of the bank, and deposition of fluid mud on the leading side (Figure 4).

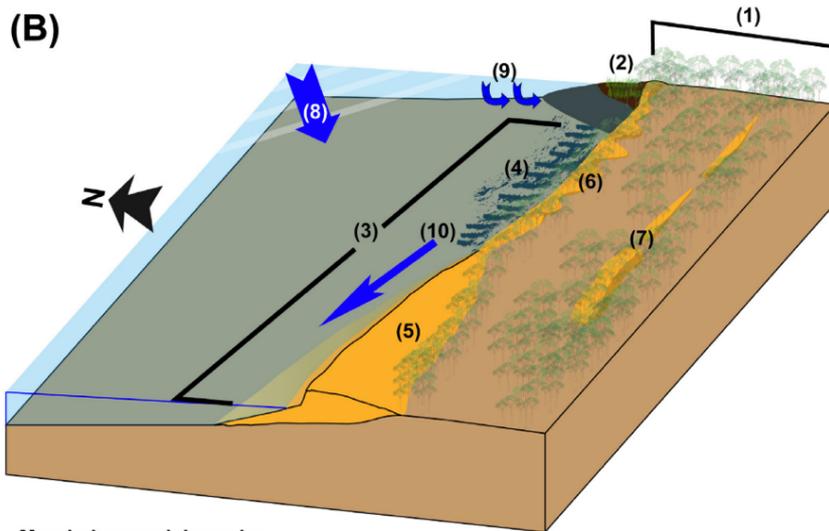
Figure 5. A conceptual model of the morphodynamics and sediment transfer at the Braamspunt chenier. (Anthony et al., 2019)

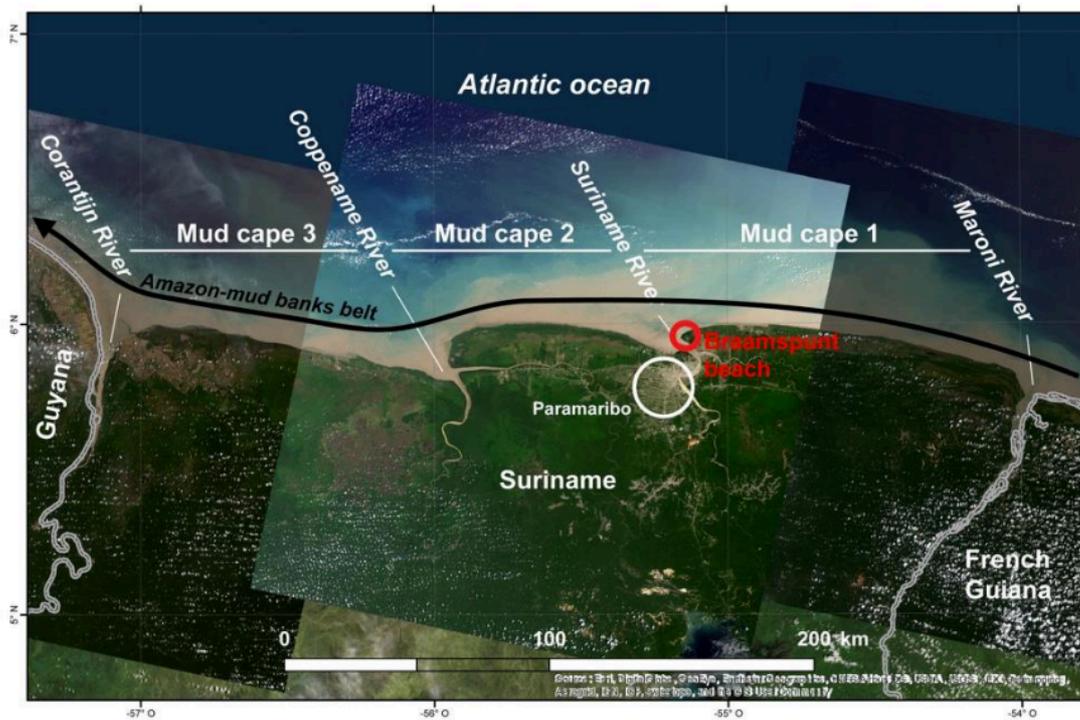
Figure 6. Satellite image of the Surinam coast, including the mud capes (orange hue) between the four main rivers (Anthony, 2016)

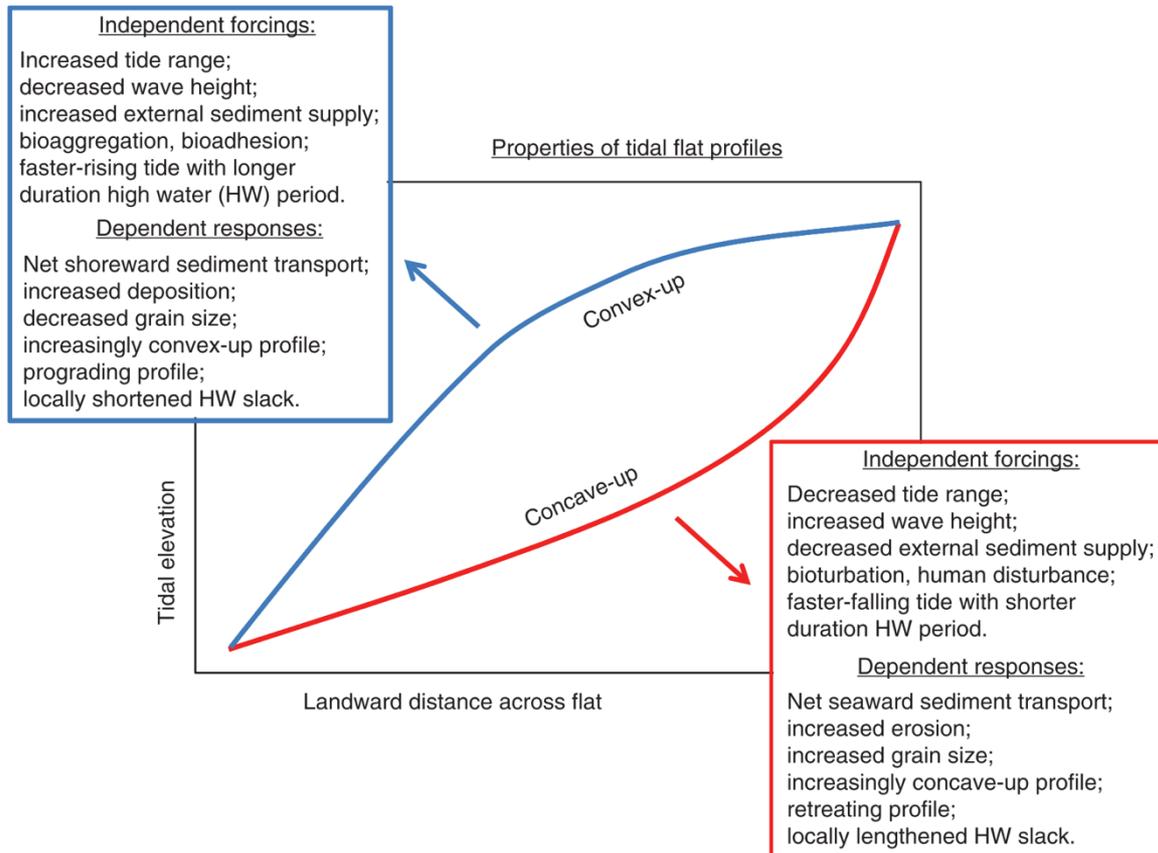
Figure 7. Conceptual diagram explaining the connection between profile shape of a tidal flat and the independent forcings, resulting in a concave-up or convex-up profile (Friedrichs, 2012).

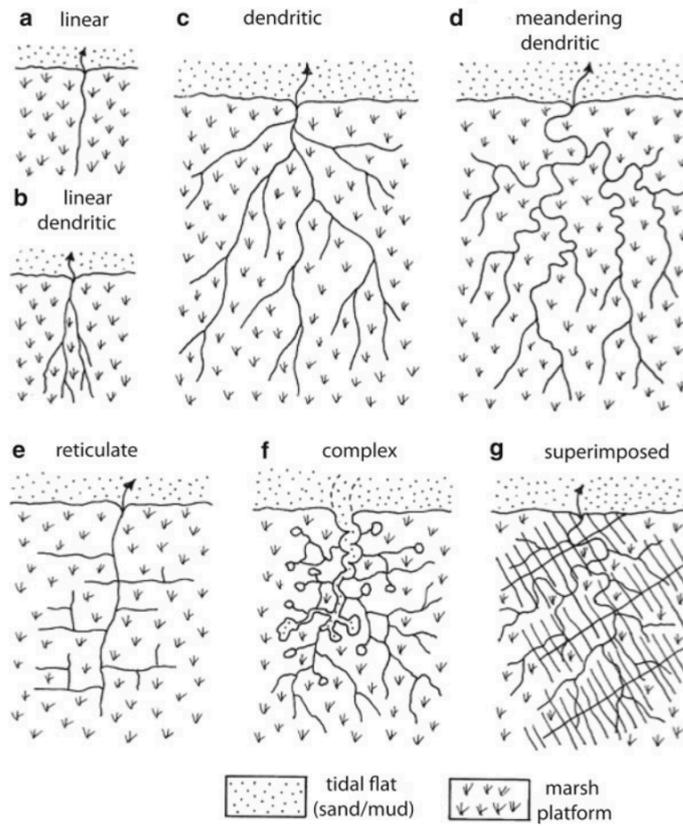
Figure 8. A classification for salt marsh creek networks (by Pye and French, 1993, via Hughes, 2011)

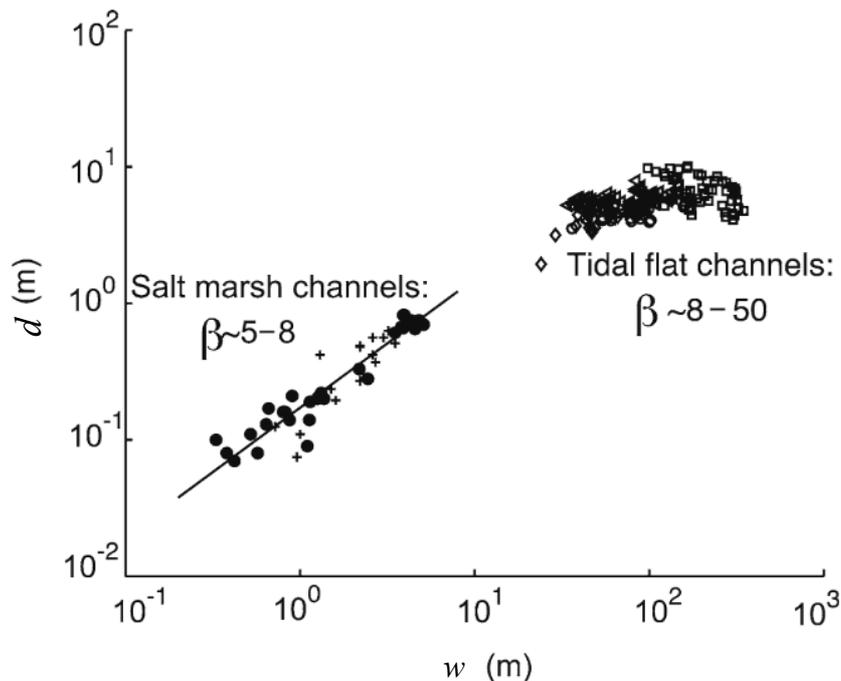
Figure 9. Width-to-depth ratio defined as $\beta=w/d$, measured from tidal channels in the lagoon of Venice. Two populations are distinguished: channels on vegetated marshes have lower width-to-depth ratio's than the channels on tidal flats (altered from Hughes et al, 2011).

Marani et al. (2002) compared tidal channel in different systems, based on their width-to-depth ratio, and found that largely two populations can be identified: salt marsh creeks usually have smaller ratios ($5 < \beta < 8$) than tidal flat channels ($8 < \beta < 50$) (Figure 9, Hughes, 2011). In tidal flat systems, sediments are usually coarser and less cohesive. This makes them more easily eroded, causing wider, shallower channels. Furthermore, vegetation will slow down the flow once it overtops the channel bank, which leads to increased deposition near the channel edges, locally enhancing accretion. This leads to larger channel depths (Hughes, 2011).

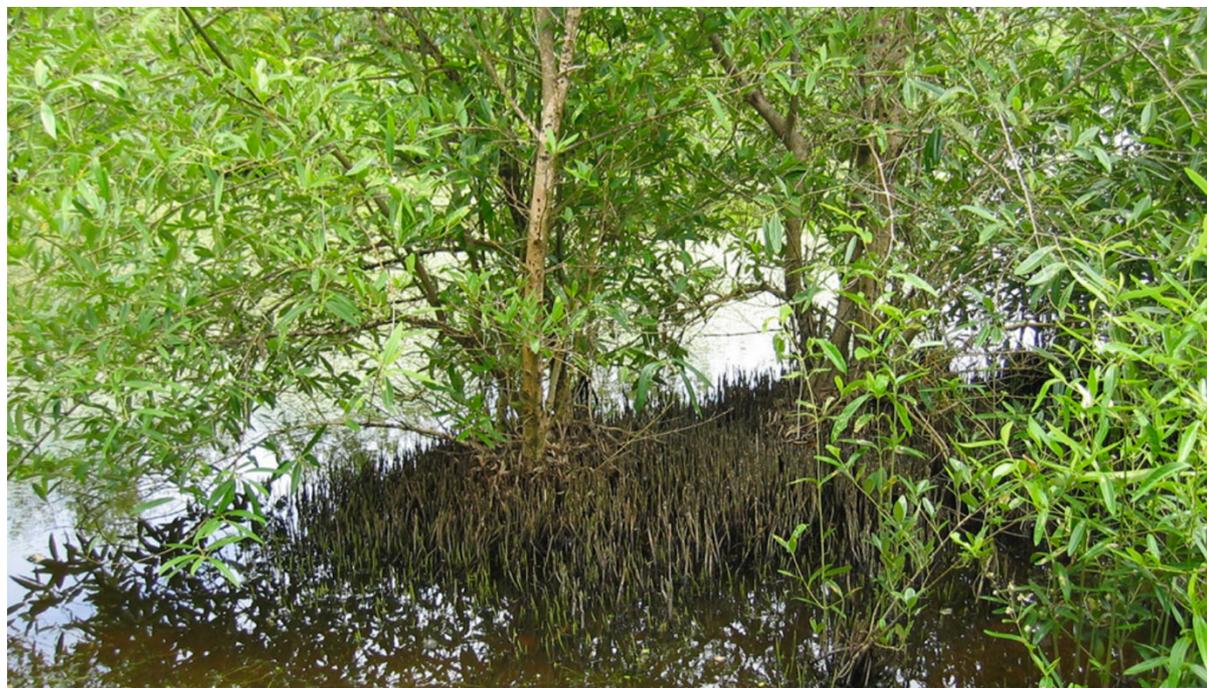
Figure 10. Black mangrove (*Avicennia germinans*), with its pneumatophore root system. (Toorman et al., 2018).

Unlike other coasts, the Atlantic coast of the Guianas has only a few mangrove species. The black mangrove (*Avicennia germinans*) dominates the coastal fringe (Figure 10), and red mangroves (mostly *Rhizophora mangle*) grow along the banks of tidal rivers and creeks, rather than at the coast itself.

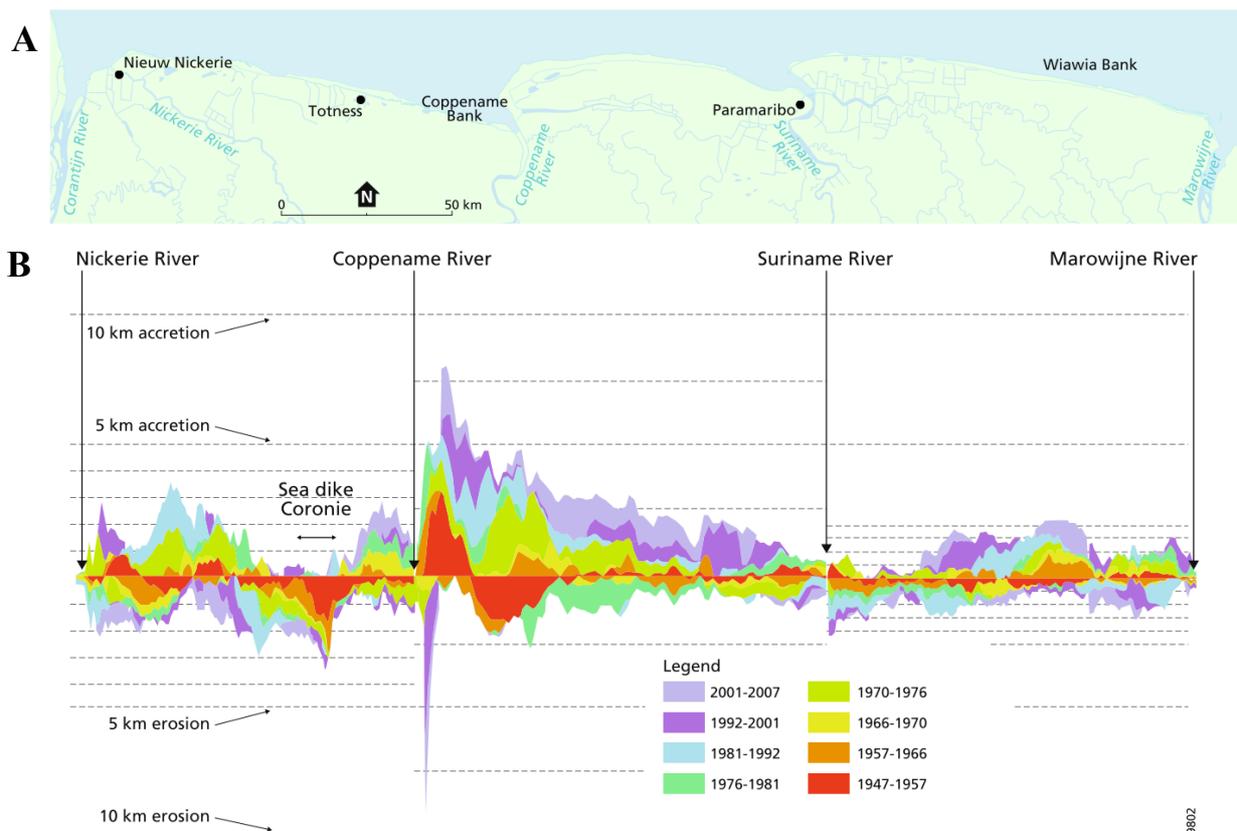
Figure 11. Map of the Suriname coast and its three sections (A), and the corresponding overview of coastal erosion and accretion along the Suriname coast, between 1947 and 2007 (B) (Wong et al., 2017, via Jong et al., 2021)

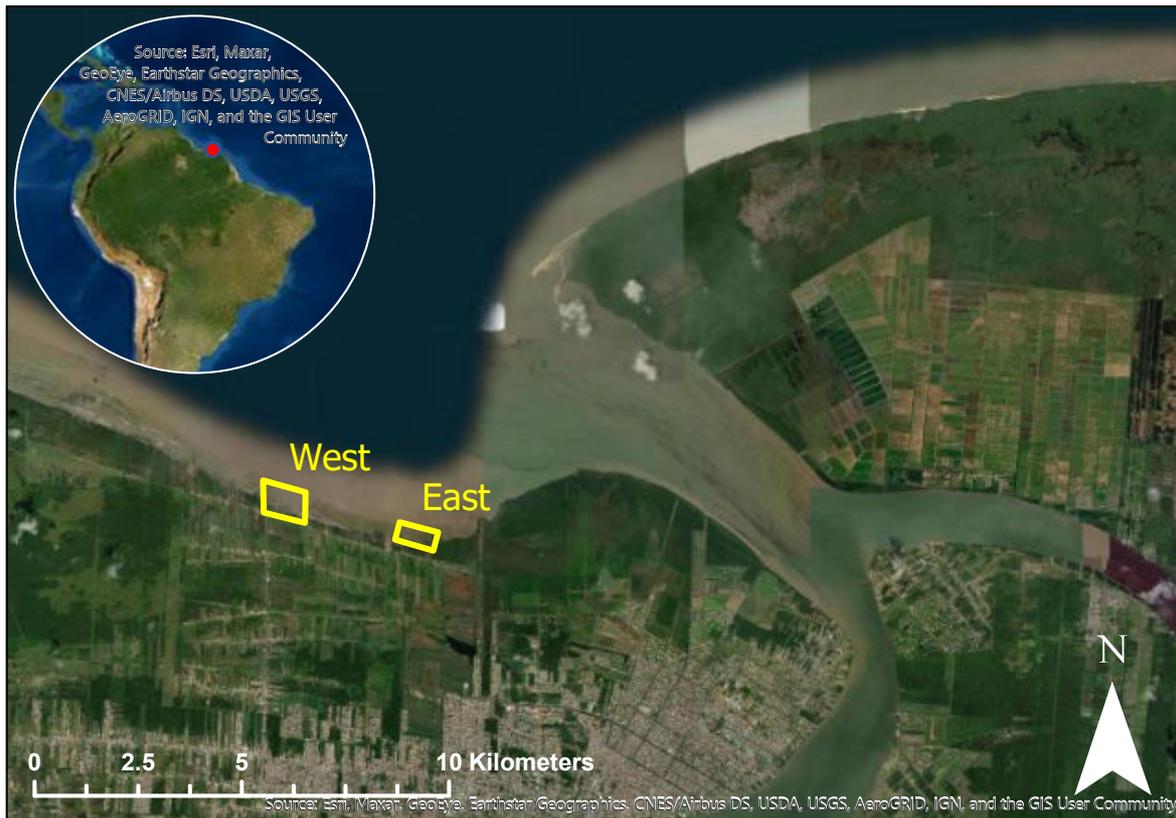
Figure 12. Location of the study sites, at the coast near the Suriname river mouth, north of Paramaribo, Suriname.

The main data for this study is UAV imagery with a resolution of 2,5 cm. The imagery covers the two intertidal locations of ± 500 m x 1000 m that are 2.2 km apart: location East and location West (Figure 12). This data is available for two different moments in time: June 2019 and February 2020. Thus, four surveys were carried out: West-2019, West-2020, East-2019, and East-2020. However, due to camera issues, East-2020 turned out to be unusable. Therefore, three datasets were available in the end.

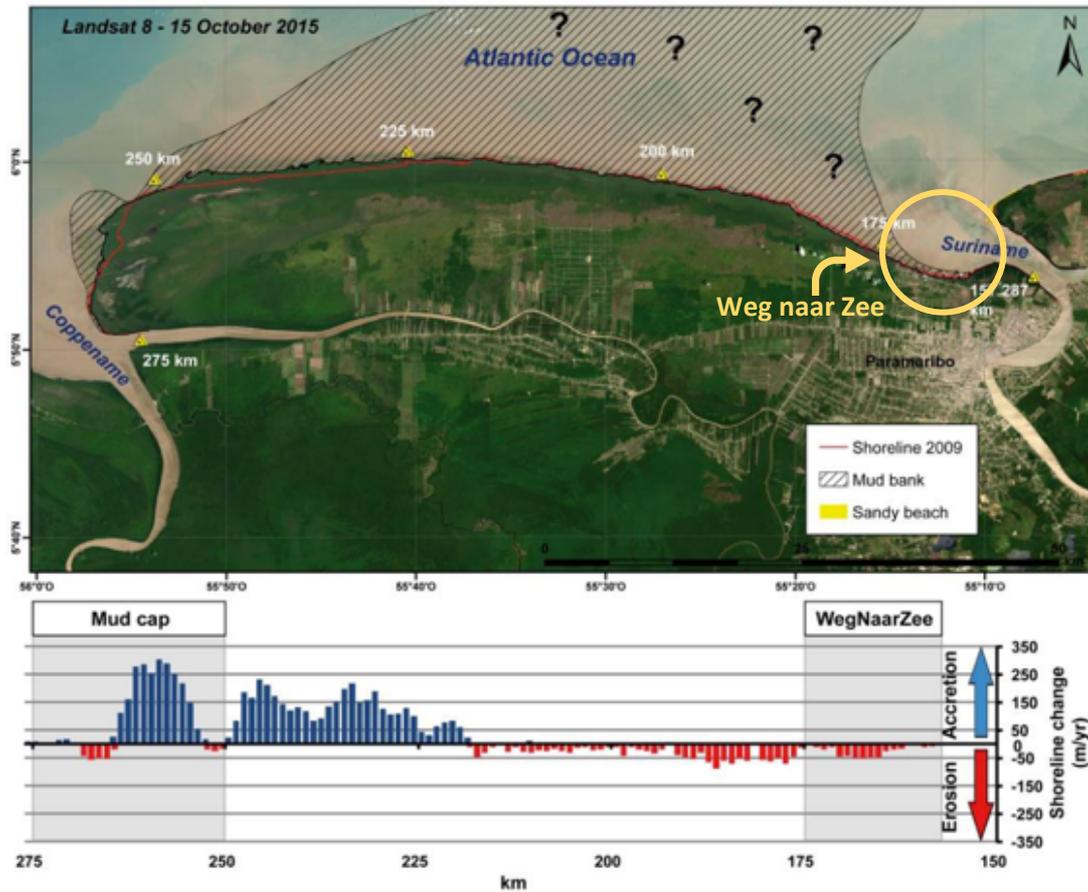
Figure 13. Shoreline changes between 2009 and 2015, between the Coppename river and the Suriname river. The western section shows muddy accretion, whereas the eastern section shows (inter-bank) erosion. (Anthony, 2016)

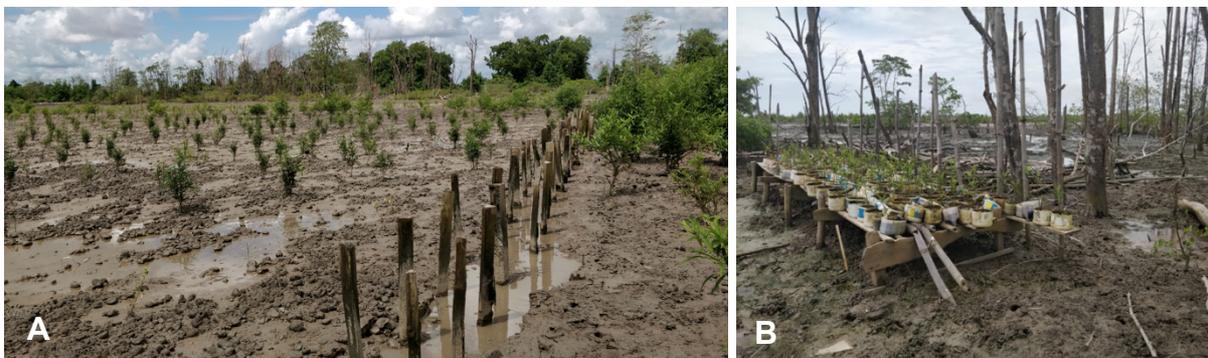
Figure 14. A: Newly planted mangroves in West-2019, and two parallel lines of upright poles. B: sprouted mangroves, ready to be planted on the mudflat.

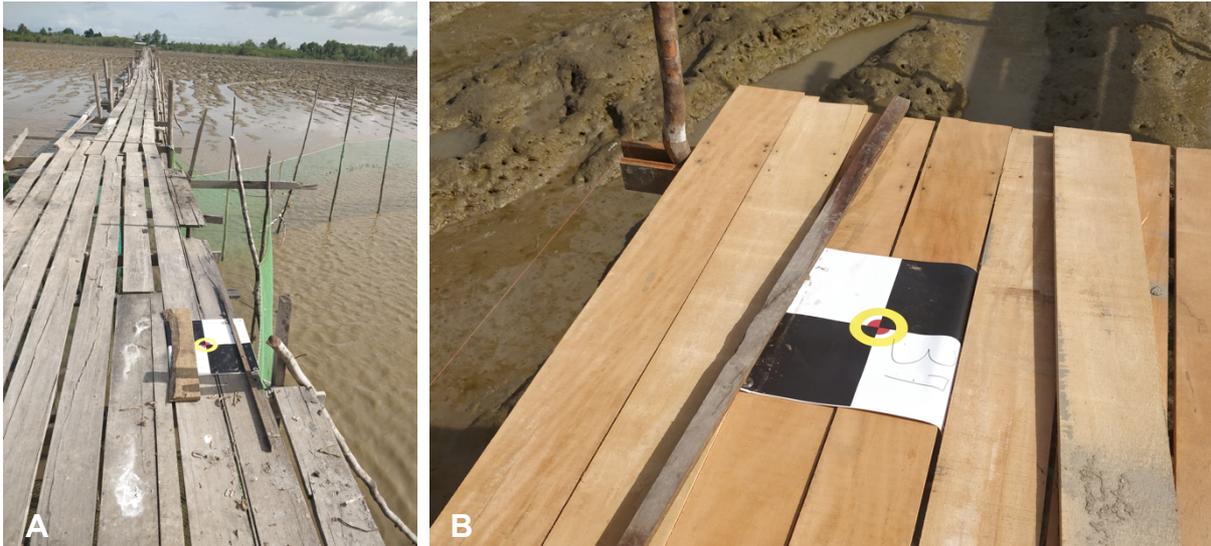
Figure 15. Wooden jetties in the western study site, with examples of Ground Control Points (GCPs).

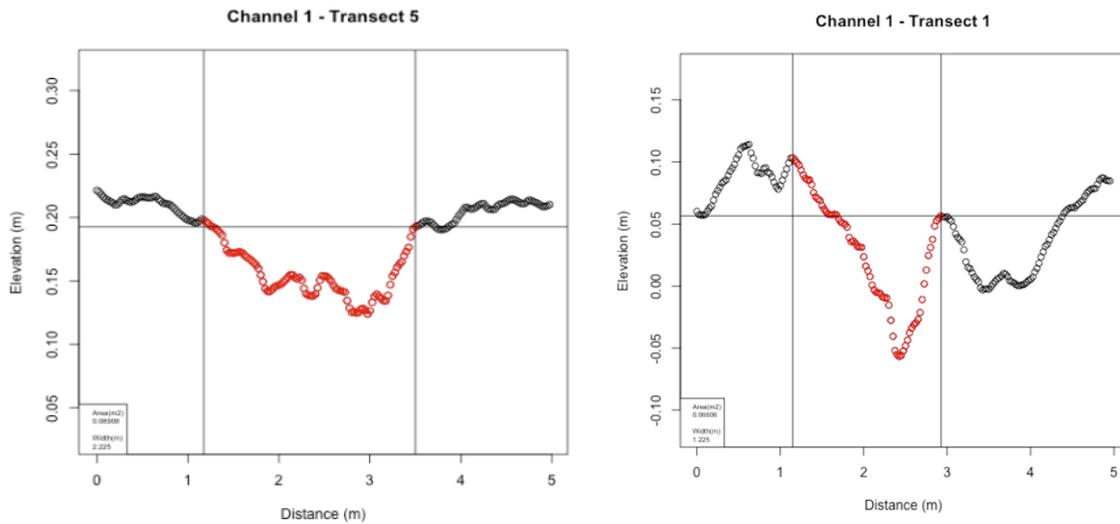
Figure 16. Examples of transects and the identified channel boundaries in RStudio.

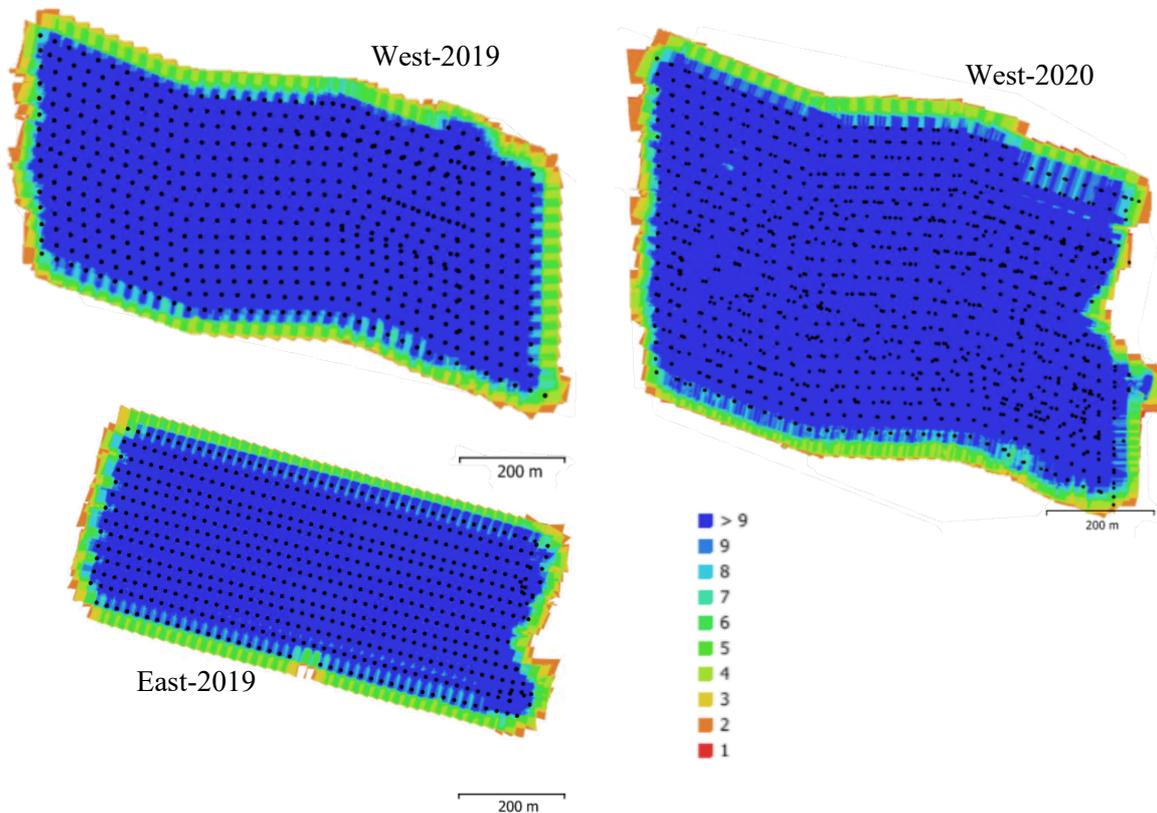
Figure 17. Camera locations (dots) and image overlap (colours) of the image processing in Agisoft.

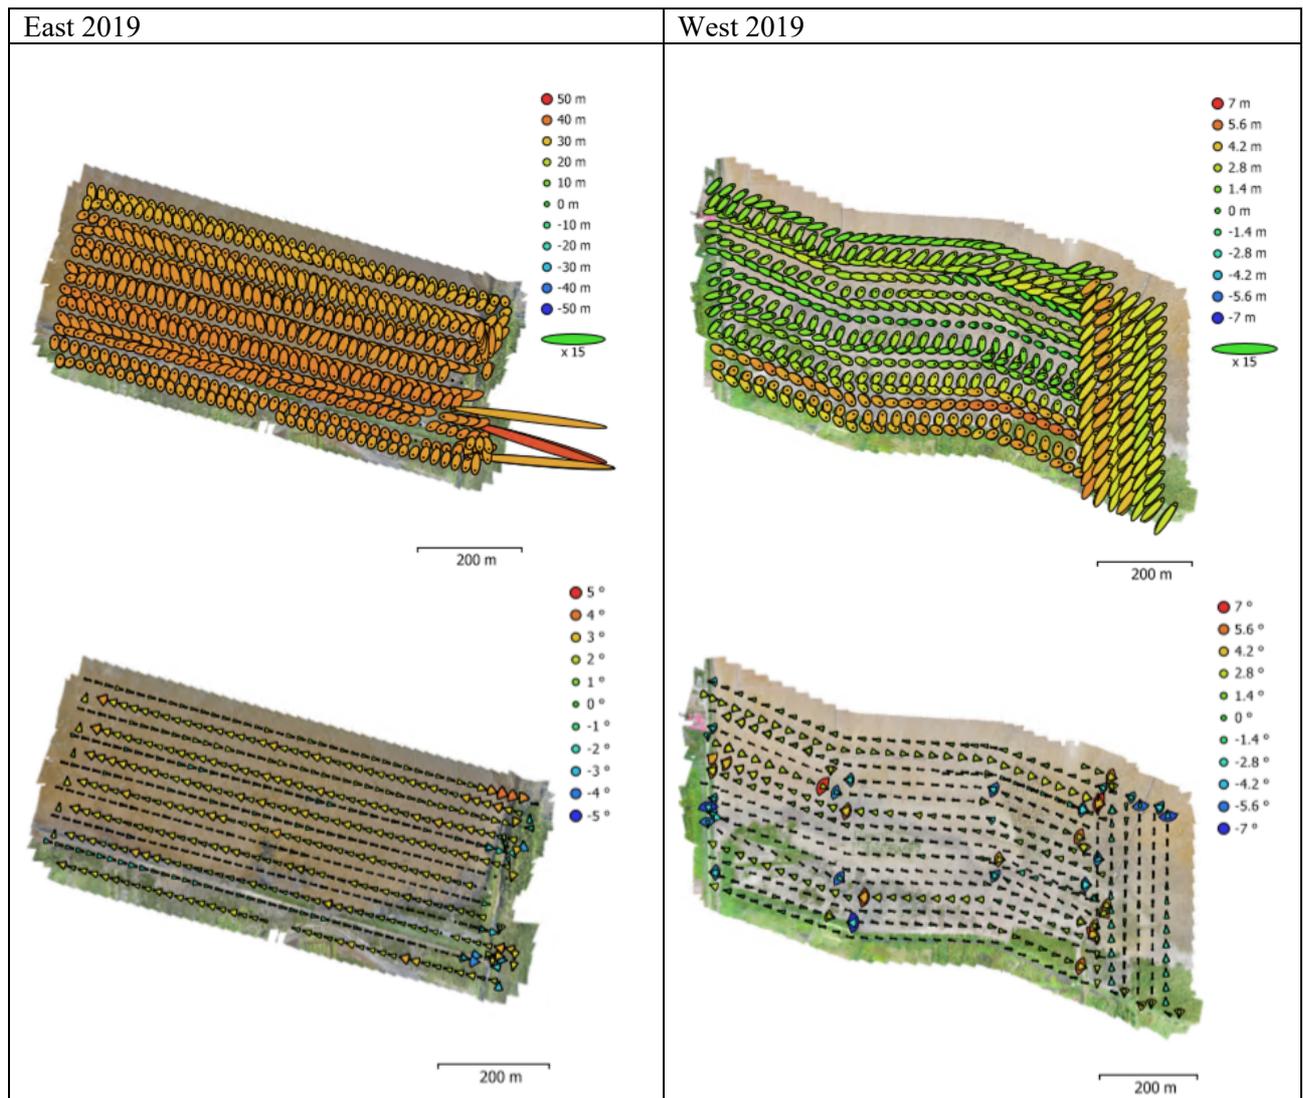
Figure 18. Camera processing data and error estimates, for East-2019 (left column), West-2019 (right). Note the different colour scales. Top: camera locations and associated error estimates (Z error is represented by the ellipse colour, and XY errors by ellipse shape). Bottom: camera orientations and associated error estimates, the arcs represent yaw error estimates. West-2020 has no errors for camera locations and rotations, as these were not adjustable during alignment.

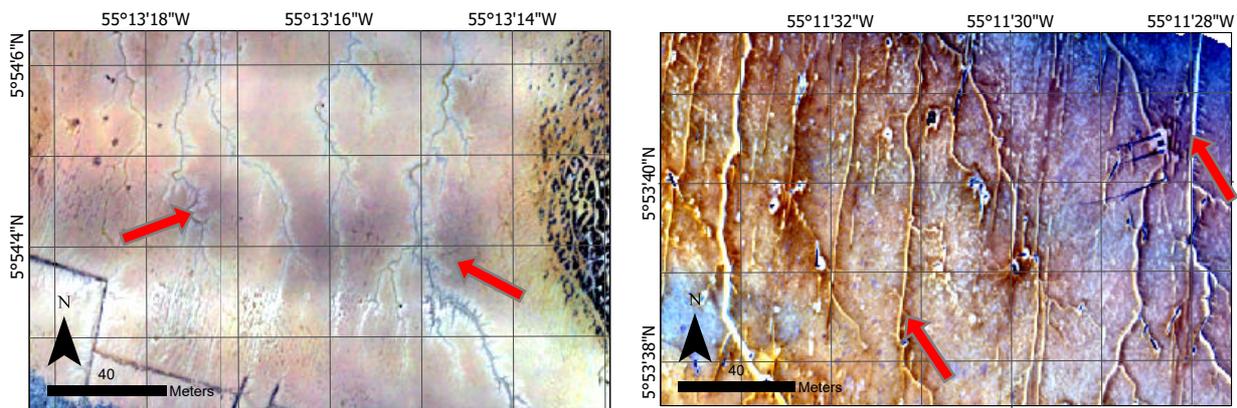
Figure 19. Examples of the typical channel network patterns in West-2019 (left) and East-2019 (right), shown with increased contrast to enhance visibility. Channels in West-2019 have a stronger meandering and are dendritic, whereas East-2019 channels are straight, and parallel rather than dendritic.

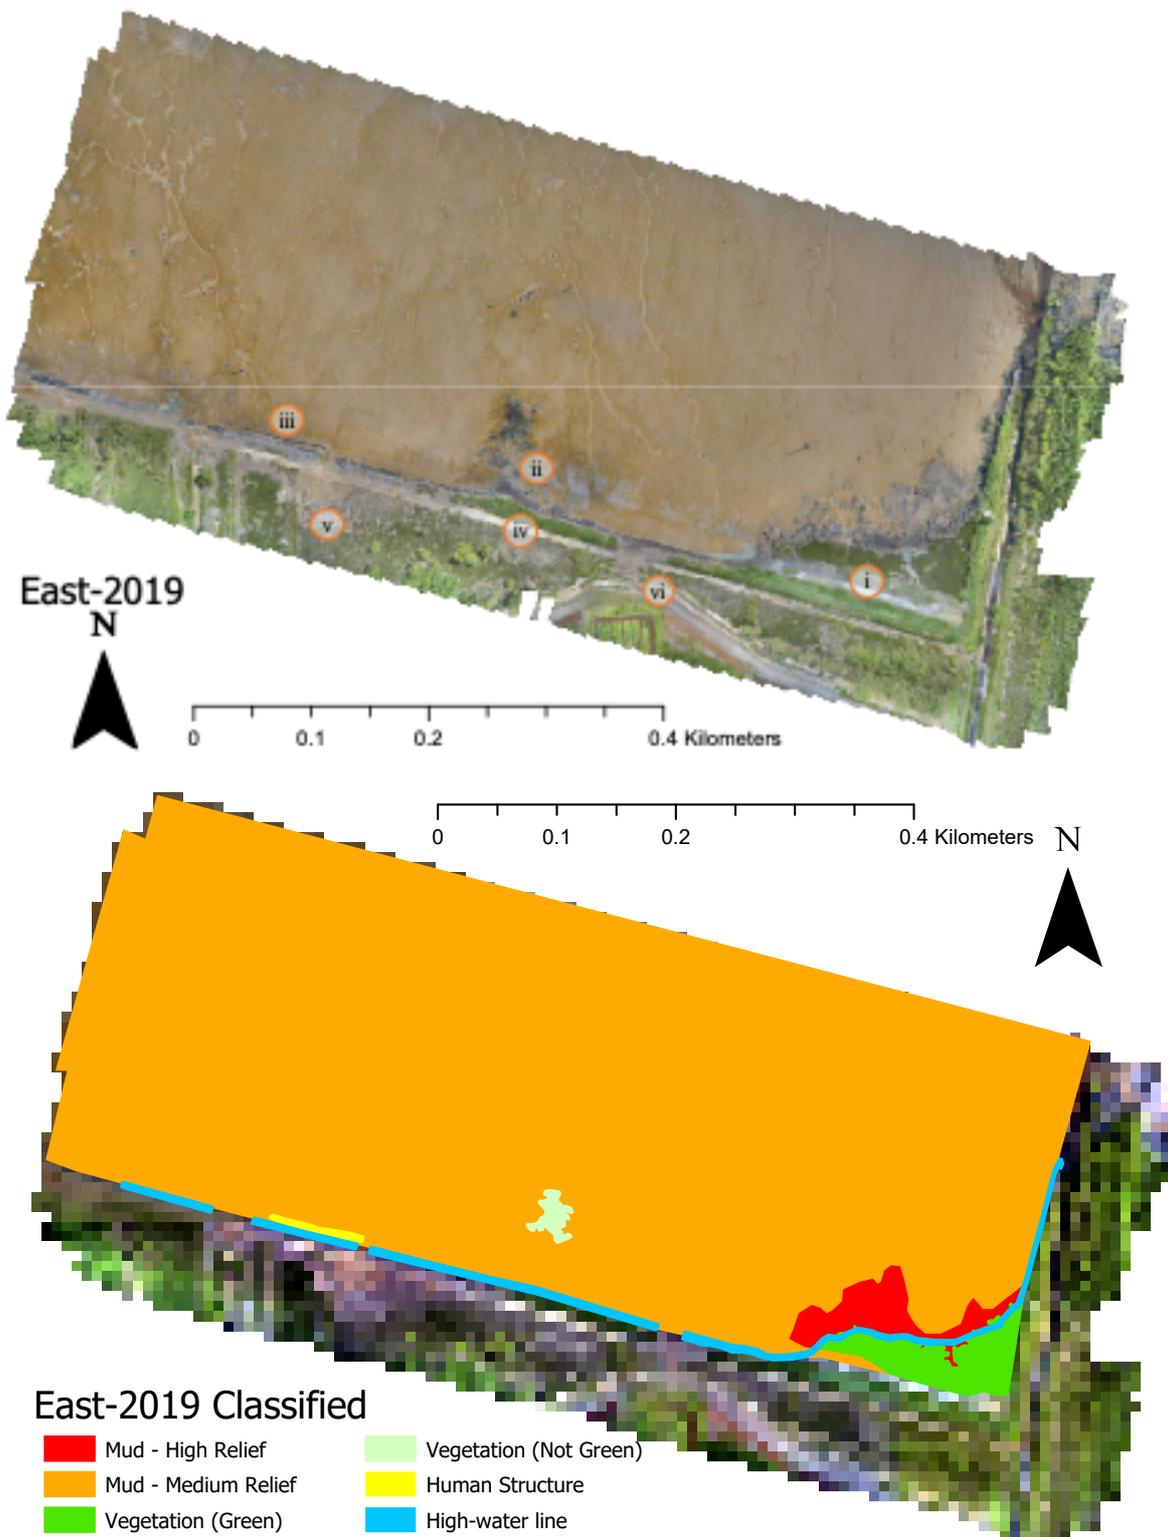
Figure 20. Orthophoto and classified map for East-2019

Processing the UAV imagery in Agisoft gave the output orthophotos shown in Figure 20a, Figure 21a, and Figure 22a. Visual interpretation of these orthophotos resulted in the classified maps shown below the orthophotos. These maps are distinguishing between human structures, vegetation (green and not green), and bare mud (high, medium and low relief). The output DEM's are shown in Figure 25, 26 and 27. Enlarged displays of the orthophotos and DEMs can be found in Appendix D. As processing the maps for East-2020 did not succeed, these are not included. In the following paragraphs, the quality of the output is examined, and the spatial and temporal differences observed from the orthophotos and DEMs are explained. A summary of the spatial and temporal differences is provided in Table 2 at the end of this paragraph.

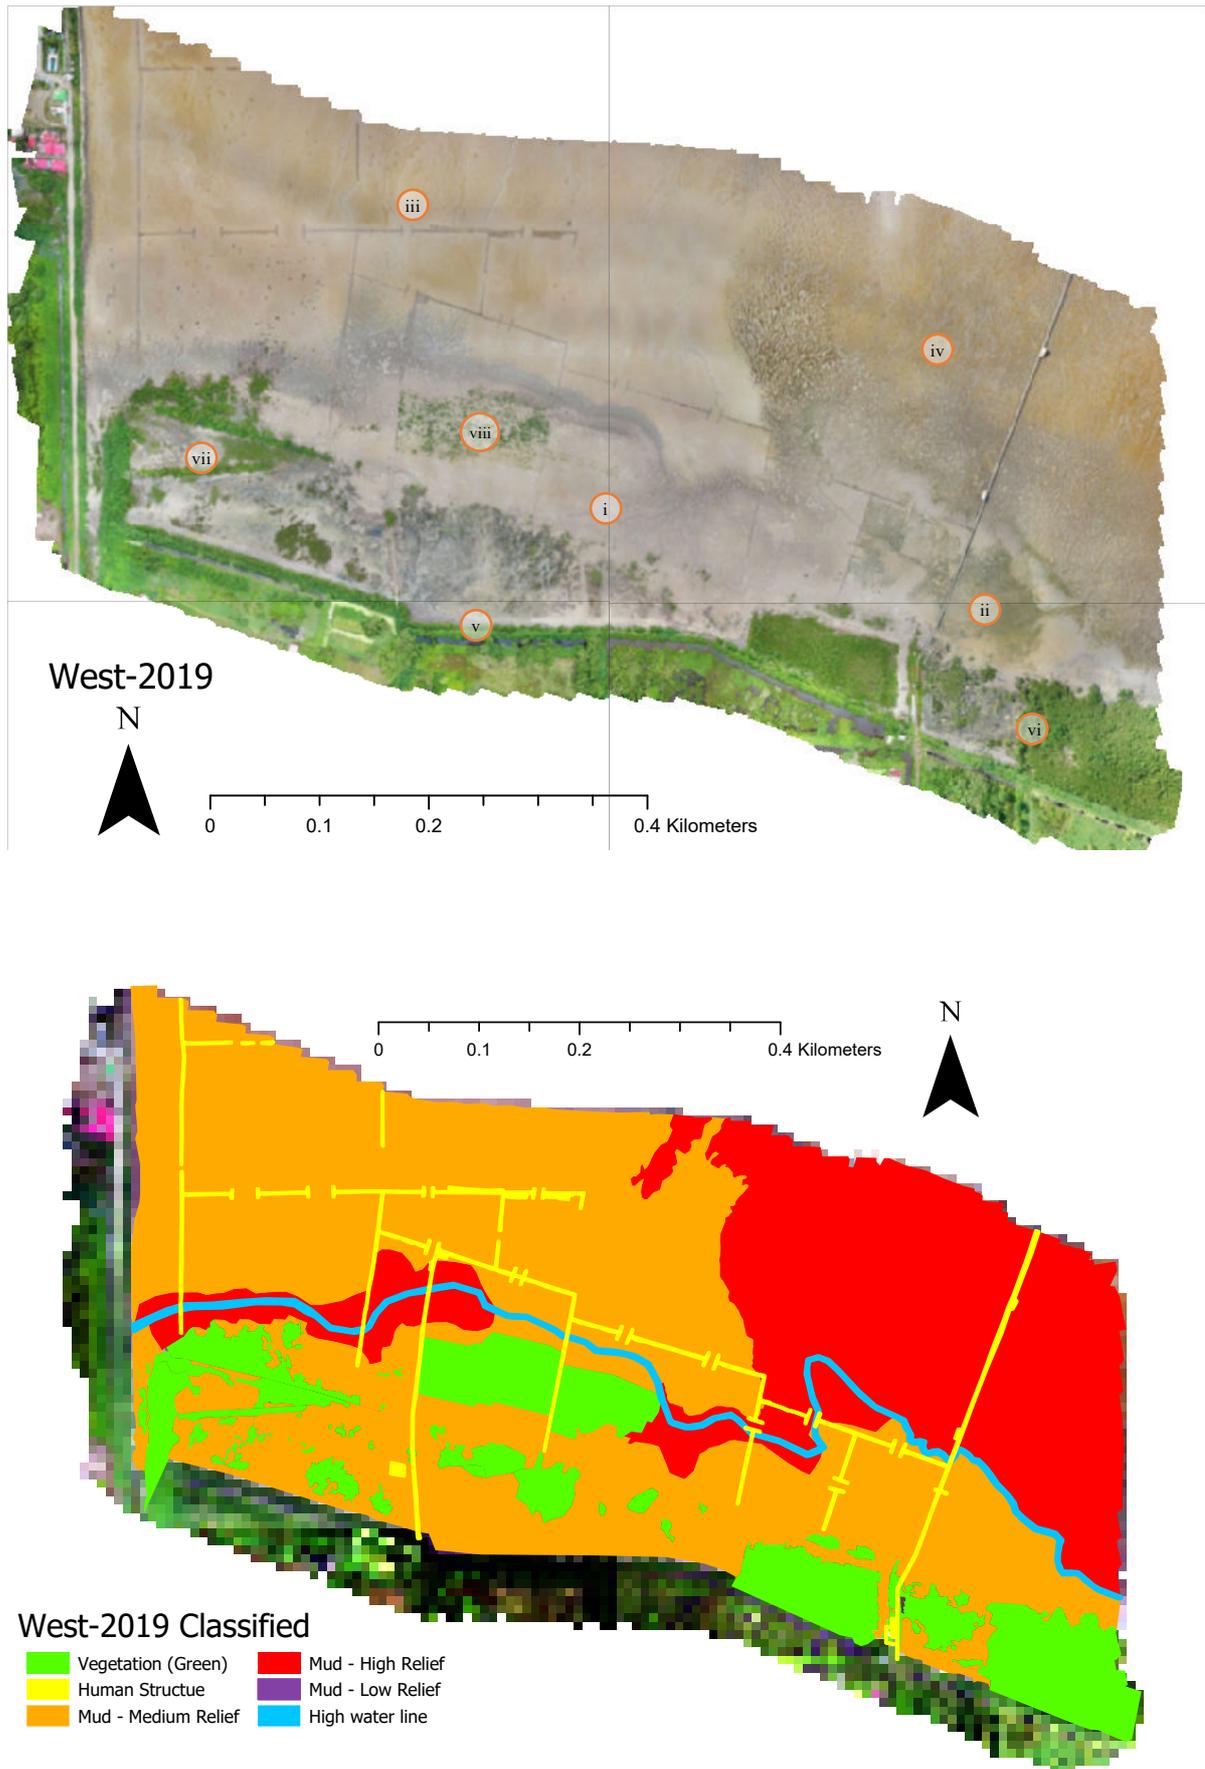
Figure 21. Orthophoto and classified map for West-2019.

The sediment in West-2019 is more heterogeneous (Figure 21). Largely, three sections can be distinguished. A strip with a width of ± 100 -200 m along the coast (*i*) is grey coloured and has medium, irregular relief. On the east of this section, a green coloured patch is visible, with some areas showing a mud crack pattern (*ii*). A second section is present in the northwest (*iii*), where the sediment is light brown, and it has a medium relief with some channels passing through. The boundary between these sections has higher relief, with a denser channel and pit network. In these first two sections, the channels are meandering more than in East-2019 (Figure 19) and the pattern is closest to the meandering dendritic network according to the classification of Hughes et al. (2010). These channels include third order and fourth order channels (see 2.3). Some channels contain lighter coloured sediment than its surroundings, while others contain darker sediment. The north-west of this study area shows a very high relief area, with dark brown coloured sediment (*iv*). The relief is caused by a regular, continuous pattern of alternating channels and pits, with an orientation that is on average N-NE to S-SW, but which varies more going shoreward. The pattern is unlike all categories in the aforementioned classification but is most similar to the “complex” pattern. The boundary between the landward grey sediment on one hand and the second and third section on the other hand, corresponds to the interpreted mean high water line, and zones of increased relief are present on both sides of this line, caused by increased channel formation. In the area above this line, still signs of occasional inundation are visible, such as channels and accumulated dead wood (*v*). Furthermore, well-developed vegetation is present in large dense rectangular patches in the south-east (*vi*), and in lines in the south-west (*vii*), which contains mostly tall trees and shrubs. Furthermore, a patch with small trees in a grid is present in the middle of the area (*viii*), which is the rehabilitation project. Some isolated patches of low shrubs are located on the landward side of this. All vegetation is above the high-water line, within the area with grey sediment. Multiple artificial structures are present: two cross-shore jetties extend on to the mudflat, and a block pattern is formed by permeable dams, which is part of the sediment trapping project. These dams have some openings, mostly on the along-shore dams and some on the cross-shore dams. Channels are often deflected when intersecting with a dam, and then run along the dam, and a gully is usually present around the dam. Lastly, multiple isolated human objects are lying in the area, primarily on the landward side.

Secondly, the difference in erosion between West-2019 and East-2019 might be caused by human interventions. Human interventions at West-2019 comprise the permeable dam pattern, and the planted mangrove trees (Figure 21). Both are aimed at trapping sediment, rather than completely blocking the sea. As the mean high-water line is 100-200 m seaward of the dike, it leaves a buffer zone where sediment can accumulate. East-2019 has no sediment trapping units on the mudflat itself, but the eastern and southern boundaries of the flat are all but pristine. Remnants of an old dam and dike are visible on the southern side, and the dewatering channel levee forms the boundary on the east, all within reach of the high tide (Figure 20). As a depression in elevation is observed in the DEM (Figure 25) in front of the remnants of the dam, it most likely refracts waves thus increasing turbulence and enhancing erosion. Thus, there is a big difference in human interventions. In East-2019, poorly maintained “hard” coastal defence structures have been implemented aiming to block the sea but with the side-effect of increasing erosion by wave refraction, as well as a decrease in functionality by deterioration of the structure. In West-2019, “soft” coastal defence methods are used to trigger accretion by making use of the sea.
