SPATIAL VARIATION AT THE SURINAME COAST:

Deriving alongshore and cross-shore patterns in tidal channel geometry, elevation and vegetation from UAV imagery

Tessa Deggeller (5655374)
Utrecht University

February 2021

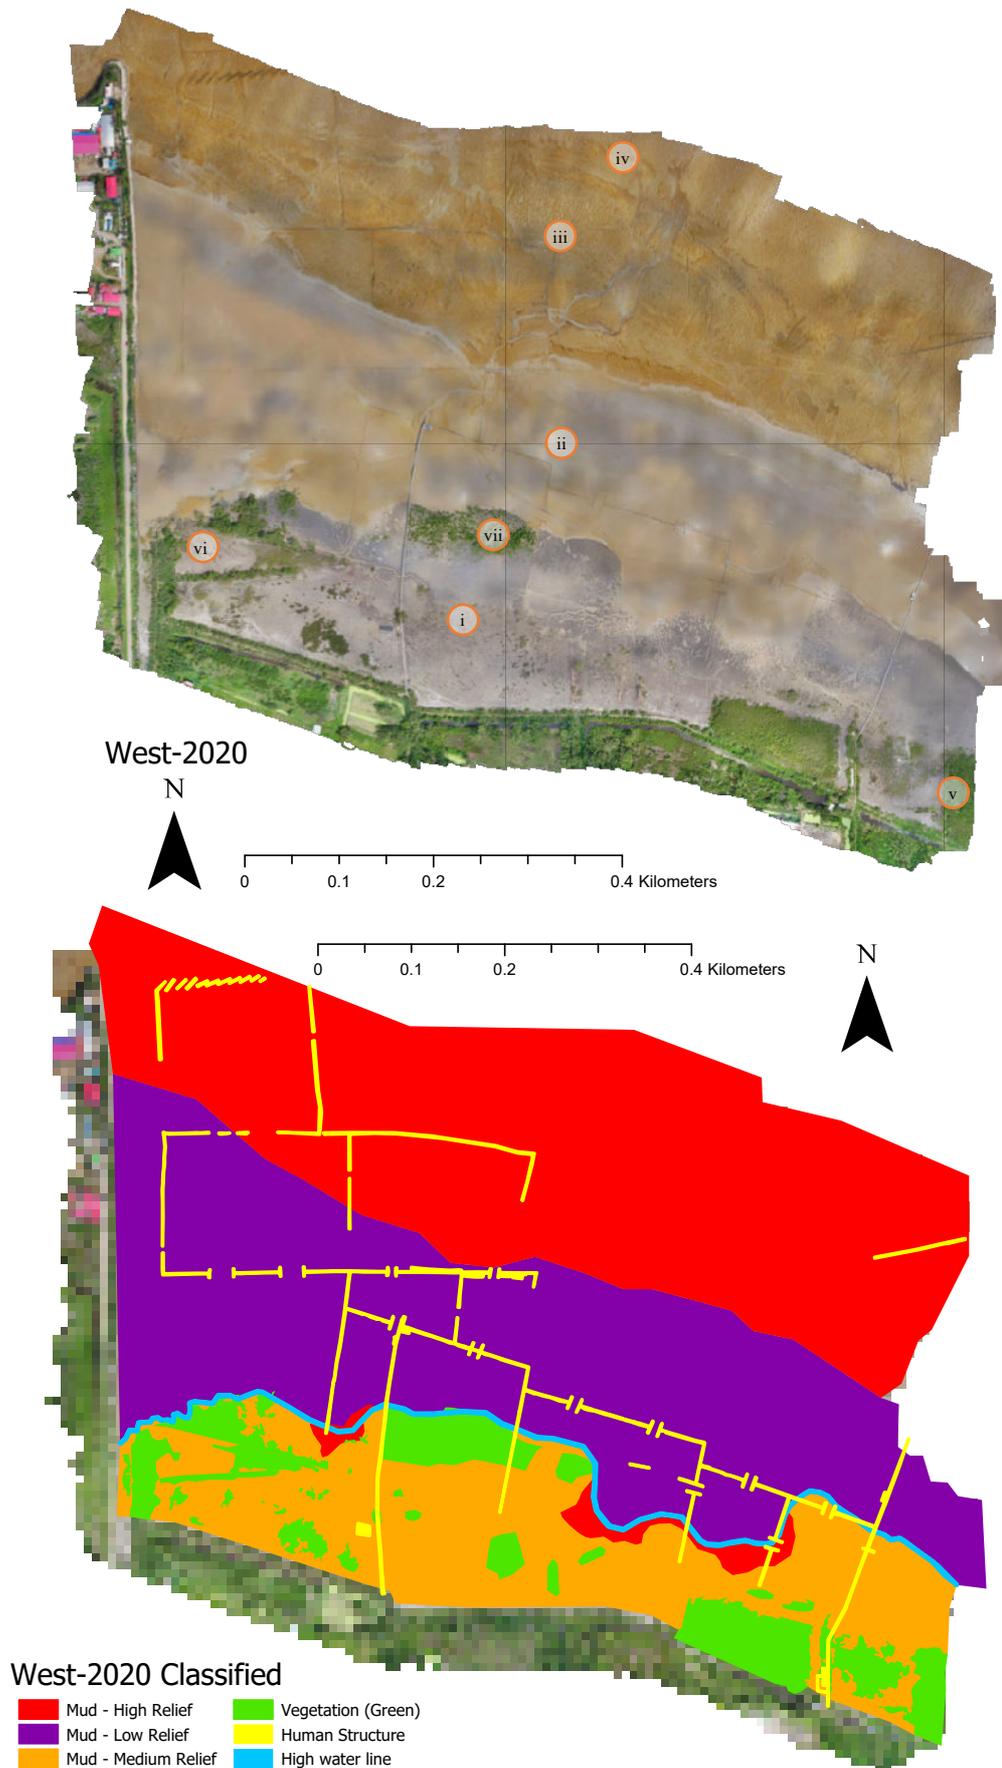
Figure 22. Orthophoto and classified map for West-2020.

The zonation of the sediment is different in West-2020 (Figure 22). Three sections can be distinguished, which are all parallel to the coast. The landward strip (sign *i*) is still similar to the one in West-2019. It has a grey colour, and medium relief. The green patch on the east of this zone has faded and is no longer present; this is now green sediment, and the mud crack pattern has become more evident (see Figure

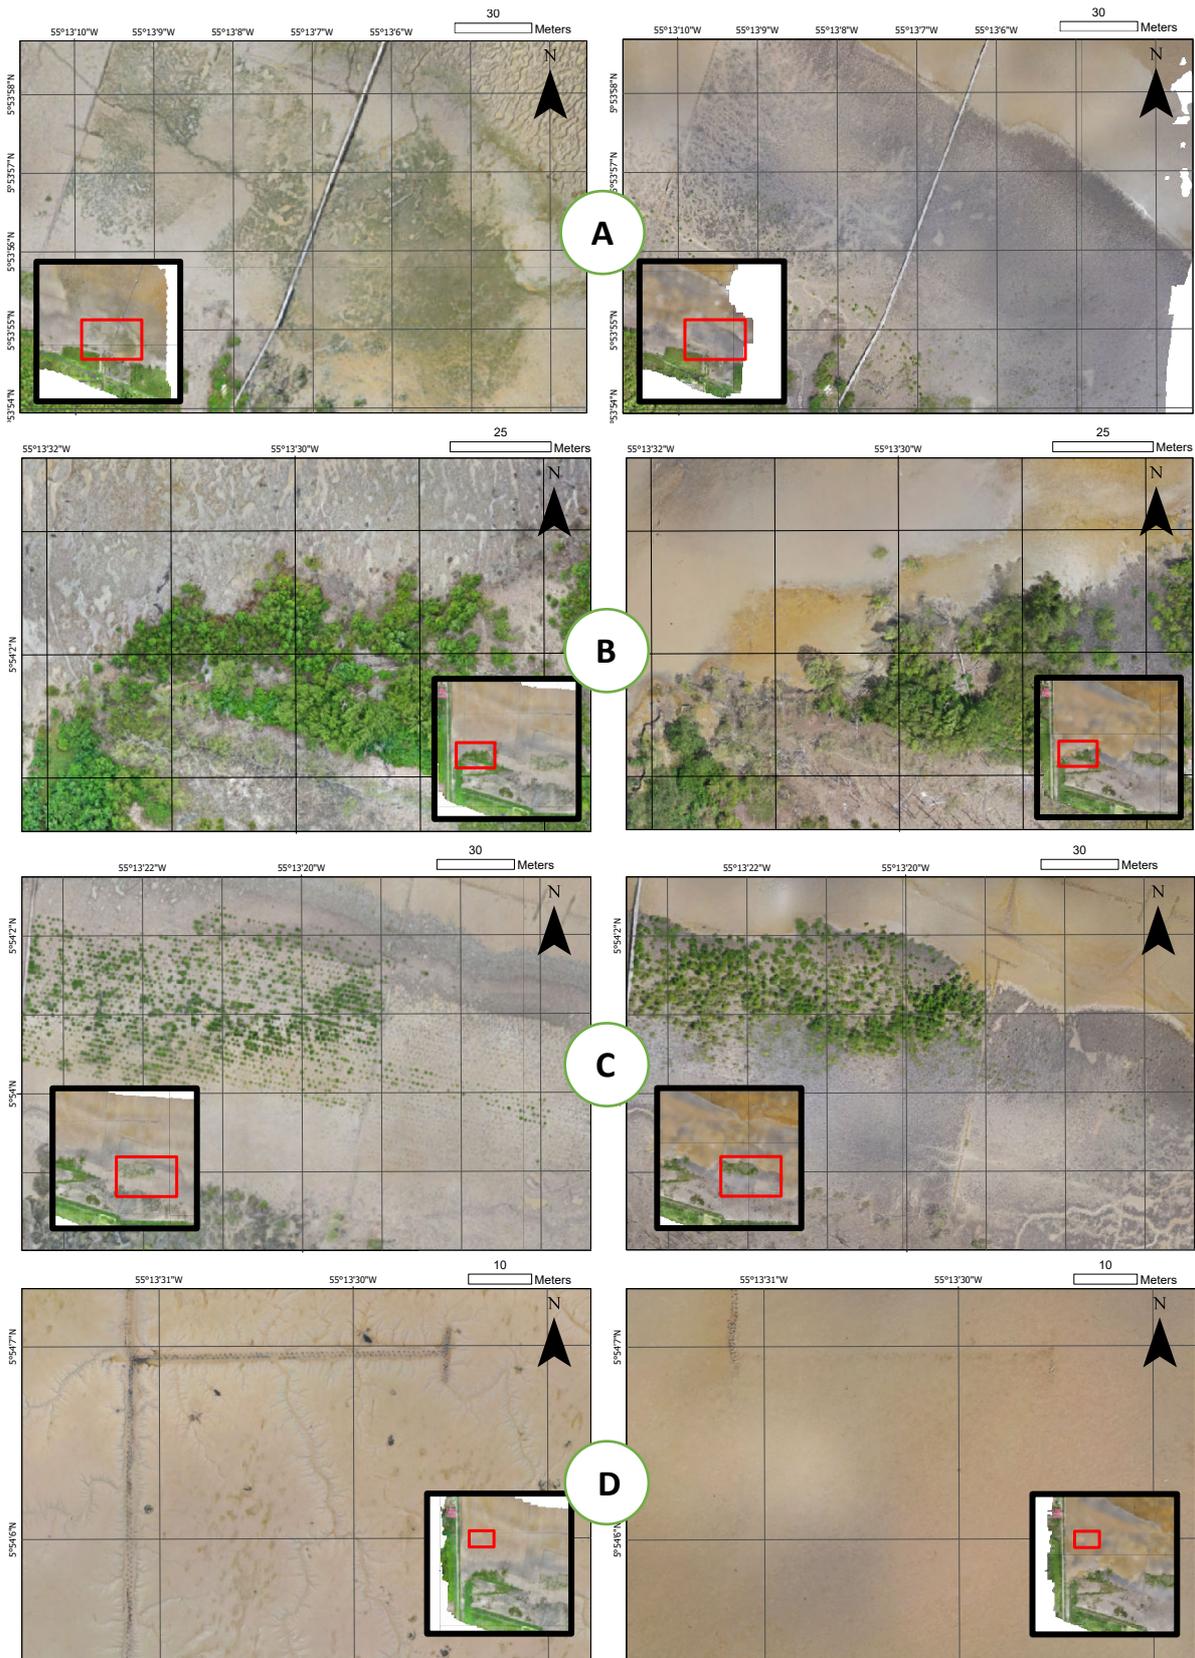
Figure 23. Close-ups of differences between West-2019 and West-2020. A: green coloured patch has disappeared and stronger mud cracking is visible in 2020. B: the northernmost edge of the vegetation has disappeared and smooth sediment is now visible. C: some of the trees on the planted mangrove patch have grown (northwest) and some other areas the trees are gone (east). D: the dams on the west end of the area are not visible anymore

23a for a close-up). The second, middle section (ii) is light, beige coloured sediment with very little relief and a uniform colouring. Third, the section on the seaward side has an orange colouring (iii). This section has much relief, which is very irregular. Several channels are visible, and elongated depressions with a cross-shore orientation. Also some large scale patterns have an alongshore direction (iv). However, since the majority of this section is not included in West-2019, it cannot be compared to the previous situation. The high-water line has moved shoreward in some places, with 20 – 40 m. As no other lined can be distinguished on the middle section, it is likely that the high-water line corresponds to the boundary between the shoreward and the middle section. Vegetation is largely similar to West-2020. The rectangular patches in the south-east (v) are still the same. The vegetation in the southwest (vi) is also the same, apart from the northwest end of this patch. There, trees have disappeared and smooth sediment is now present on that location (see Figure 23b). The mangrove patch from the rehabilitation project (vii) has developed heterogeneously. Figure 23c shows a close-up of this patch. On the north-western part, most mangroves have grown, these are mostly the mangroves that were already relatively large in 2019. The southern edge of the western part has mostly disappeared. On the east side of the patch, some mangroves are left, but the majority has disappeared. The jetties are still present, the western one has been renewed in the meantime. Most of the permeable dams are still visible on the same location, apart from some segments of the westernmost dams which have disappeared or are less distinct (Figure 23d). Also, the dams no longer show gullies around them.

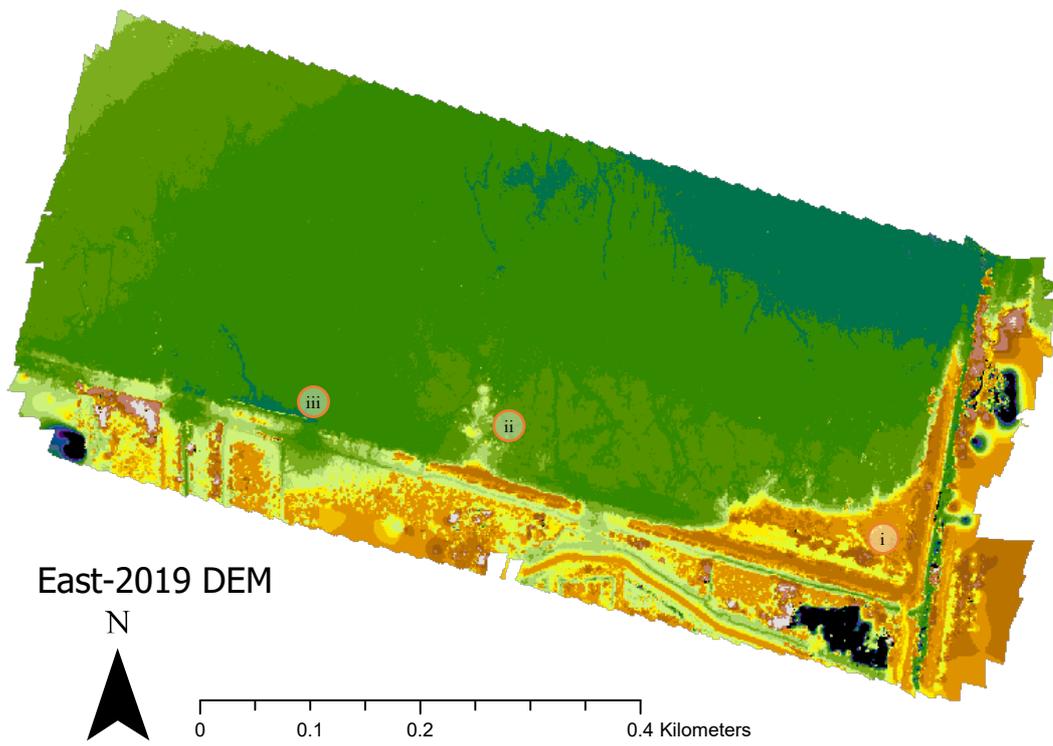
Figure 25. DEM for East-2019

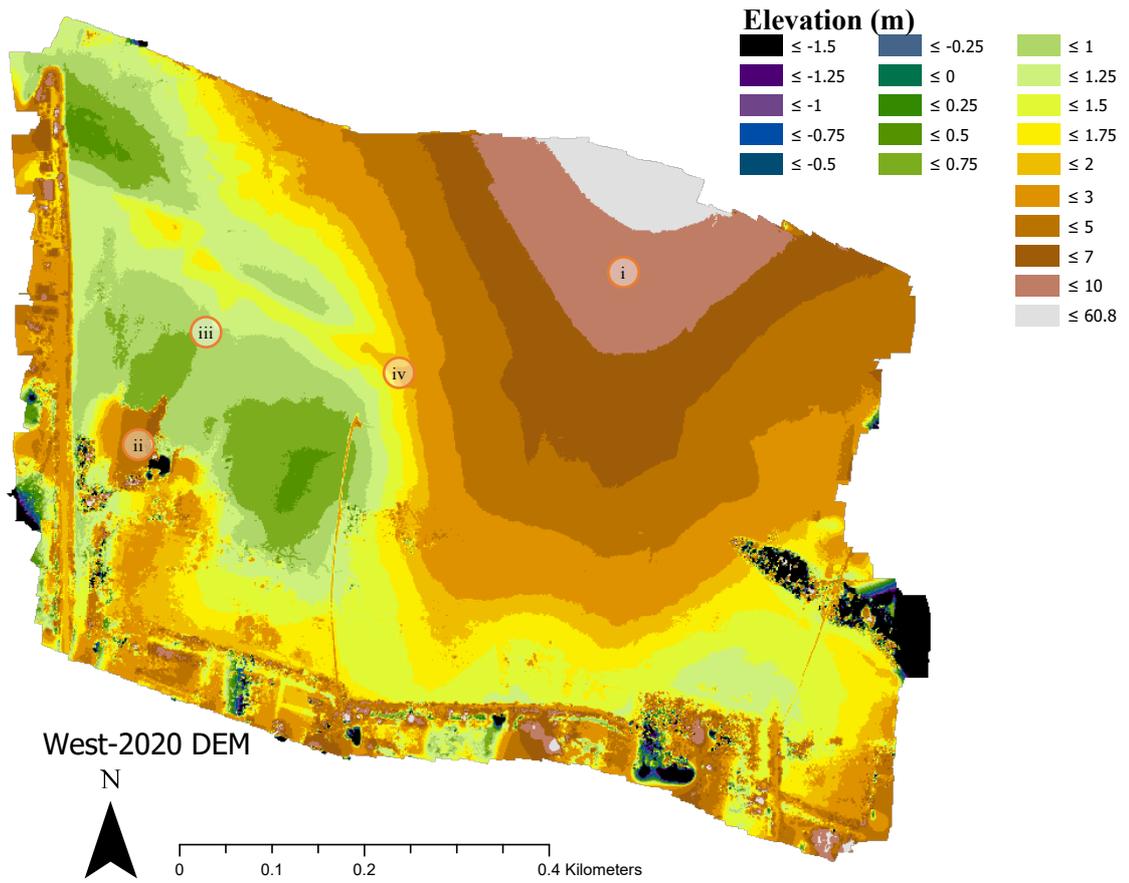
Figure 26. DEM for West-2020

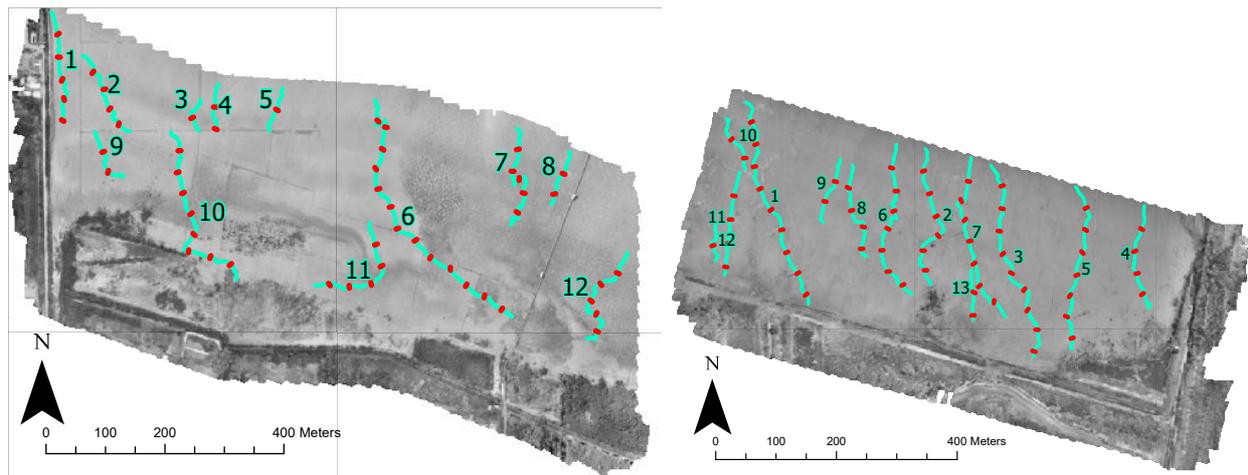
Figure 27. Location of the channels and their transects chosen for geometry analysis in West-2019 and East-2019. For West-2020, the same channels and transects were used as for West-2019.

The channels and transects that were used for geometry analysis are displayed in Figure 27. A larger version of the channel locations, projected on the DEM can be found in Appendix E. The elevation of the channel bed is plotted over the channel distance from the seaward side ($x=0$) to the landward side, shown in Figure 28. At West-2019, all channels are increasing in bed elevation, and this increase becomes stronger when going landward. In East-2019, most channels are also showing an increasing elevation in landward direction but some channels (1, 10, 11, 12, which are all located on the western side) show an opposite trend. Comparing this to the DEM, it becomes evident that these channel data are influenced by doming from the northwest corner of the study area. Their absolute height data is therefore inaccurate and will not be taken into account for further analysis. However relative elevation differences within the transects seem to be accurate on the DEM, so geometry values can still be derived. The same is true for channels 5, 6, 7 and 11 of West-2020. Furthermore, channels 8 and 12 are located on the edges of the DEM of West-2020, causing both very extreme values and missing data. These channels are therefore excluded from all further analysis for absolute elevation as well as channel geometry. When excluding the channels with doming effects, the average slope of the channel bed can be calculated (Figure 28).

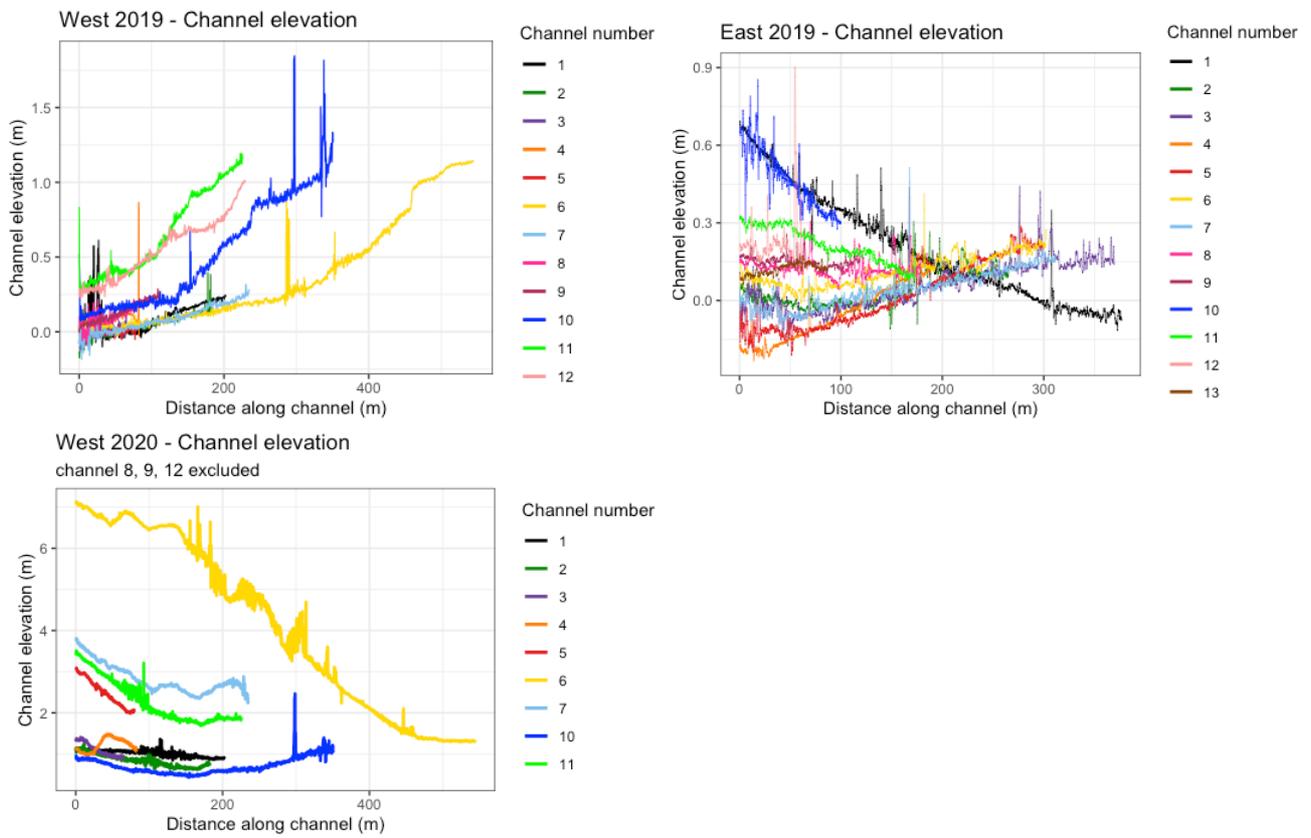
Figure 29. Elevation of the channel-polyline, depicted over the distance along the channel. Left ($x = 0$) is the most seaward end of the channel polyline, and towards the right of the graph is the landward direction along the channel.

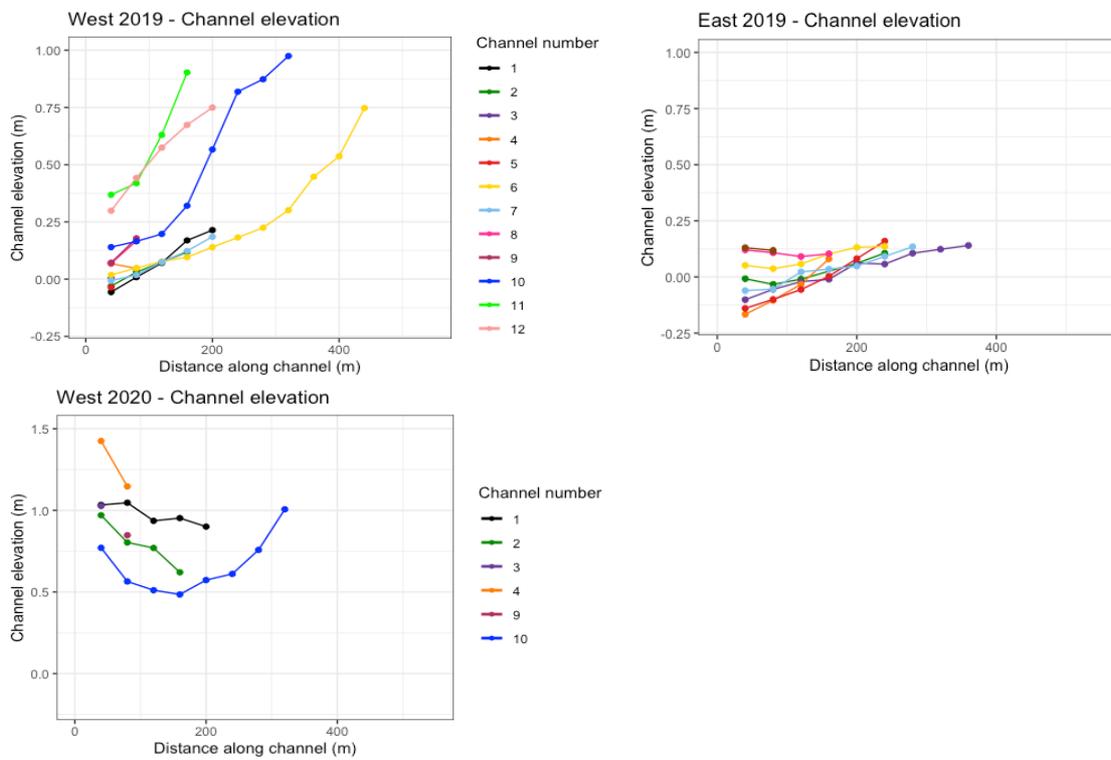
Figure 28. Channel bed elevation over the distance along the channel.

In East-2019, the channels have an average bed gradient of $\pm 0.6\text{m/km}$. In West-2019, this is 1.9m/km . These numbers serve as an indication for the total study areas, but are very dependent on location. Furthermore, starting points and end points, as well as length of the channels, differ strongly between the surveys. Looking more closely at the individual channels, in East-2019 (Figure 28b), the sections of the channels that are included in the analysis are between 8 and 360 m long. They start at a bed elevation of anywhere between -0.5 and 0.17 m, and most end between 0.5 and 1.5 m. The channel sections in West-2019 are 80 to 520 m long and start at an elevation of $-1 - 0.4$ meters, and most of the longer channels end between 0.7 and 1.1 meters. In West-2020, the channels that are not influenced by doming are 80 to 320 m long, start at a height of $0.75 - 1.5$ meters, and they remain in that same range.

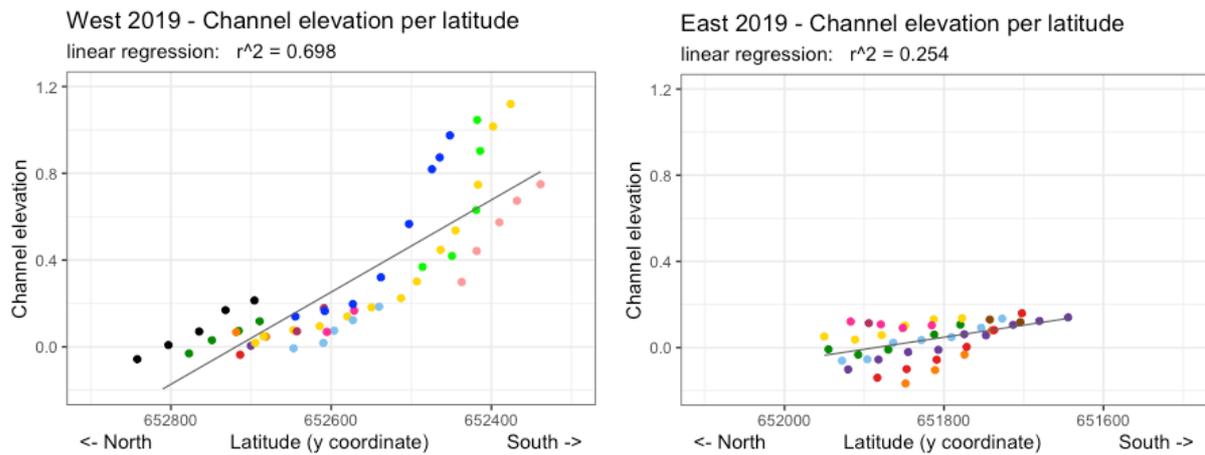
Figure 30. Channel elevation per latitude for West-2019 (left) and East-2019 (right).

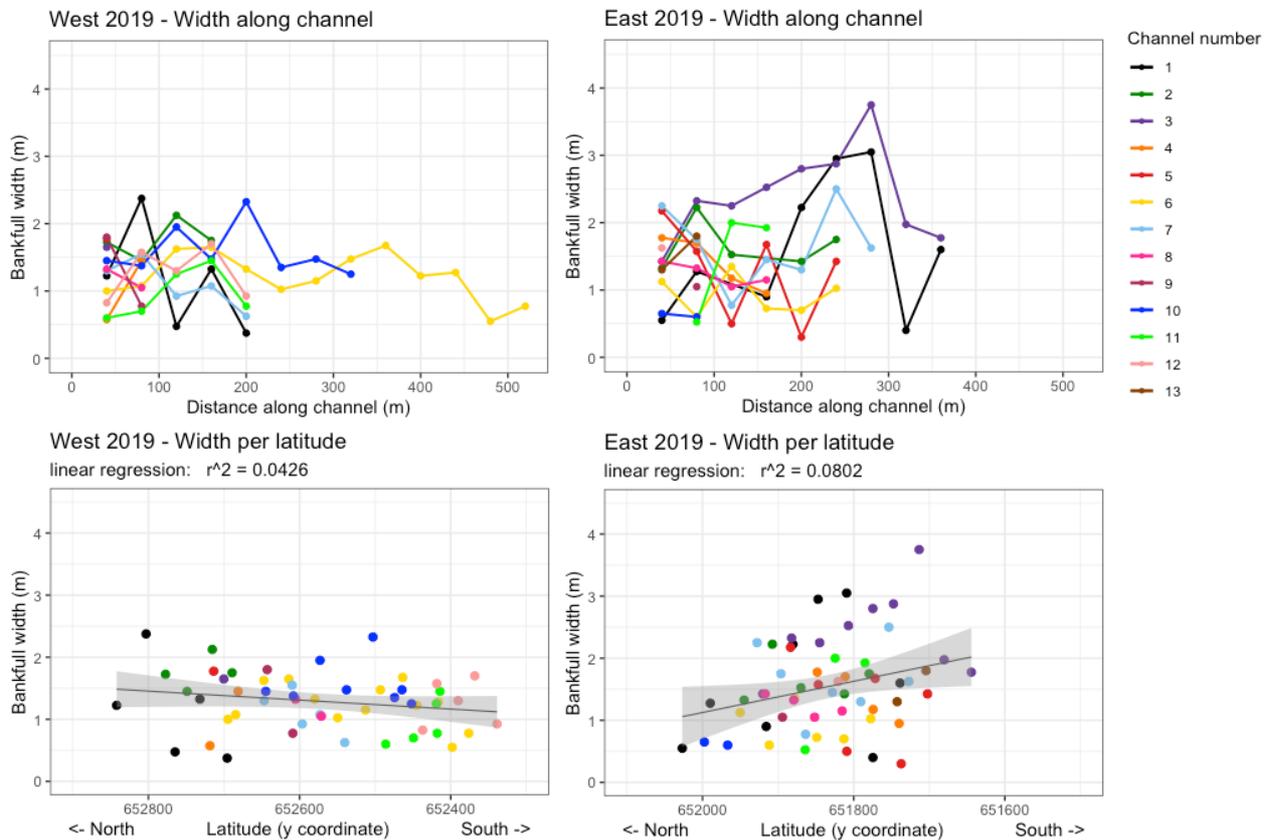
Figure 31. Channel width along channel distance (top) and per latitude (bottom) for West-2019 (left) and East-2019 (right)

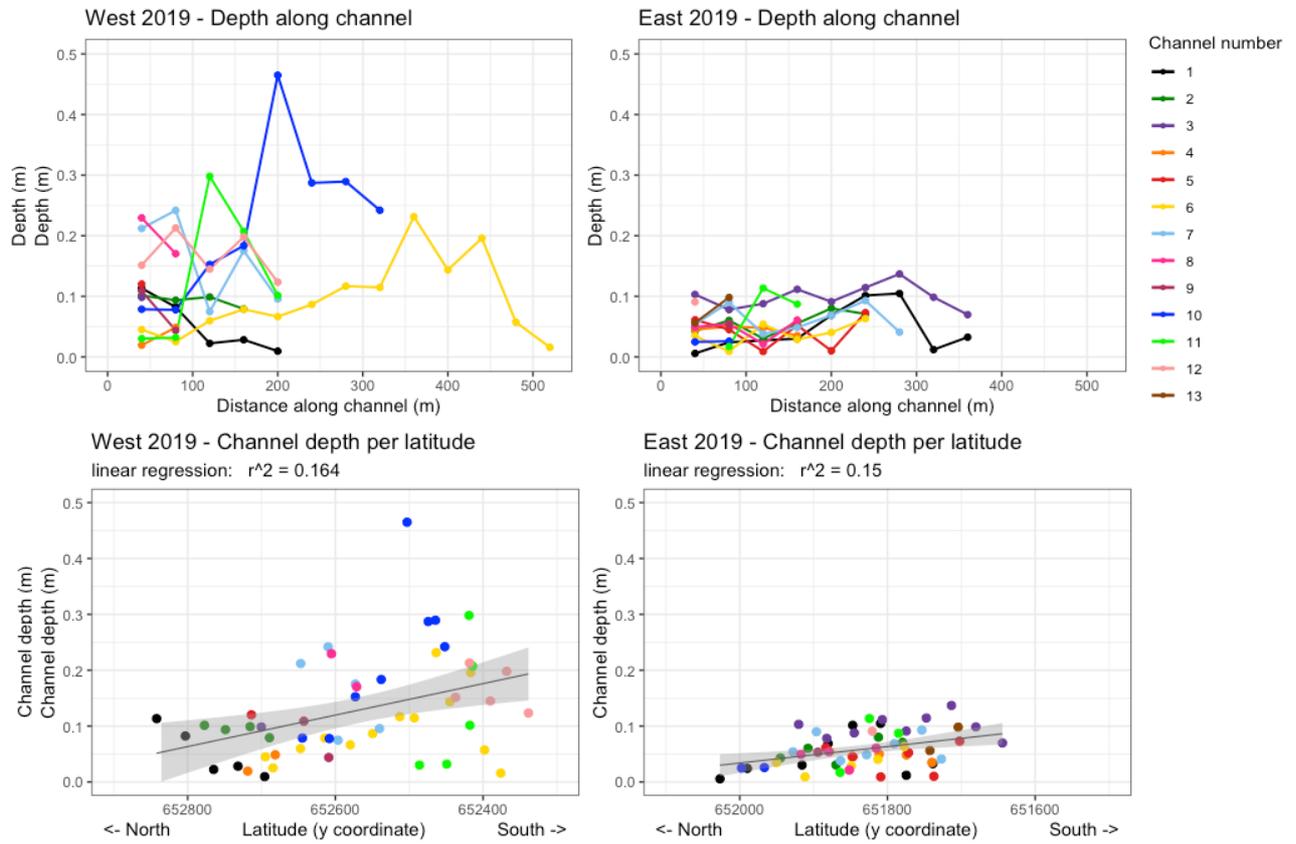
Figure 32. Channel depth along channel distance (top) and per latitude (bottom) for West-2019 (left) and East-2019 (right)

The analysis on channel transects (section 4.2) suggested spatial differences in channel geometry between our two study sites. In both sites, channels are deeper near the coast, although a larger range in depths was observed in West-2019 (0 - 0.3) compared to East-2019 (0 - 0.15) (see Figure 32). The opposite was true for width of the channels, which was 0.4 - 2.3 m in West-2019, compared to 0.3 - 4 m in East-2019. The average width-to-depth ratio (β) is therefore also higher in East-2019 than in West-2019, and decreases towards the coast. According to Hughes et al. (2011) sediment that is easily eroded tends to form wider, shallower channels (paragraph 2.3). This is in line with the imagery observations suggesting stronger erosion in East-2019. As Marani et al. (2002) stated, tidal channels usually have a width-to-depth ratio of $8 < \beta < 50$ (Figure 9). Although their measurements were based on larger tidal channels (depths of 1-10 m and widths of 10 – 300 m) than the channels in this study, the average width-to-depth ratios fall within the expected range. On average, West-2019 had an average of 16, and East-2019 had an average of 30. However not all transects were within this interval. In West-2019, 18 of the 53 transects had β -values below 8, and none above 50. In East, only 4 out of the 58 transects showed values above 50, and none below 8.

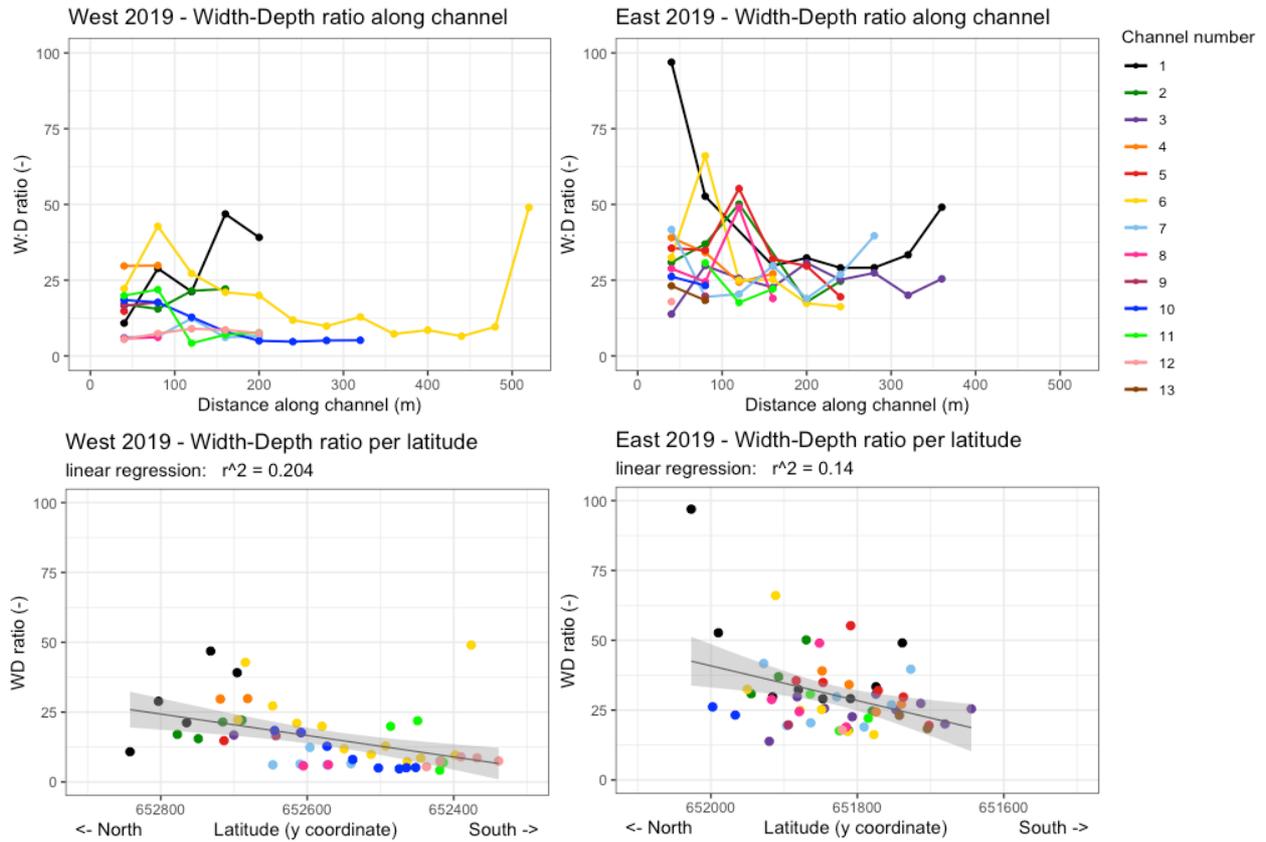
Figure 33. Channel width-to-depth ratio along channel distance (top) and per latitude (bottom) for West-2019 (left) and East-2019 (right)

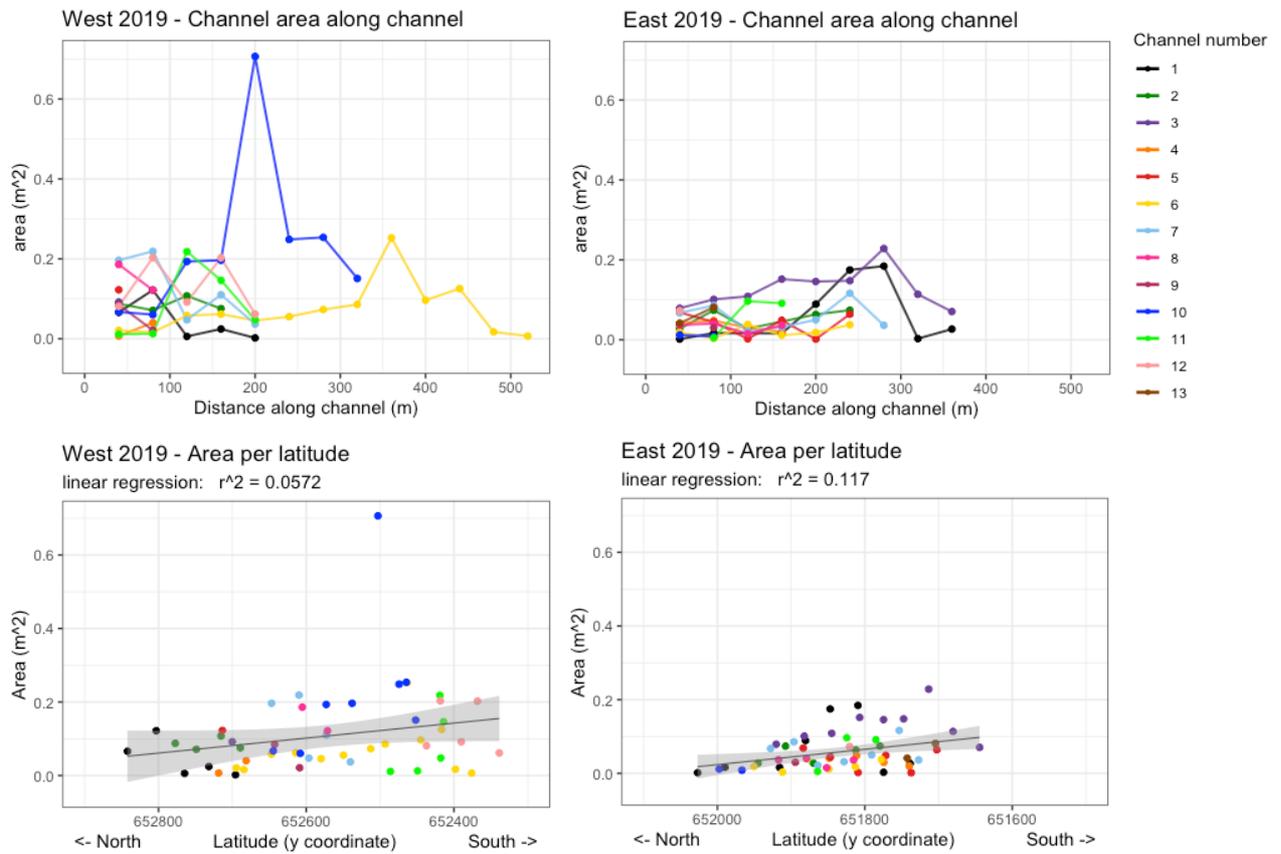
Figure 34. Channel area along channel distance (top) and per latitude (bottom) for West-2019 (left) and East-2019 (right)

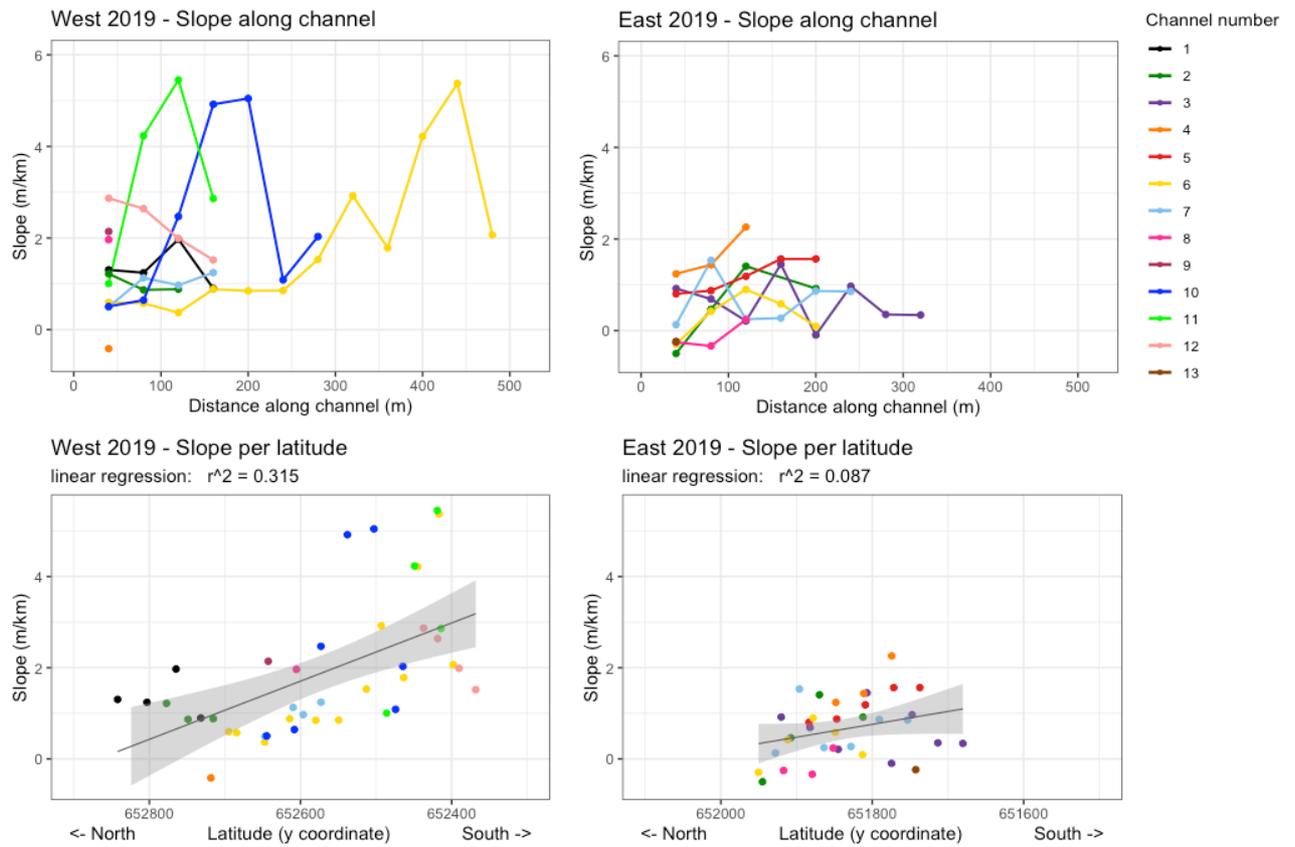
Figure 35. Channel bed slope along the channel distance (top) and per latitude (bottom) for West-2019 (left) and East-2019 (right)

The slope is calculated from the difference in channel bed elevation between the transect itself and the transect 40 meters in seaward direction. A positive slope indicates that the inland channel bed elevation is higher than that of the seaward transect (increasing elevation towards the coast). Figure 35 shows that most channels have a steeper slope when moving landward. With a slope range of -0.5 m/km to 2.25 m/km, East-2019 also includes some locations where the elevation becomes lower in landward direction. In total, 6 transects show a negative slope, these are the most seaward transects from channels 2, 6, and 8, and a transect halfway channel 3. In West-2019, slopes range between 0.4 and 5.5 m/km, except for one location with a negative slope of -0.4 m/km. The longest channel, number 6, shows a slope of 0.5 m/km at the seaward side, and this increases to ± 3 m/km at the landward side. Channels 10 and 11 also show a higher slope (and thus steeper elevation increase) on the landward side. On the other hand, channel 12 which is the easternmost channel, has a clear decreasing trend. Comparing the slope to the latitudinal position, both sites show steeper channel bed slopes land inwards (Figure 35c and d).

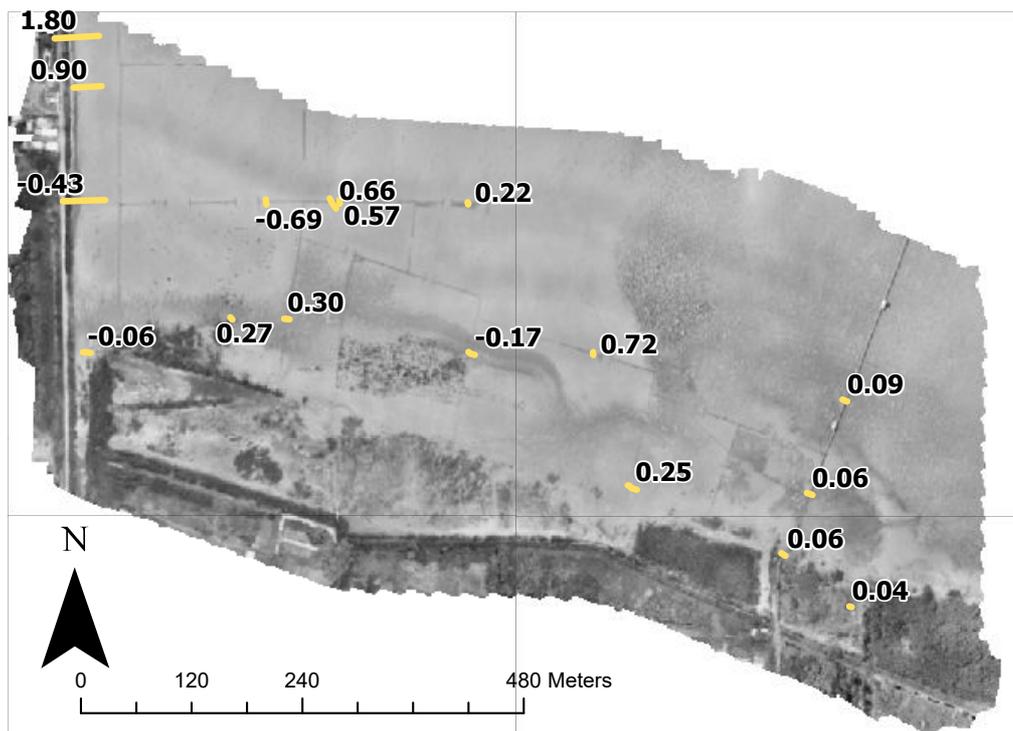
Figure 36. Relative change in sediment elevation between 2019 and 2020, compared to objects (dams, jetties, roads, etc.) that are considered of constant elevation.

In Figure 36 it can be seen that the observed relative elevation differences are variable throughout the area. Close to the coast, numbers are small (mostly <0.06 m). Further seaward, numbers are ranging from 1.8 to an occasional observed decrease of -0.69 , however most measurements are between 0.2 and 0.9 meters of assumed sedimentation.

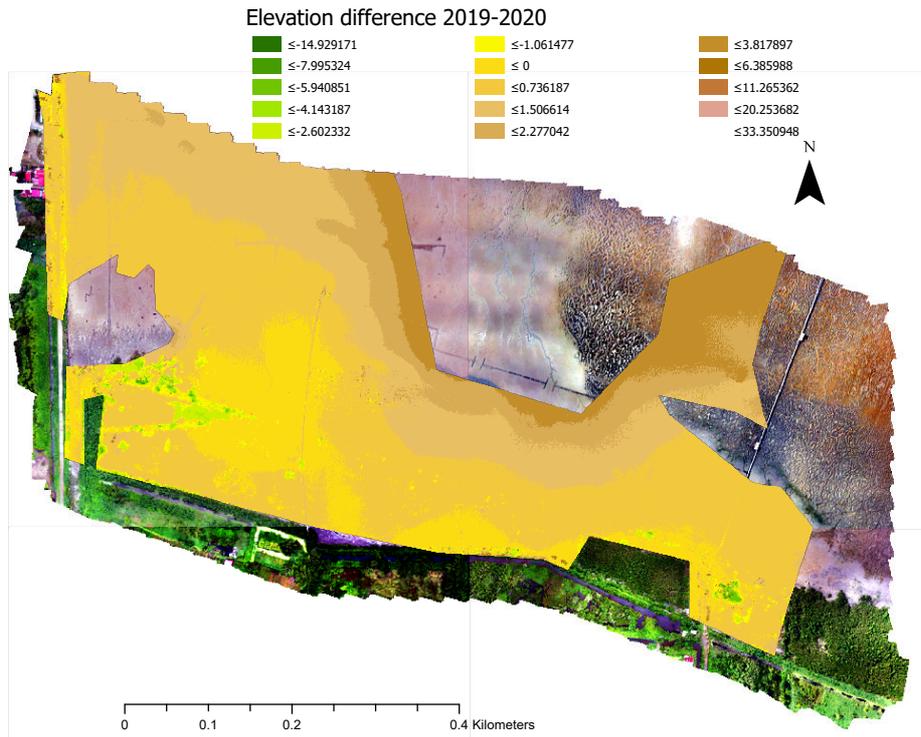
Figure 37. Elevation change between West-2019 and West-2020, derived from the DEMs of the two years. (Mean: 0.67m; Median: 0.55m). Background: orthophoto West-2019

Broadly speaking, this agrees with some areas as shown in Figure 37. Apart from the doming that is clearly visible, the north-western side of this map shows values between 0 and 1.5m. However, on the coastal side, a decrease in elevation is suggested, between -1 and 0 m. On the whole, the map shows a trend in elevation change, ranging from -1 at the coast to $+1.5$ at the seaside (ignoring the doming area).
