Master's Thesis – master Water Science and Management

Assessing the usefulness of the ecohydrological model Waterwijzer Natuur 3.0 in developing an ambition map within the Province of Overijssel.

Author: Jannes van Weele

13-07-2022

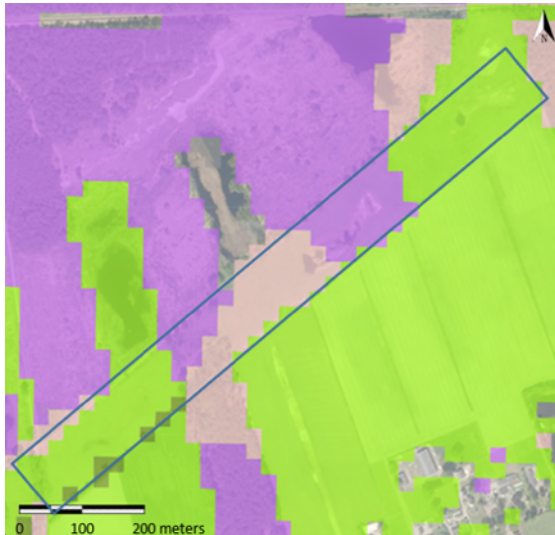
Figure 3: WWN 3.0 results of ecotope groups with highest probability. Light green = K68, dark green = K48, purple = K61, beige = K62. For legend and full descriptions of ecotope groups, see Appendices G and J. Area within rectangle.

A short example of examination of spatial data prior to a field visit is shown below (part of LESA). **Error! Reference source not found.** shows that WWN 3.0 predicted a combination of K68, K62 and K61, while the current nature management type is N12.02:

- K68: Pioneer vegetation, grasslands and shrublands on dry, moderately nutrient-rich soils (undergrowth in heavily fertilised fields, ruderal vegetation along rivers).
- K62: Pioneer vegetation and grassland on dry, nutrient-poor, slightly acidic soils (dry heathland and grey hair-grass grasslands).
- K61: Pioneer vegetation and grassland on dry, nutrient-poor, acidic soils (dry heathland).
- N12.02: Grasslands rich in herbs and fauna.

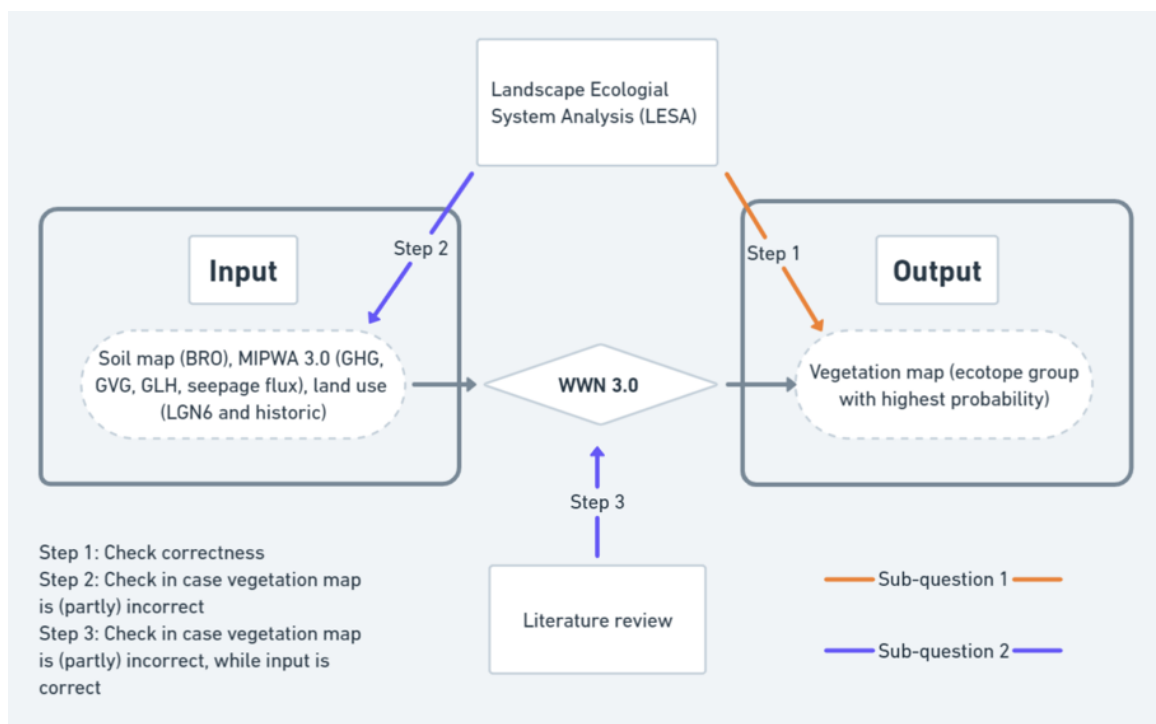
Figure 10: Flow diagram on how the sub-questions have been answered:

Comparing results from the field visits with both WWN 3.0 input and results formed the basis for answering the sub-questions. Figure 10 shows the flow diagram on how this process took place.

Answering the first sub-question has been approached by comparing results from WWN 3.0 with data obtained by means of LESAs (step 1 in Figure 10). Regarding the results of WWN 3.0, the vegetation map was used to compare, because it was assumed that it is easier to check in the field than the nature value map. Also, the consortium primarily wants to use the vegetation map in developing the ambition map. By comparing the descriptions of a suitable soil for the predicted ecotope groups (Appendix G) with measured data from the field (moisture conditions, nutrient-richness and pH of the soil), an estimate was made of the likelihood that the predicted ecotope group can be realised without major interventions. A three-part classification has been chosen, namely correct (+), partially correct (+/-) and incorrect (-). When all data from the field corresponded with the description of a suitable soil for the predicted ecotope group, a prediction was considered correct. In case one factor deviated slightly to moderately the prediction was considered to be partly correct and in case several factors deviated or one factor deviated considerably, the prediction was considered to be incorrect.

GLG, GHG, GVG, seepage flux and land use) with data from these field visits (soil profiles, groundwater table, land use) (step 2 in Figure 10). If these inputs were found to be correct and incorrect outputs were nevertheless generated, processes in the model itself would be examined by means of literature research (step 3 in Figure 10). If the input turned out not to be completely correct, the processes in the model would not be examined in depth, because in order to assess the correctness of the processing of the input, the input has to be correct.

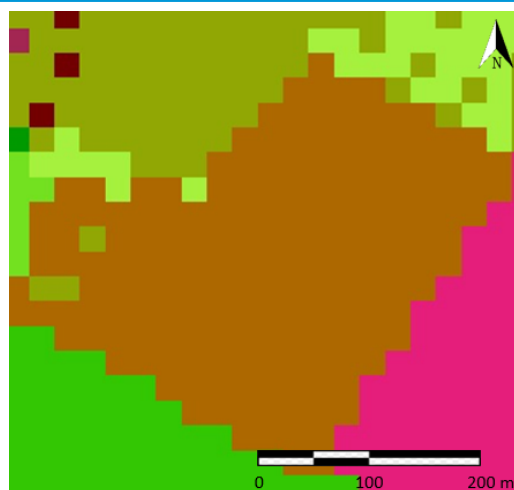
Figure 1: According to LGN6, the plot of location 2 was a potato field (dark brown).

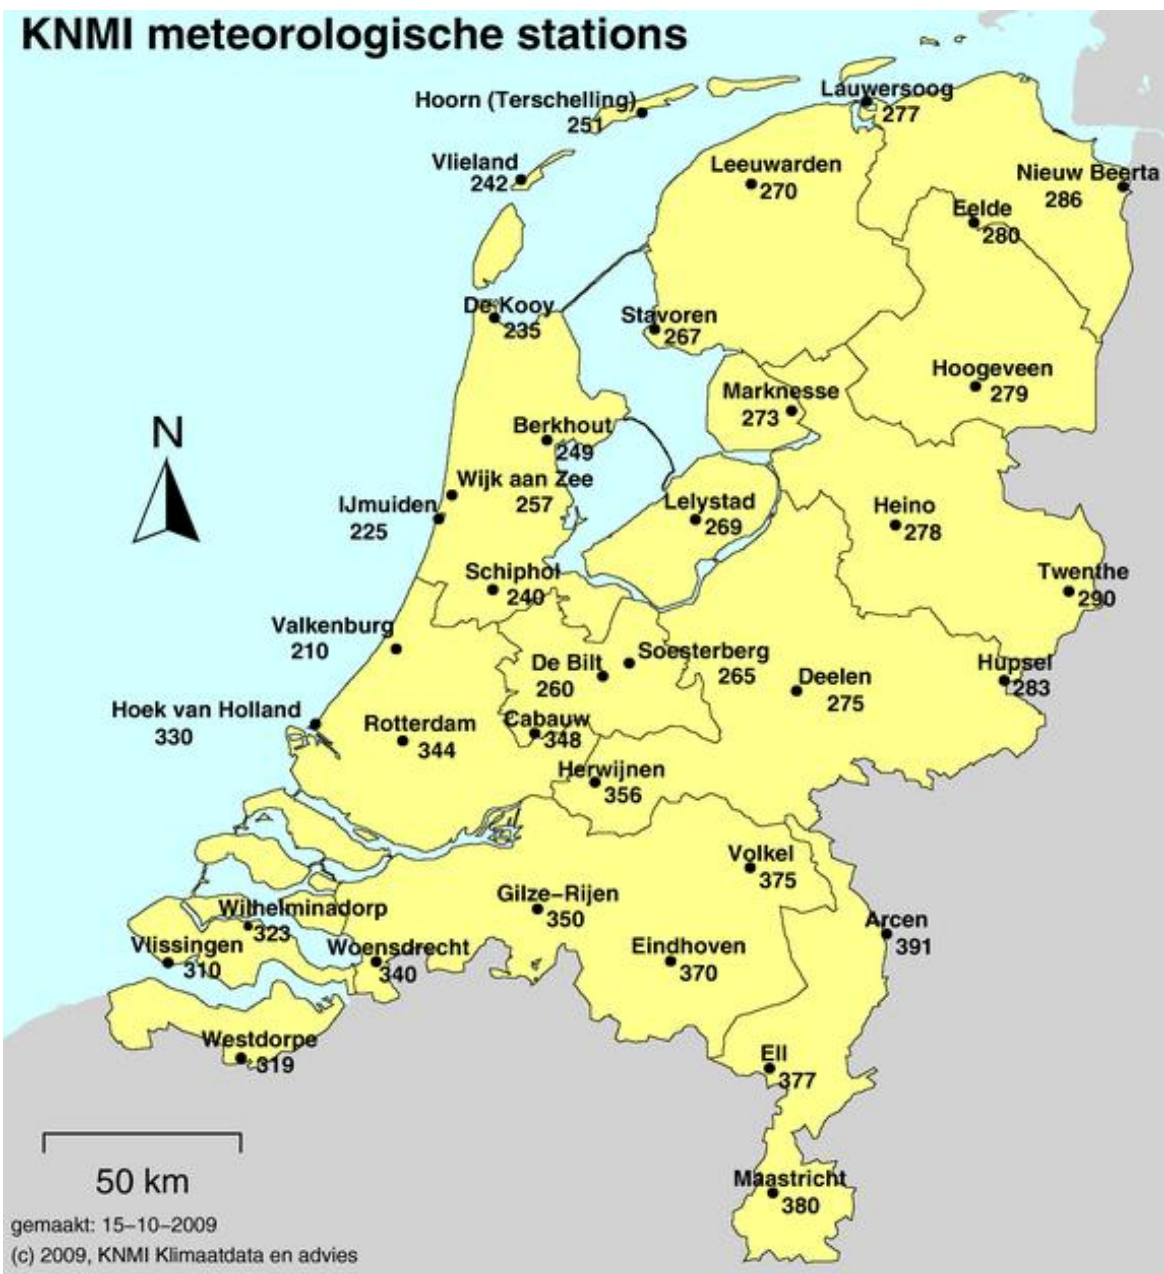
Figure 19: Overview map of Dutch meteorological weather stations (KNMI, 2009).

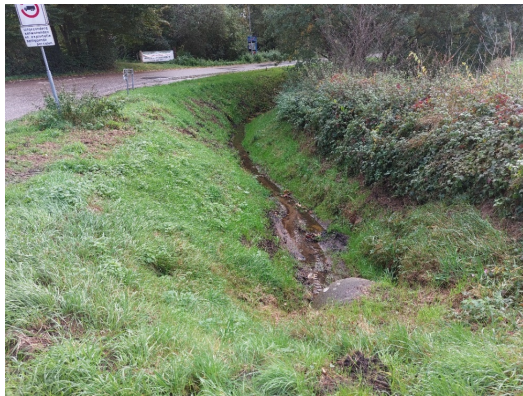
Figure 20: Deep ditch at location 15.

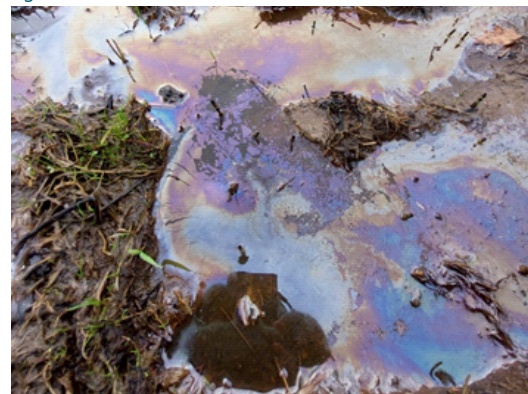
Figure 23: Iron film on water at location 14.

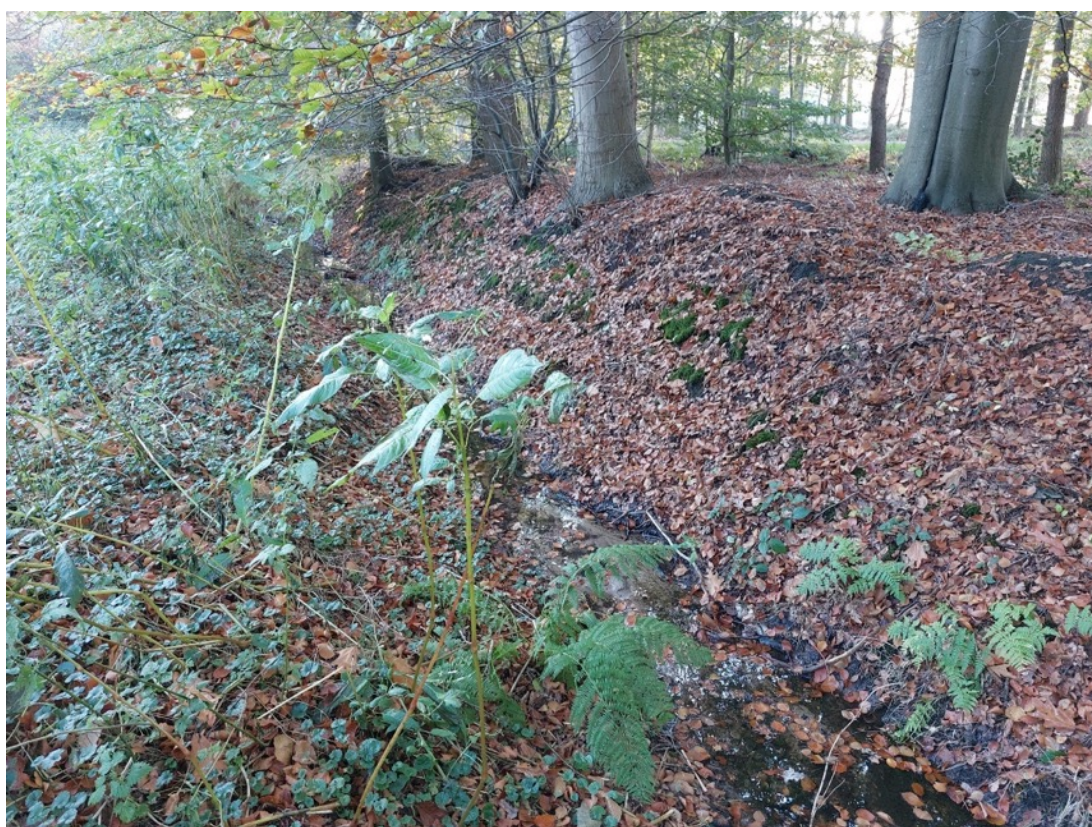
Figure A.1.6: Ditch of 1.20m deep with 5 to 10 cm running water.

5	204368, 538853	n/a	n/a	Damp ditch of 1.20m deep with a few cm of stagnant water (figure A.1.11) between the field with planted production forest and more open deciduous forest on the southwest side of the black line in Figure A.1.8.
6	204461, 538819	n/a	n/a	Between planted forest and field a dry ditch 60 cm deep (Figure A.1.12). On the field <i>Ranunculus repens</i> ,

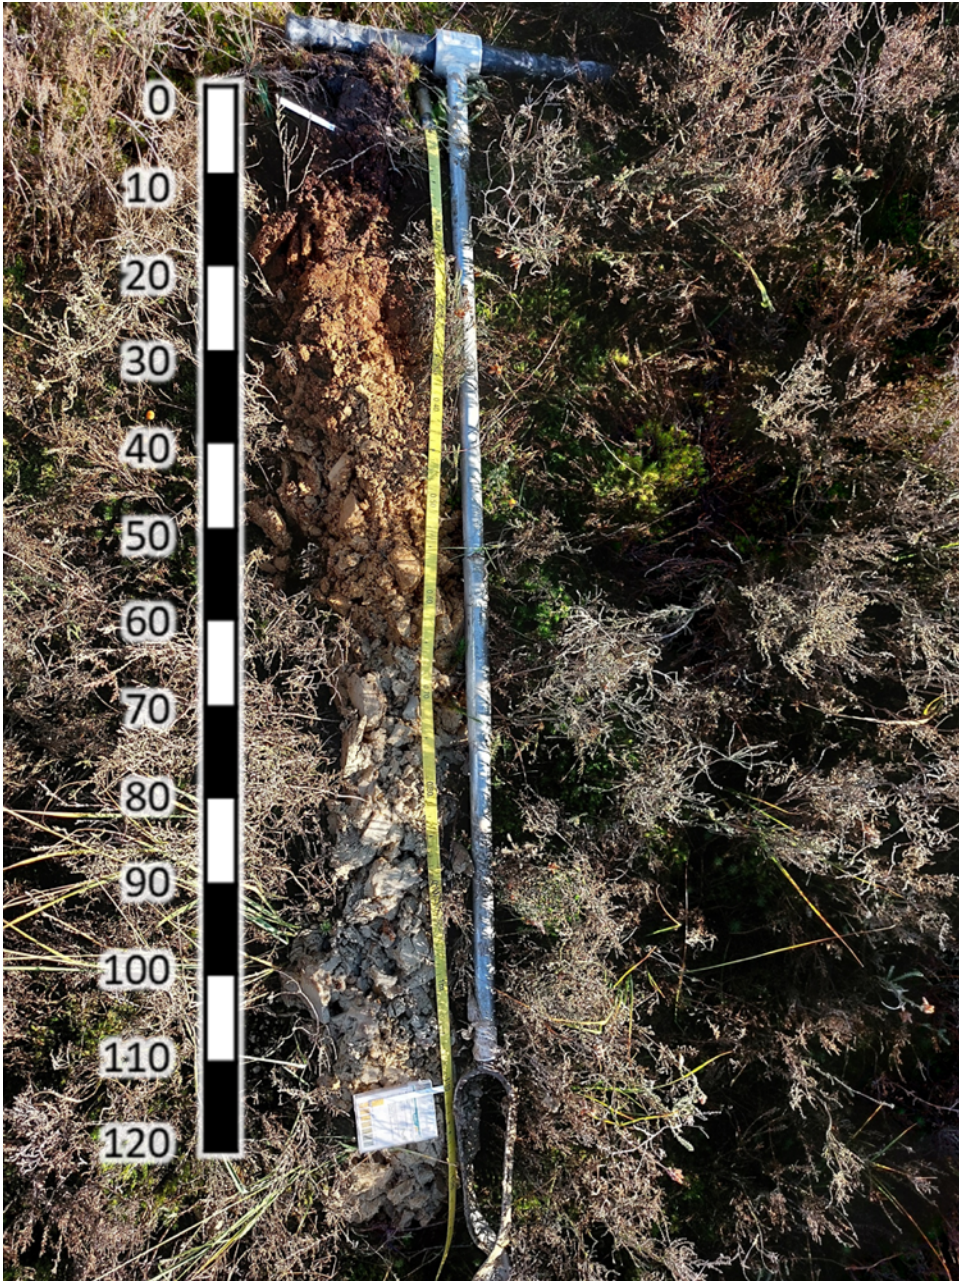
Figure A.2.5: Soil profile, topsoil at auger handle.

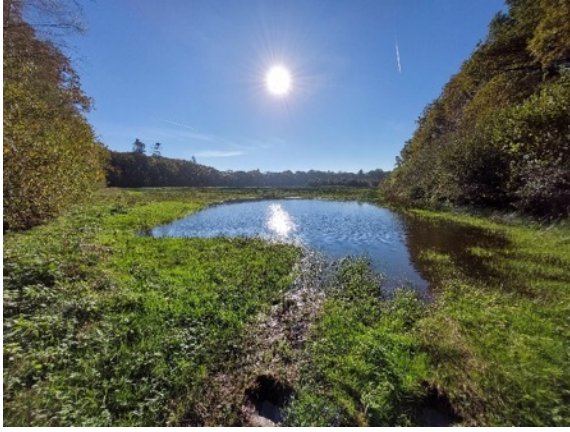
Figure A.3.4: Oligotrophic pond of approximately 1m deep.

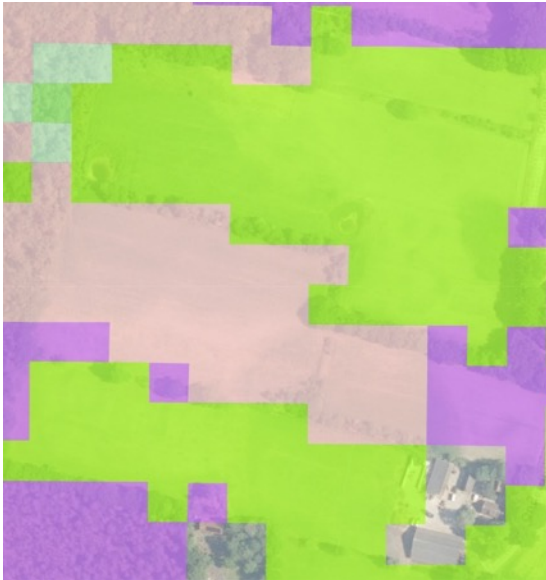
Figure A.4.5: For the current condition, WWN predicts K68 (light green) for the northern and southern field and K62 (light pink) for the middle field.

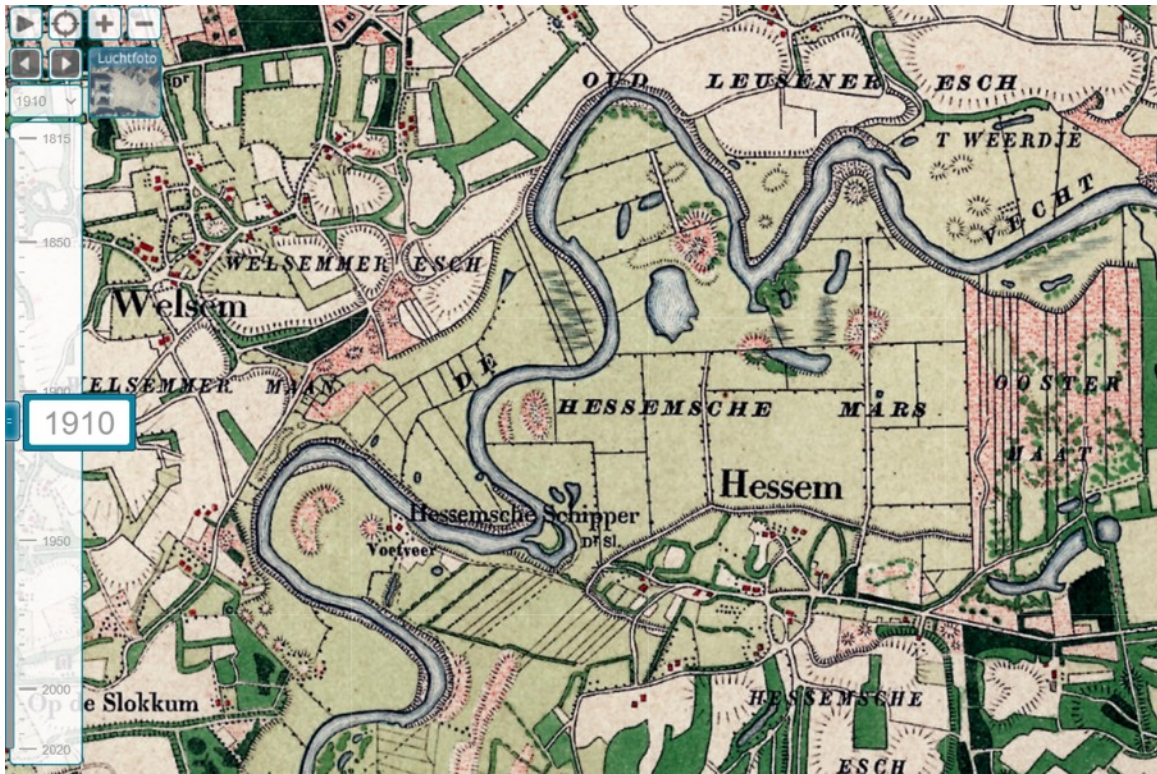
Figure C.1.3: Map from Topotijdreis 1910, showing the old meanders of the river Overijsselsche Vecht across the plots, part of the Hessemars (=marsh, wetland).

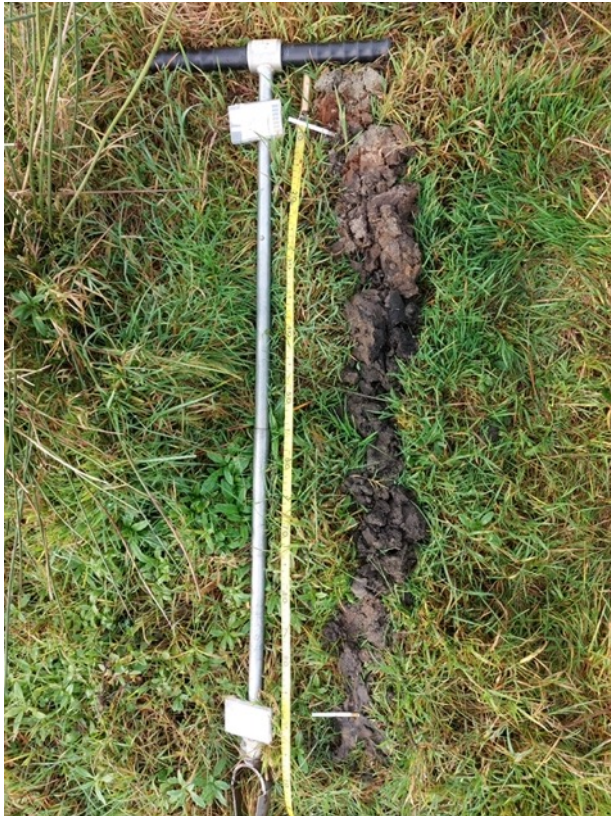
Figure C.1.12: Soil profile at location 1.

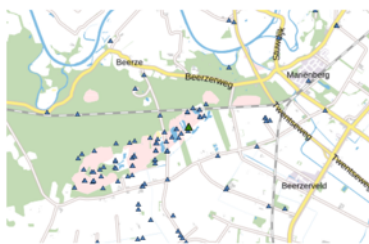
Figure C.2.11: Groundwater table data from dry heathland just north of the plot, at the green triangle (DINOloket).

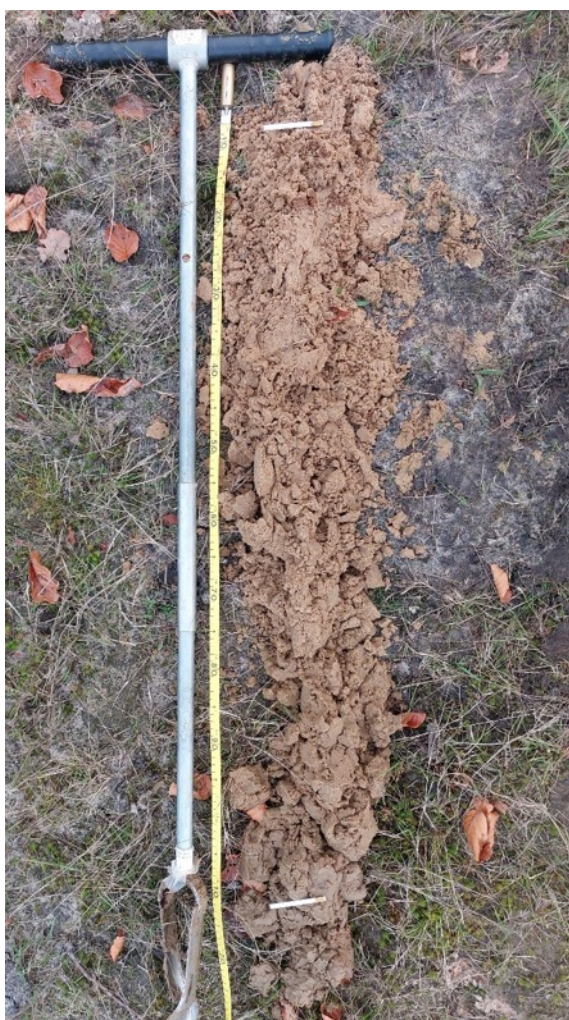
Figure C.3.13: Soil profile at location 1.

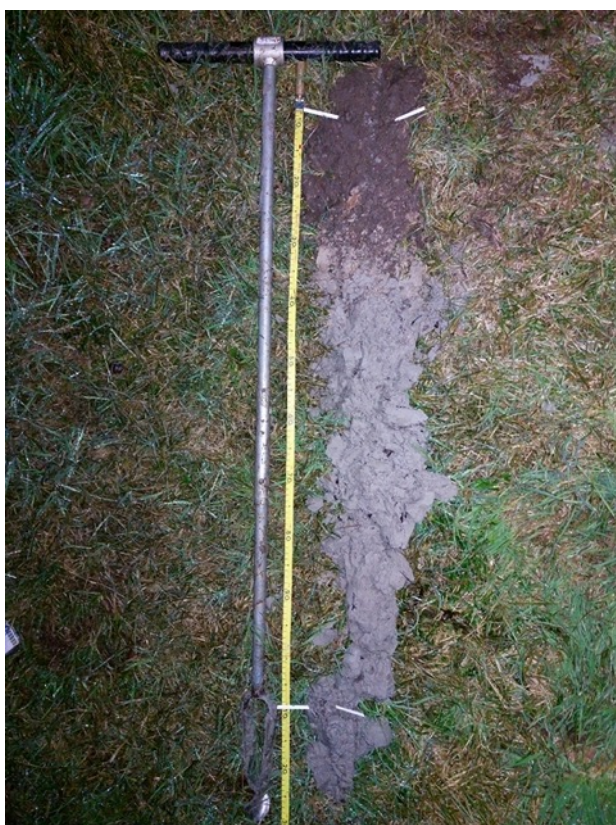
Figure D.1.12: Soil profile at location 1.

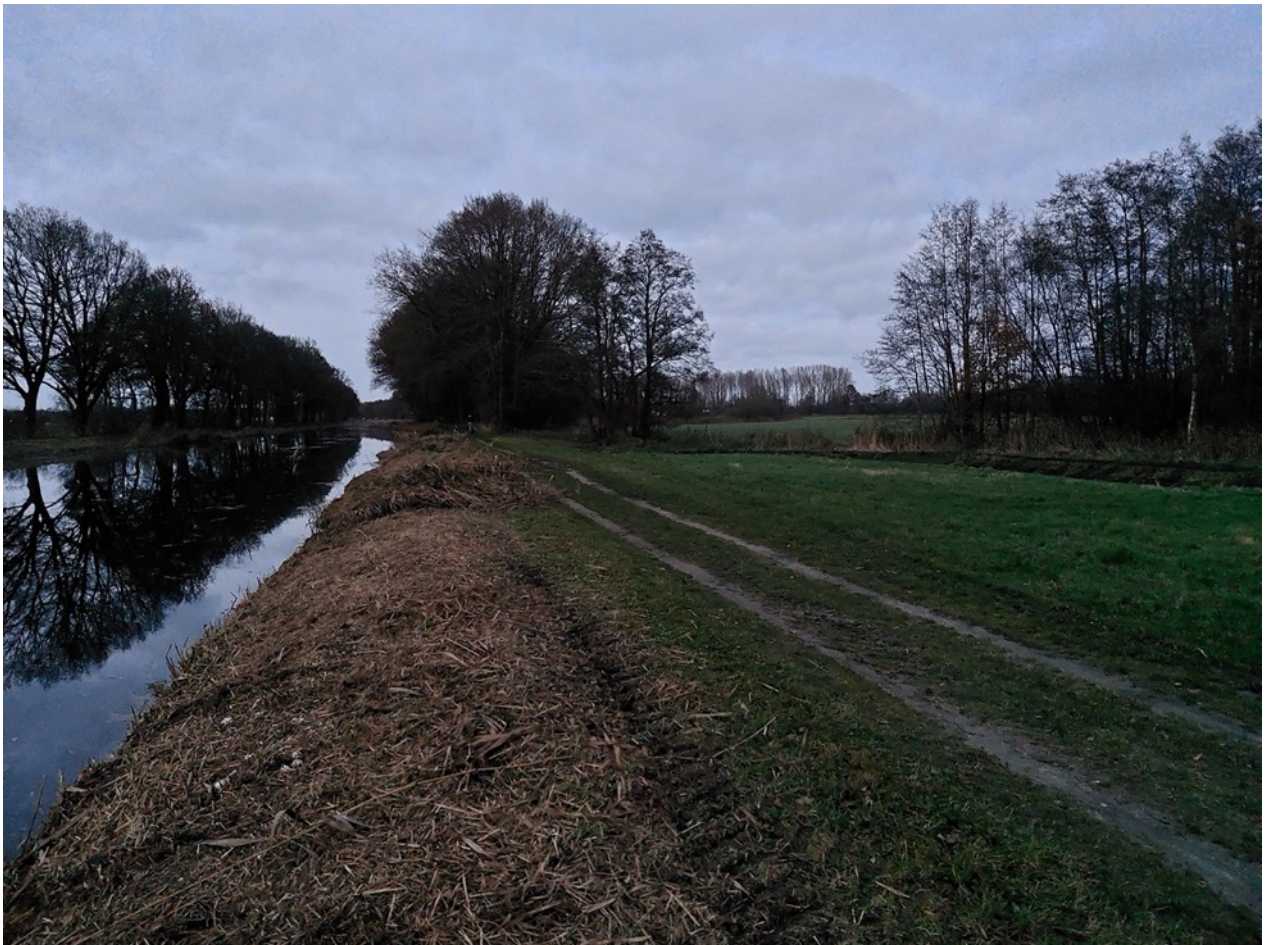
Figure D.2.32: Channel (location 16) along border of the area (visible on the far right of the picture), water surface seems to be higher than ground level of the area.

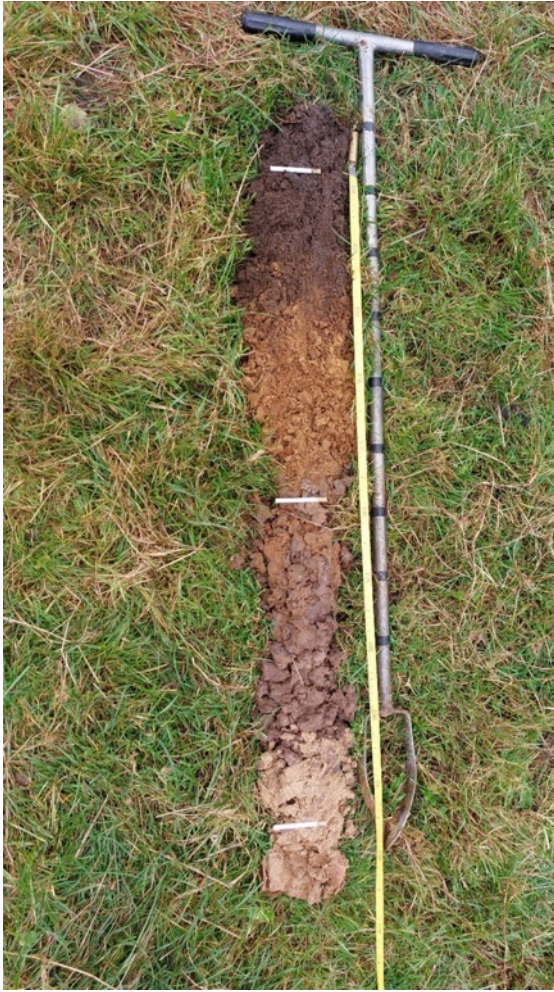
Figure E.1.13: Soil profile at location 1.

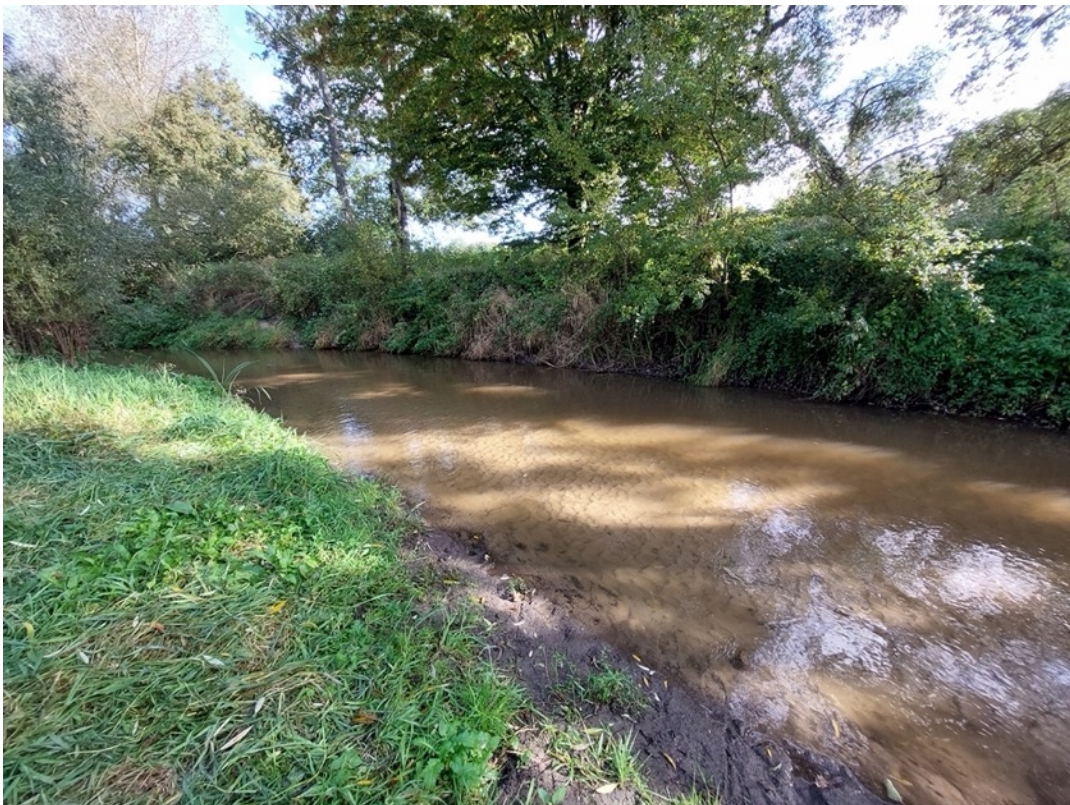
Figure E.1.16: The Dinkel, very low-lying when compared to surrounding fields (location 4).

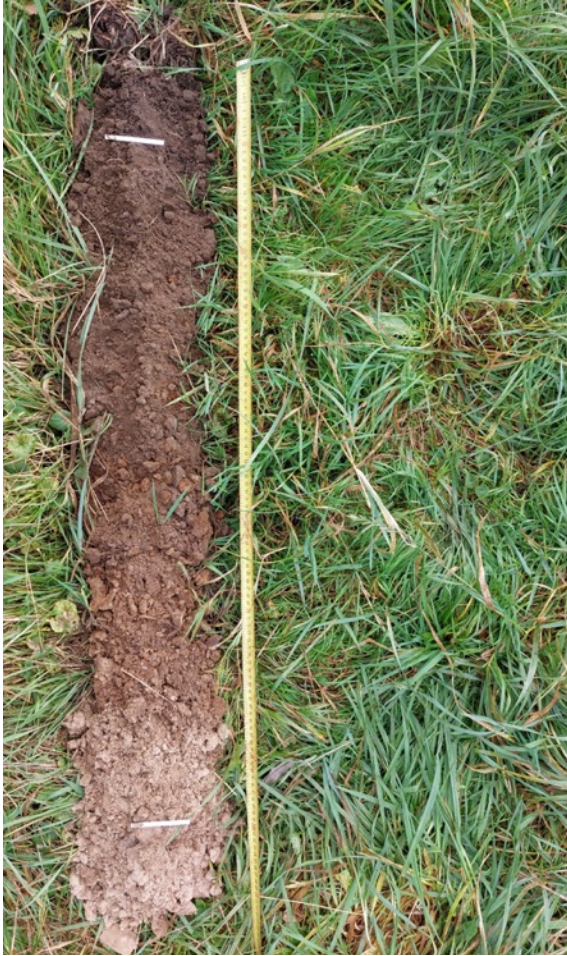
Figure E.2.11: Soil profile at location 1.

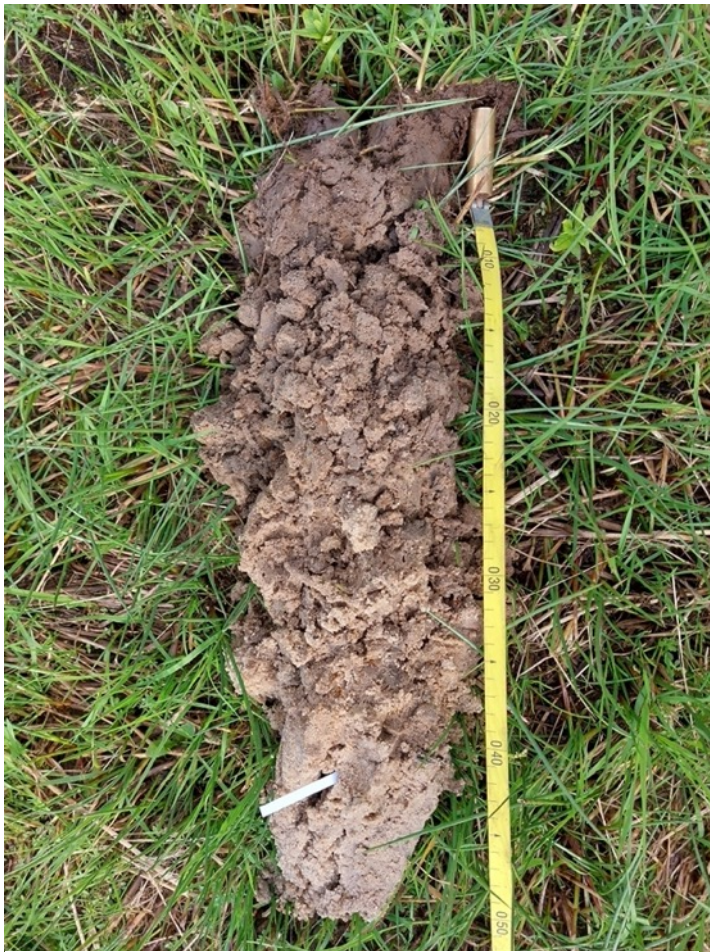
Figure E.3.12: Soil profile at location 1.

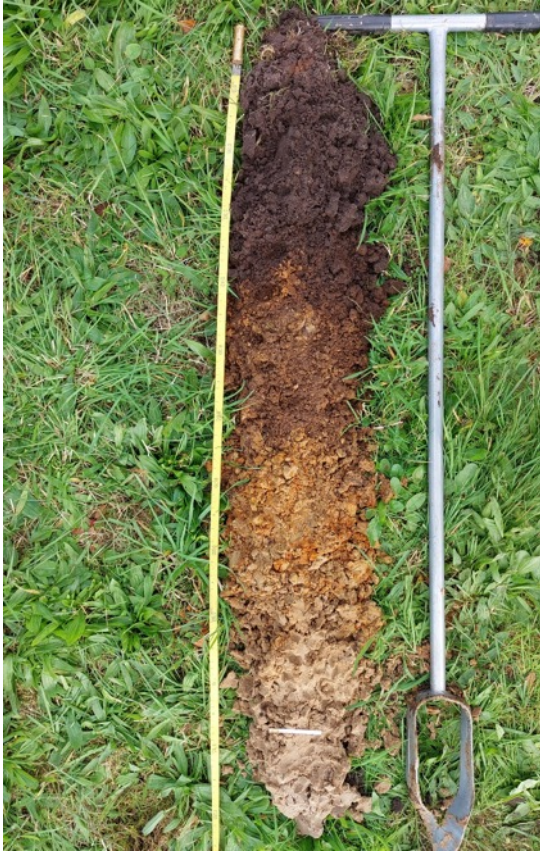
Figure E.4.12: Soil profile at location 1.
