# APPENDIX 4

## Proposed flood measures

S.R. Stapel, 2023  
RAINFALL-RUNOFF MODELLING TO ASSESS FLOOD HAZARS ON SINT-EUSTATIUS, CARIBBEAN NETHERLANDS  
**Subdivision measures – Layout with two large infiltration basins at the base of the slope**

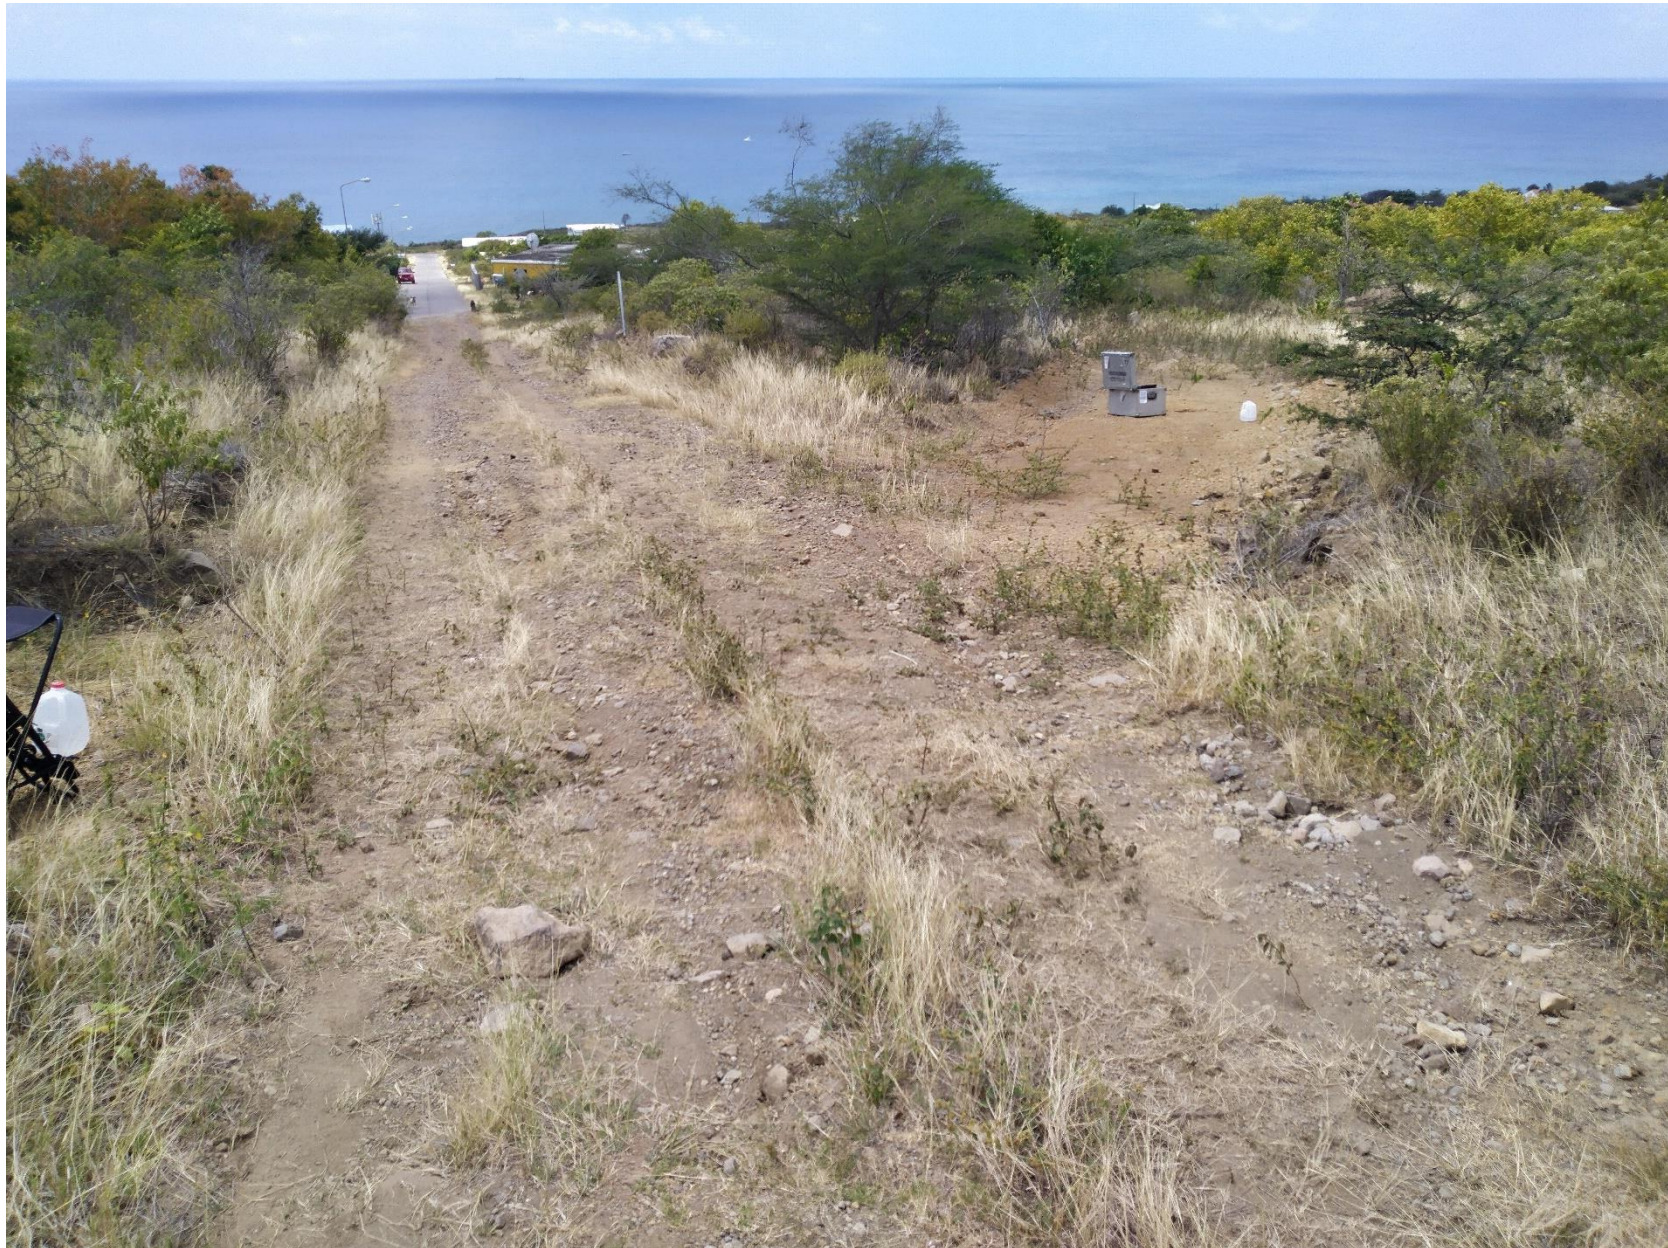
**Photo 1 – Roadside infiltration pit**

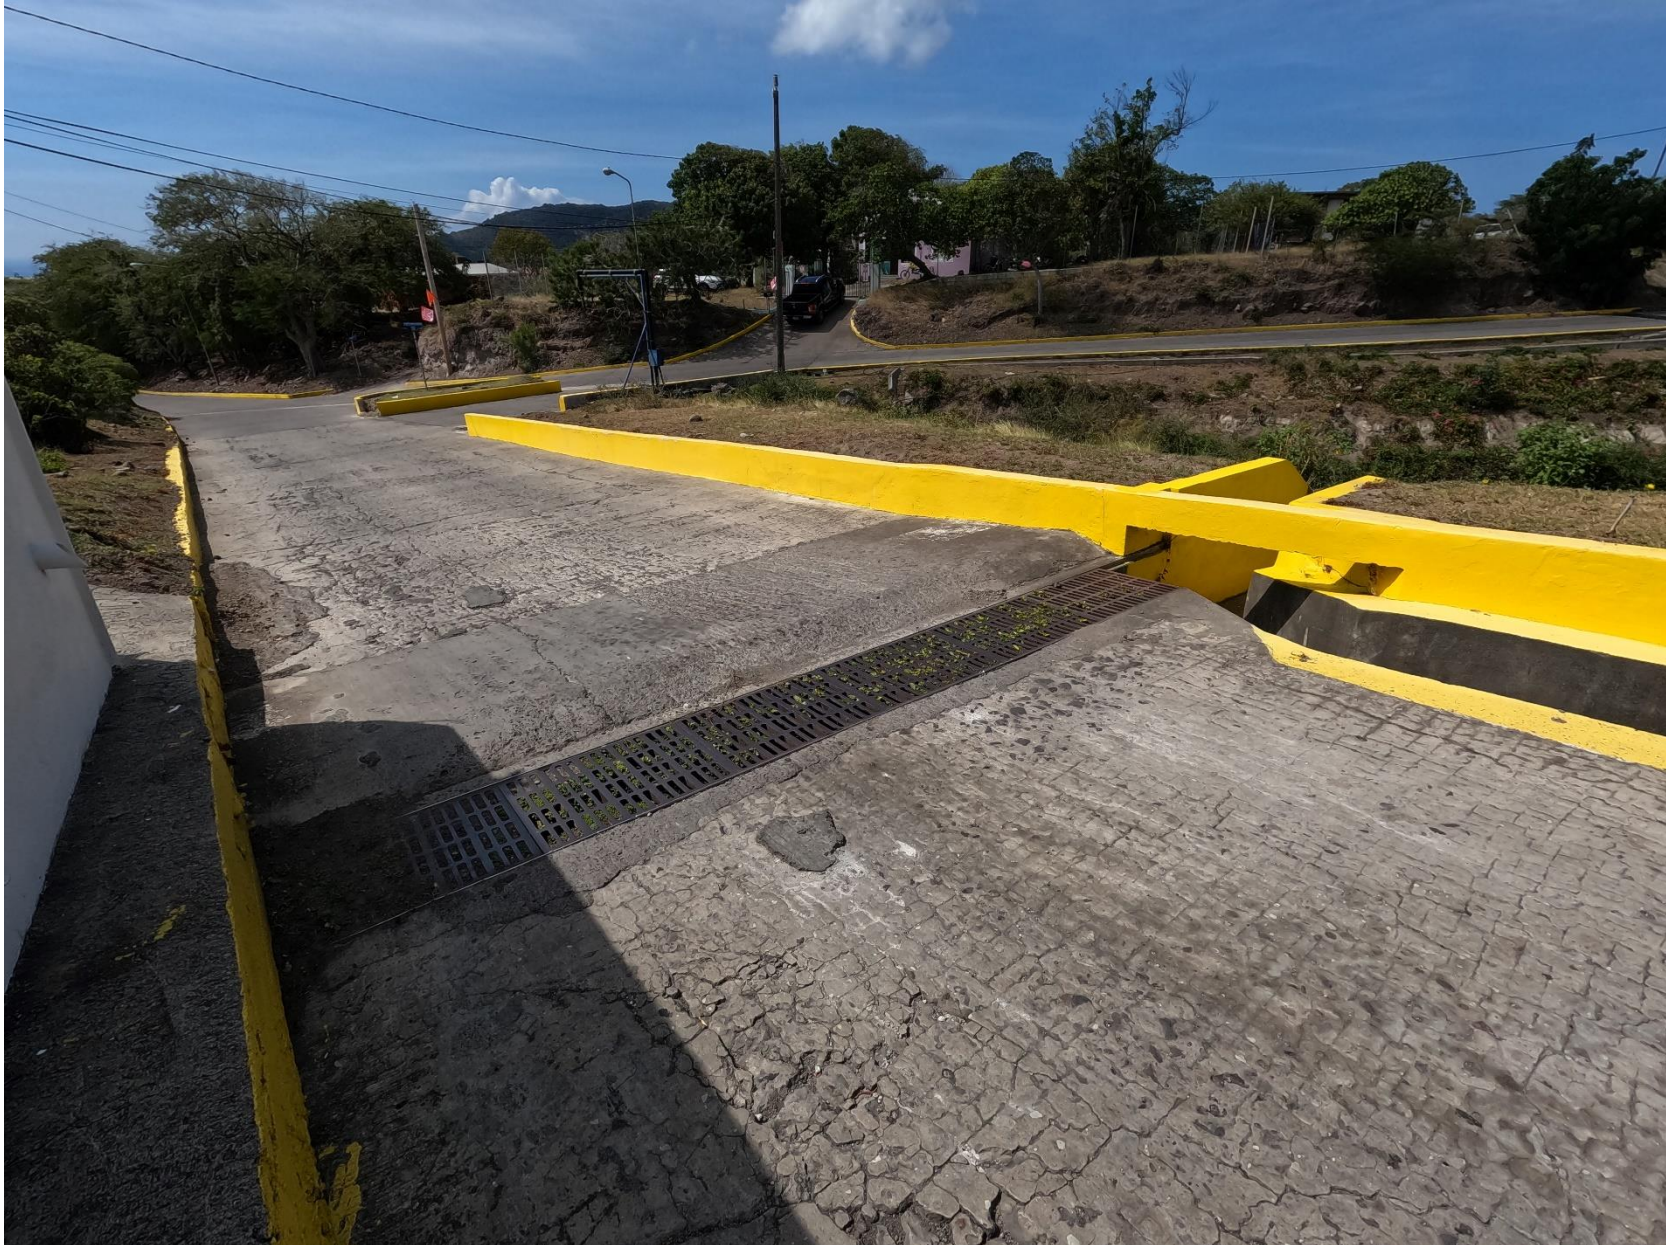
**Photo 2 – Linear drain followed by a speed bump**

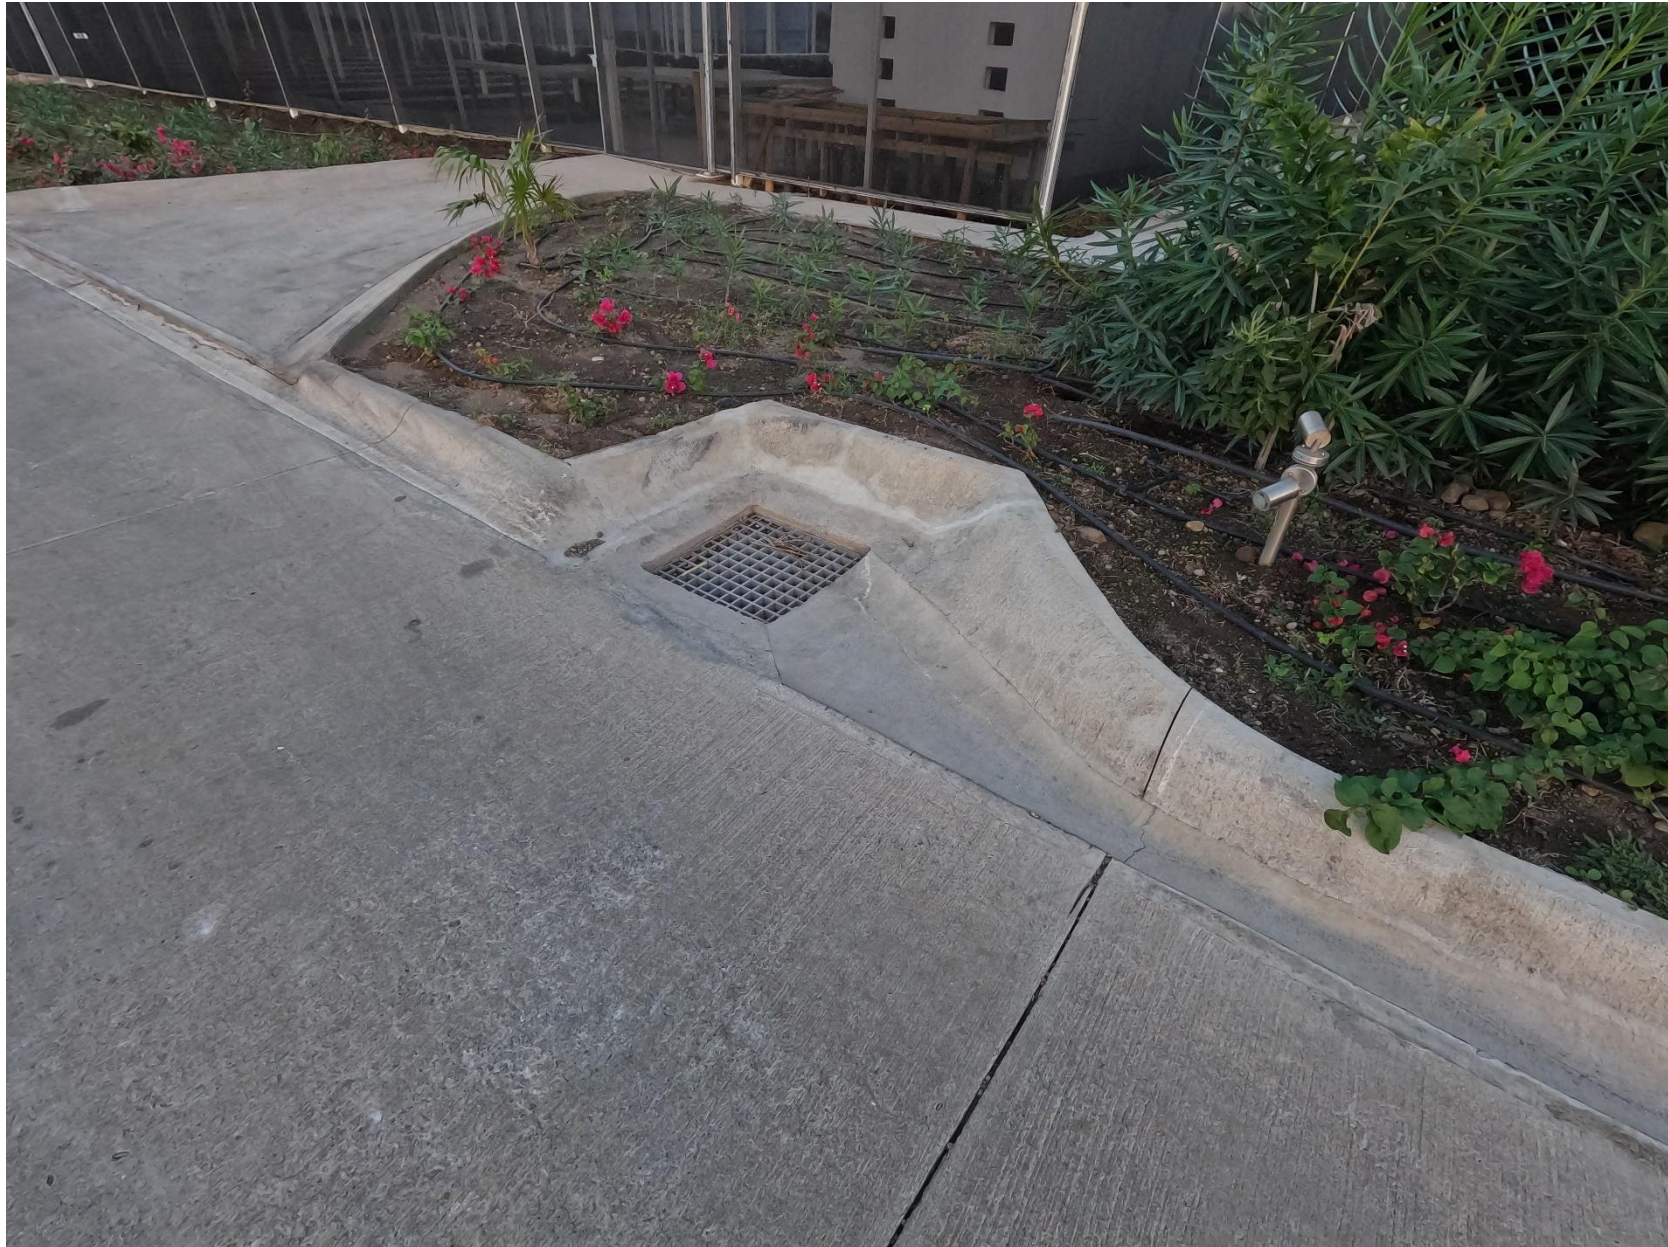
**Photo 3 – Roadside storm drain**

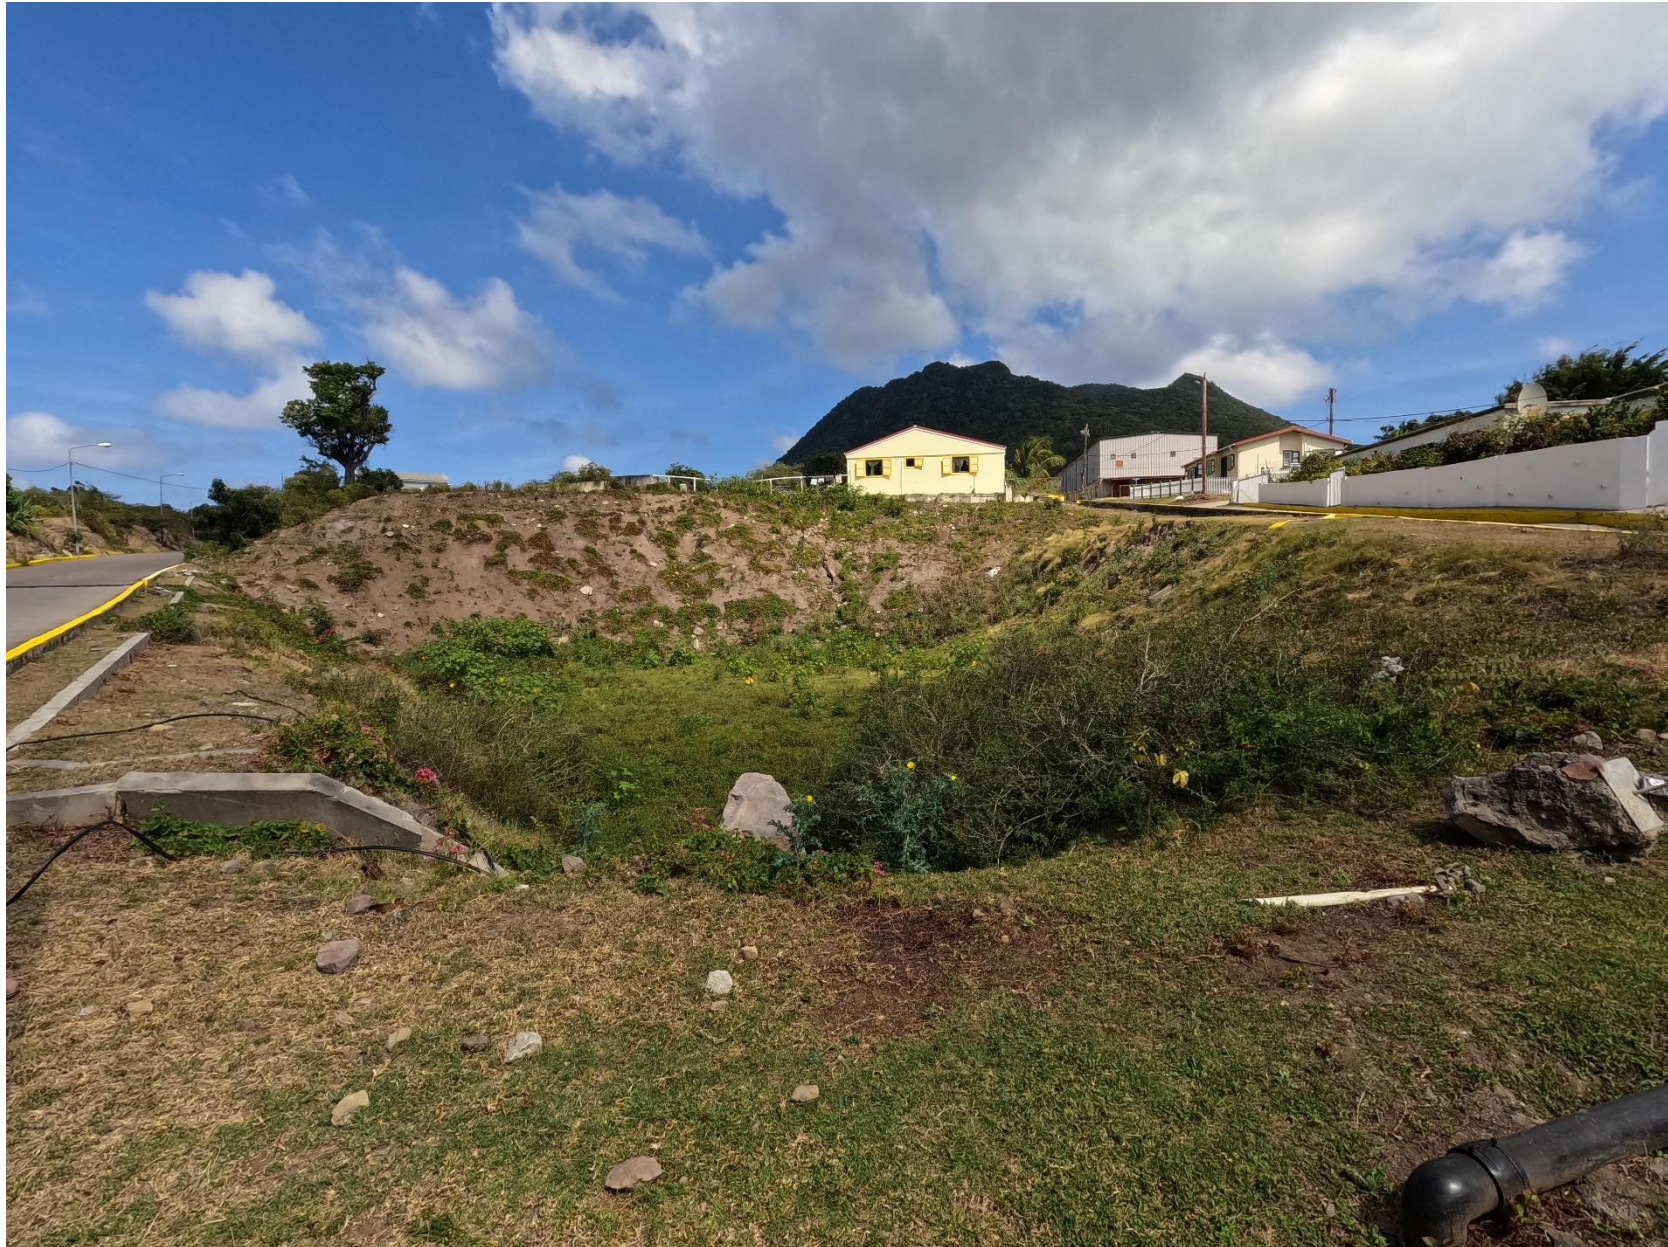
**Photo 4 – Large infiltration basin**

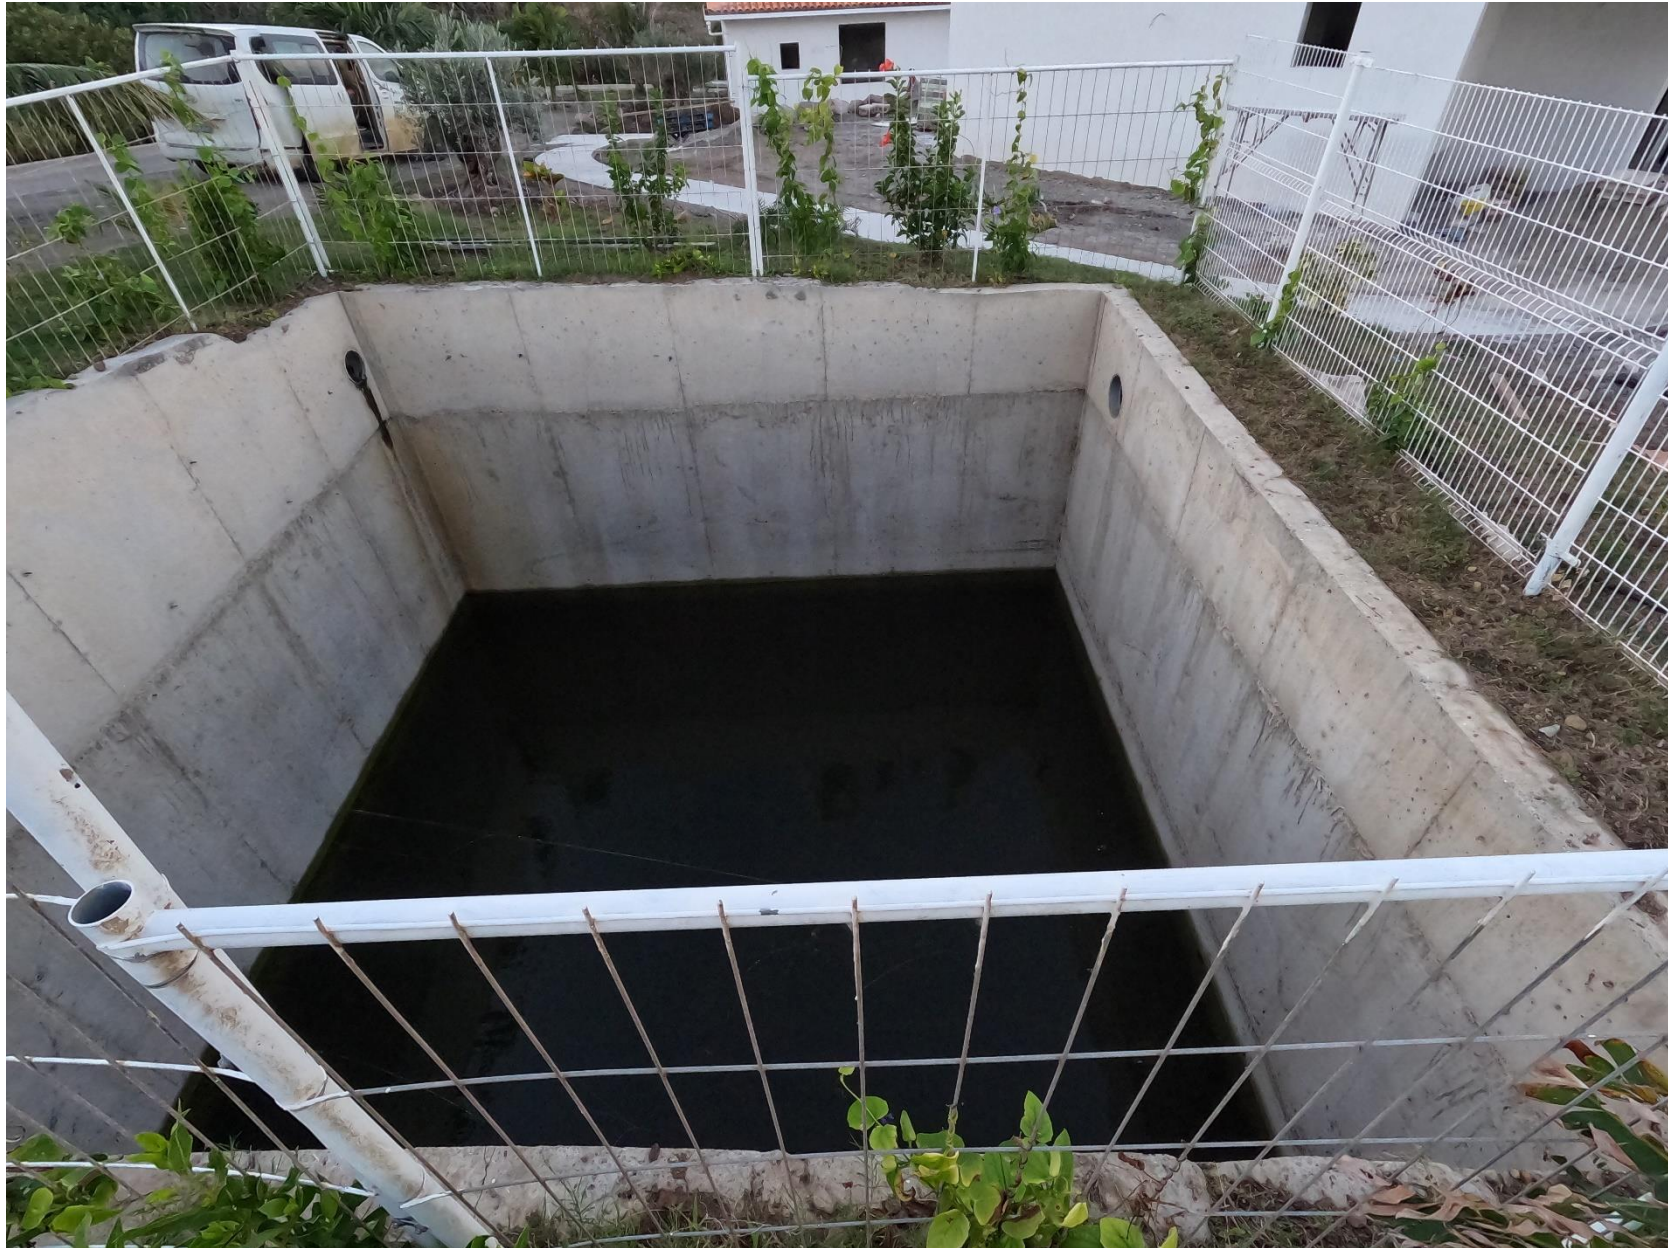
**Photo 5 – Runoff storage facility**

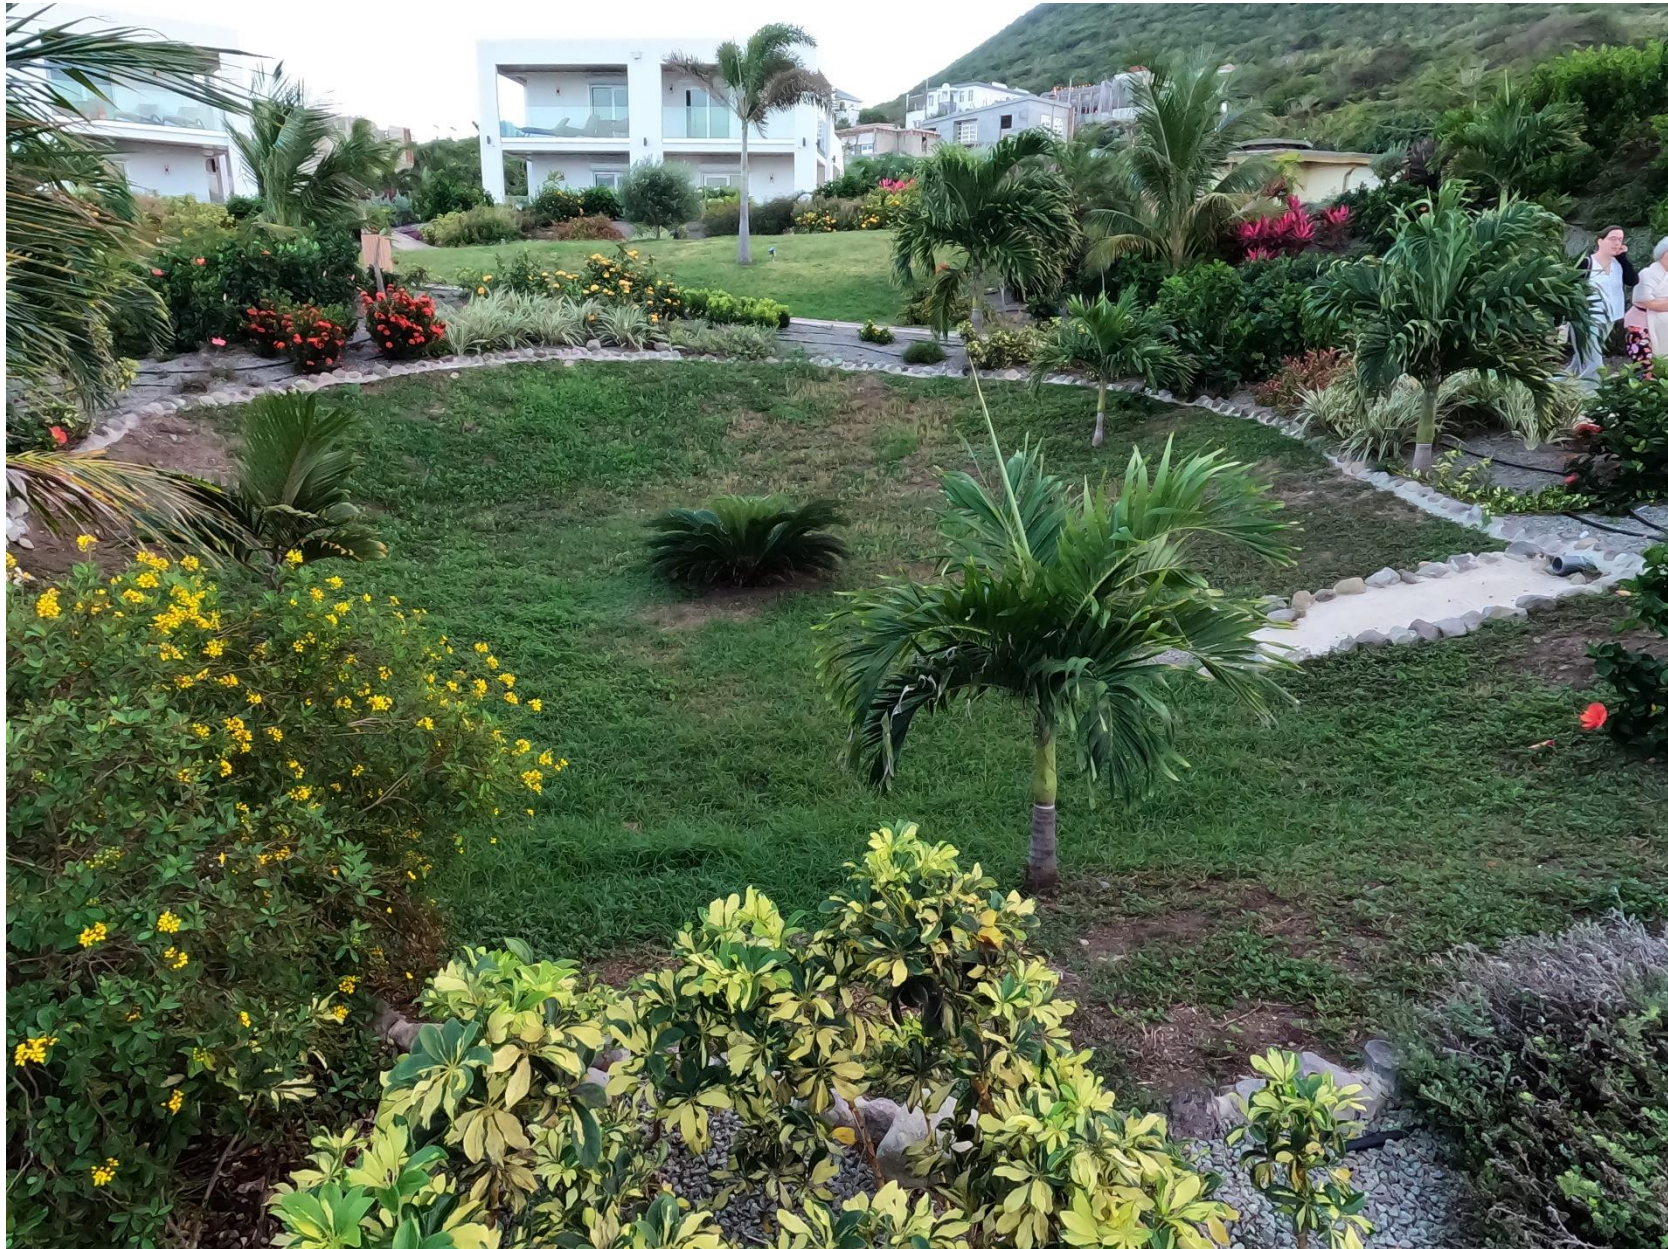
**Photo 6 – Small bioswale / infiltration basin**

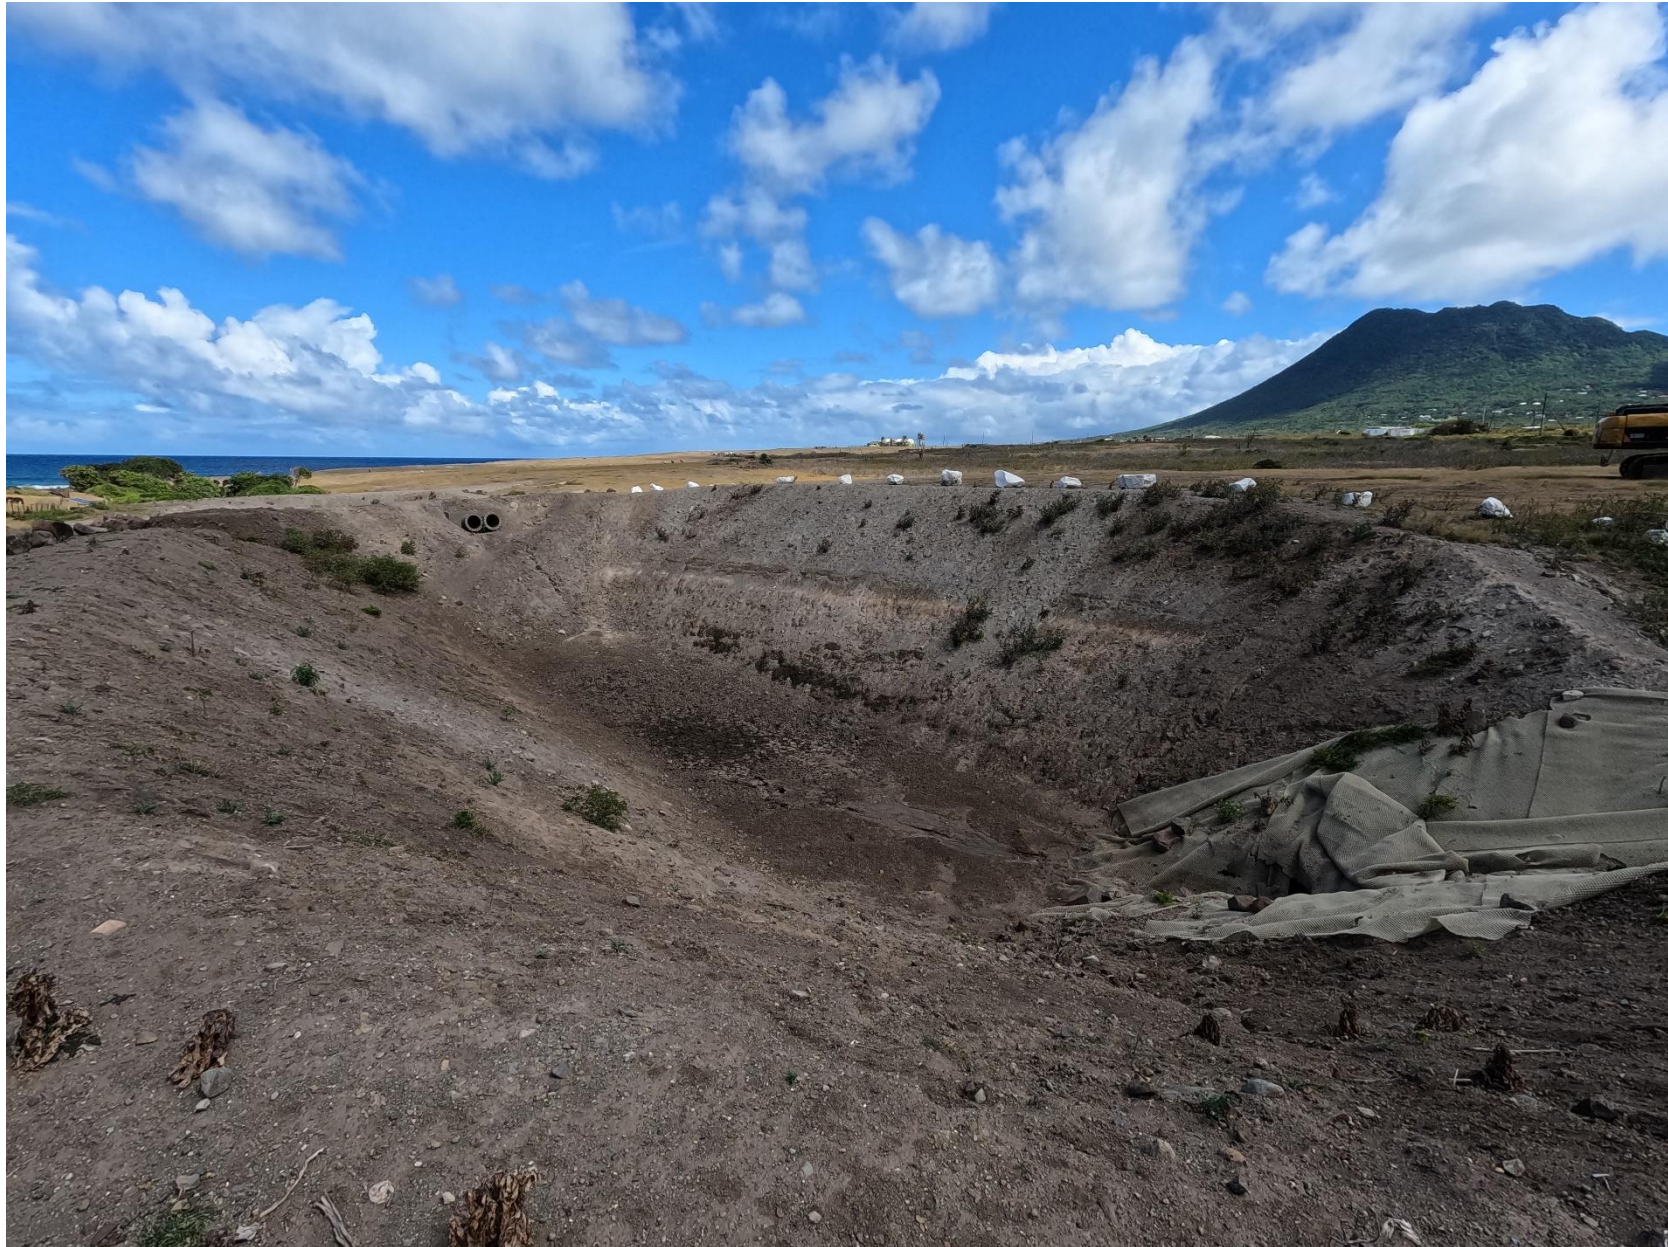
**Photo 7 – Large infiltration basin created inside a gully**

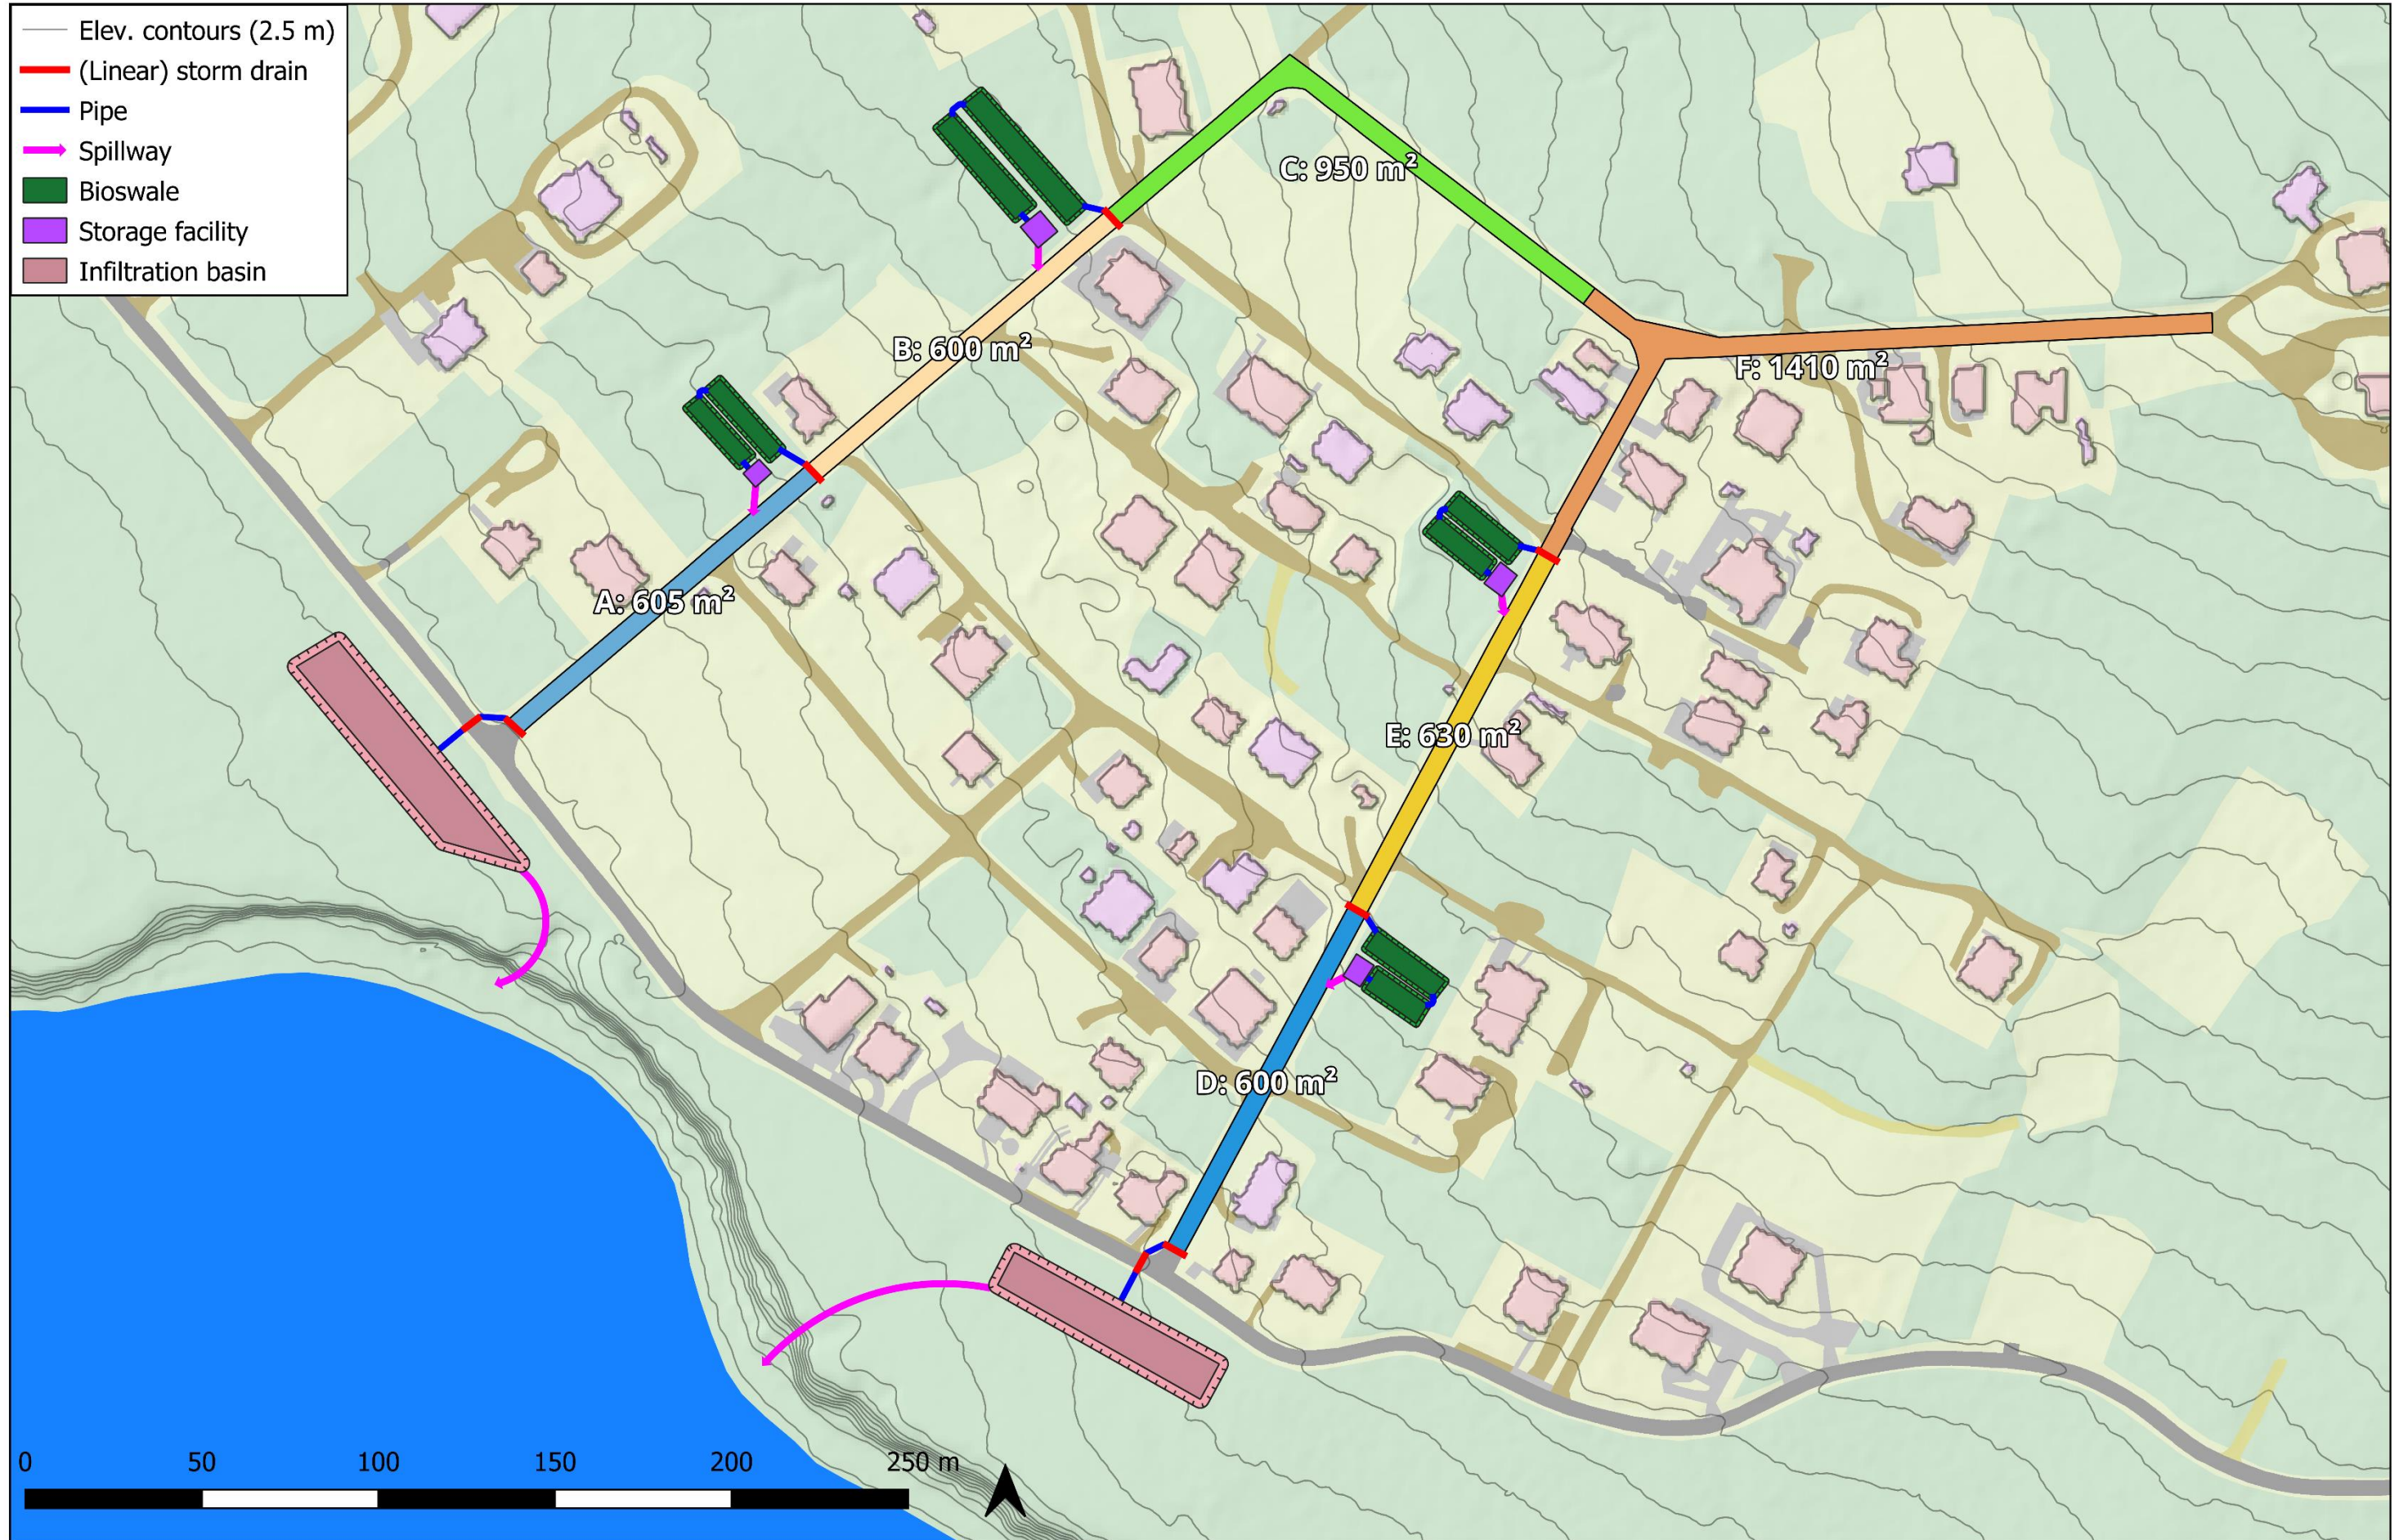
### Subdivision measures – Layout with several storages throughout the area

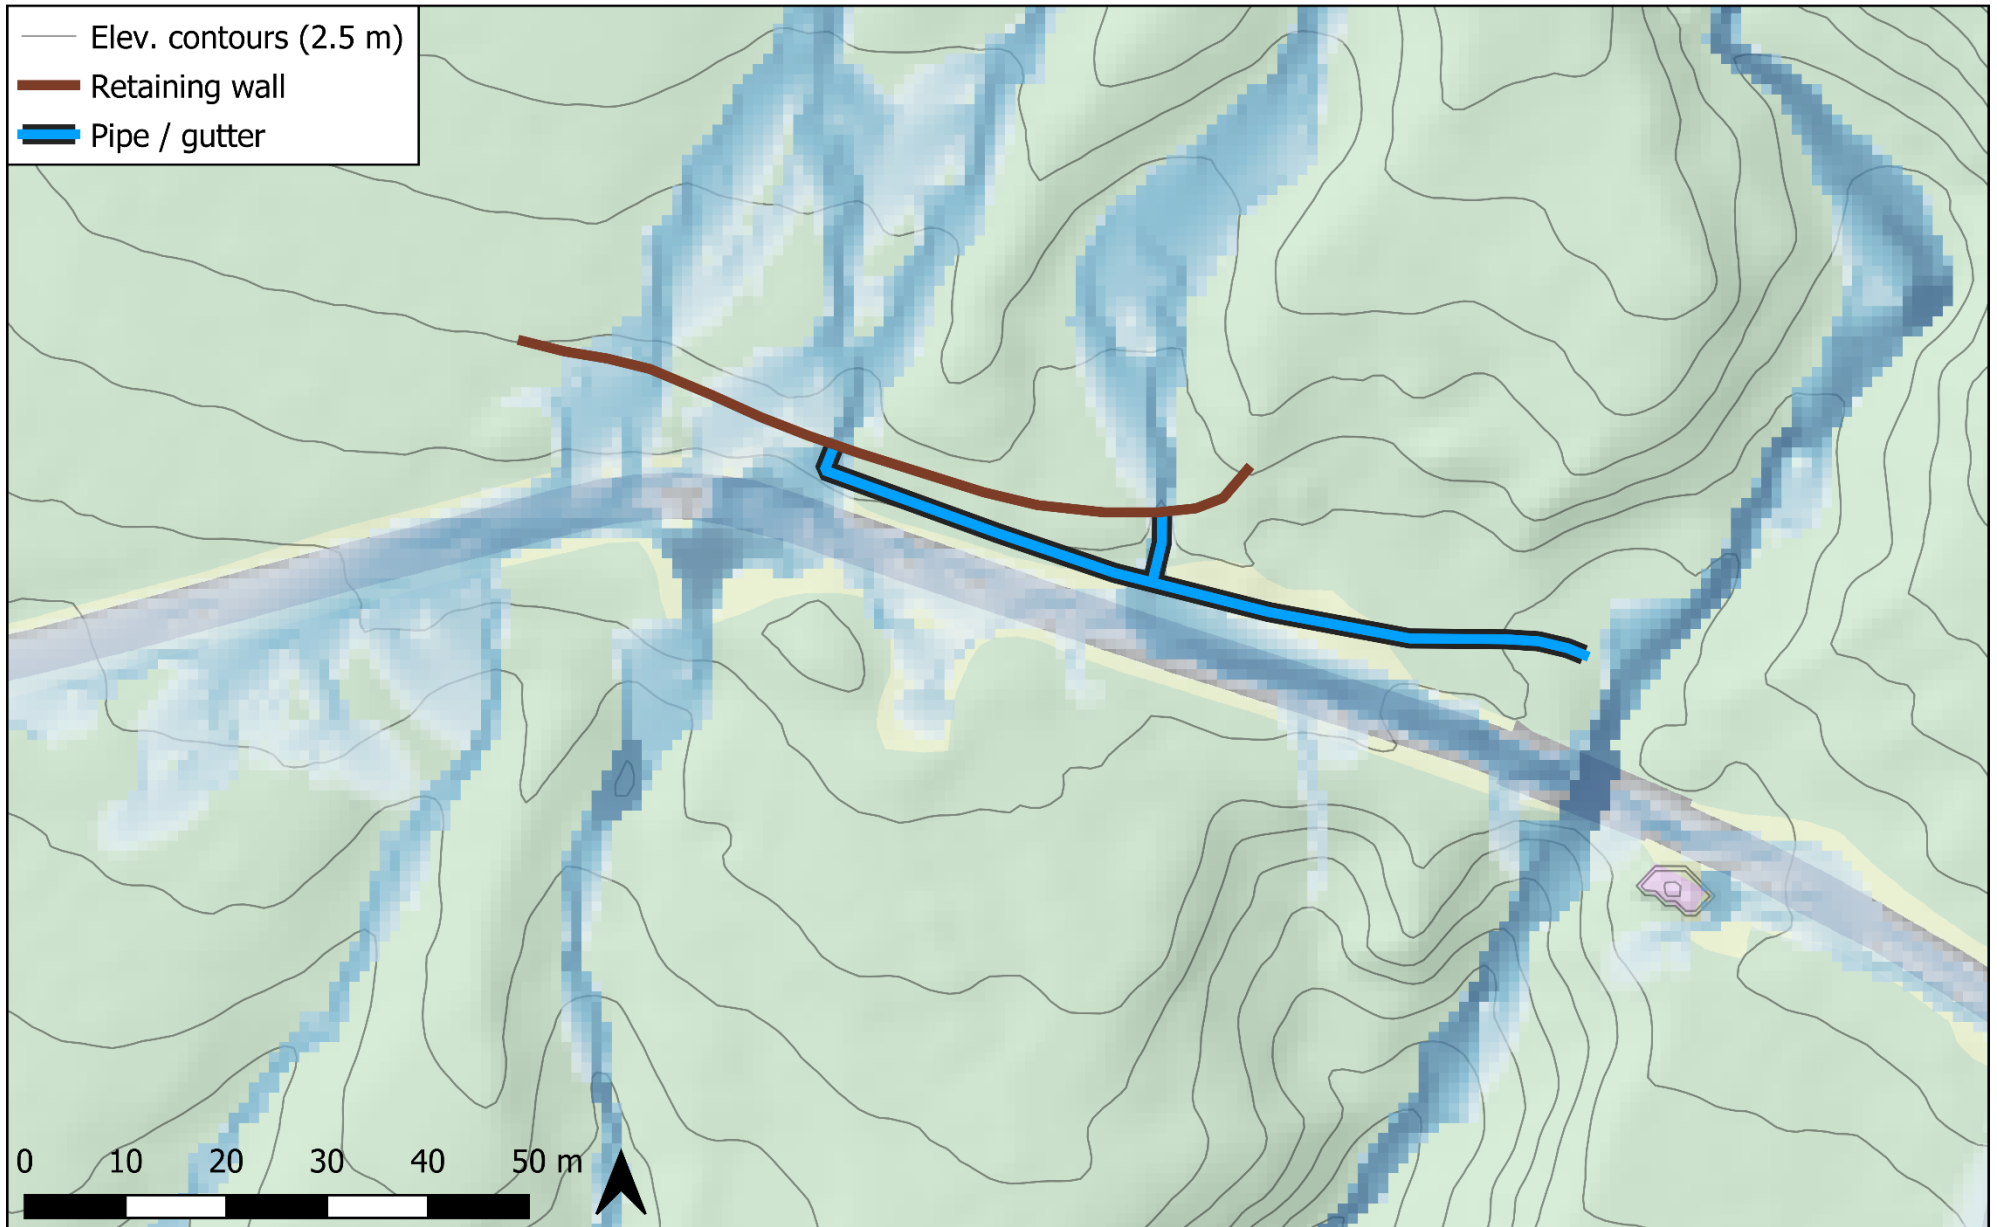
### Active gully measures – Rerouting towards gully 1
