# RAINFALL-RUNOFF MODELLING TO ASSESS FLOOD HAZARD ON SINT EUSTATIUS, CARIBBEAN NETHERLANDS

**MSc thesis**  
*Earth Surface and Water*  
2023  
*Second version*

**Samuel R Stapel**  
Student ID 5977037

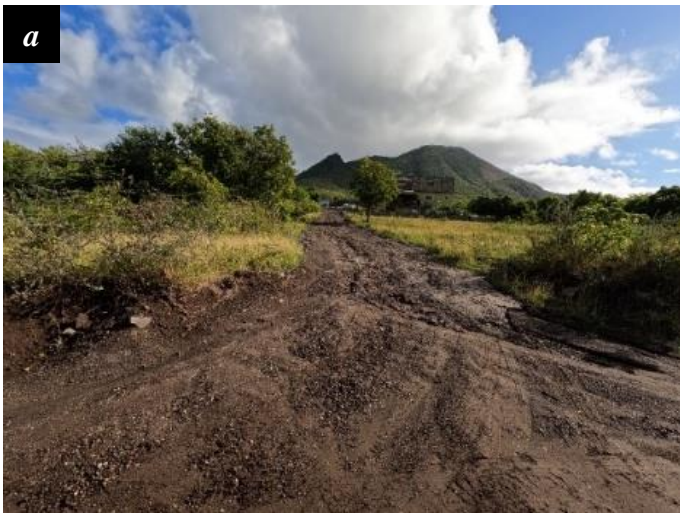
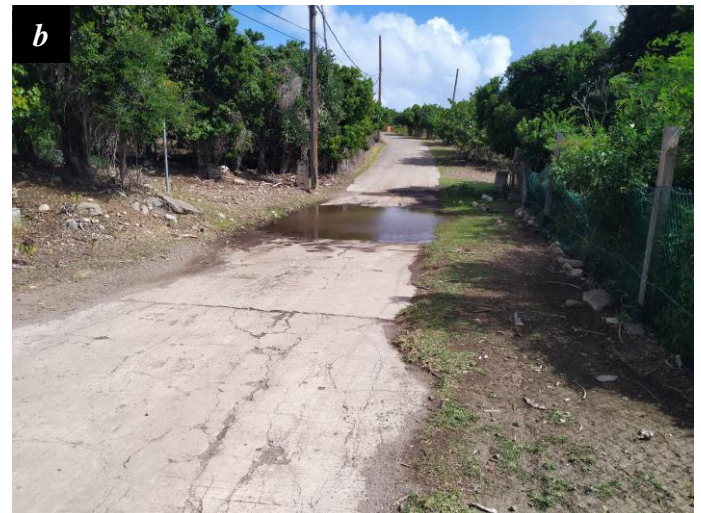
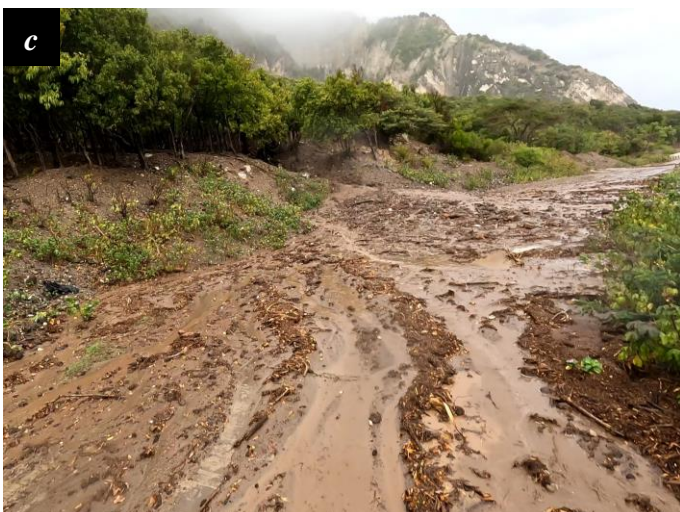
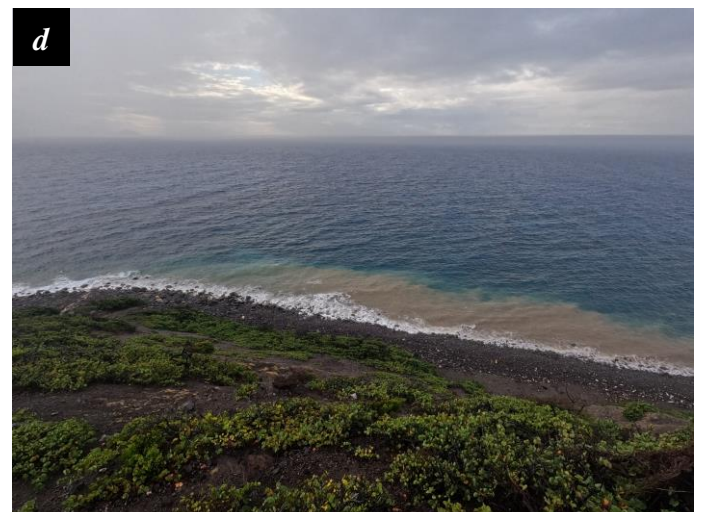
Figure 1.2: Examples of flood damage on Sint Eustatius; a. Rill erosion on an unpaved road; b. Low-lying road section that is prone to flooding; c. Massive sediment deposition from a gully onto a paved road; d. Sediment-laden discharge from gullies into the Caribbean Sea.

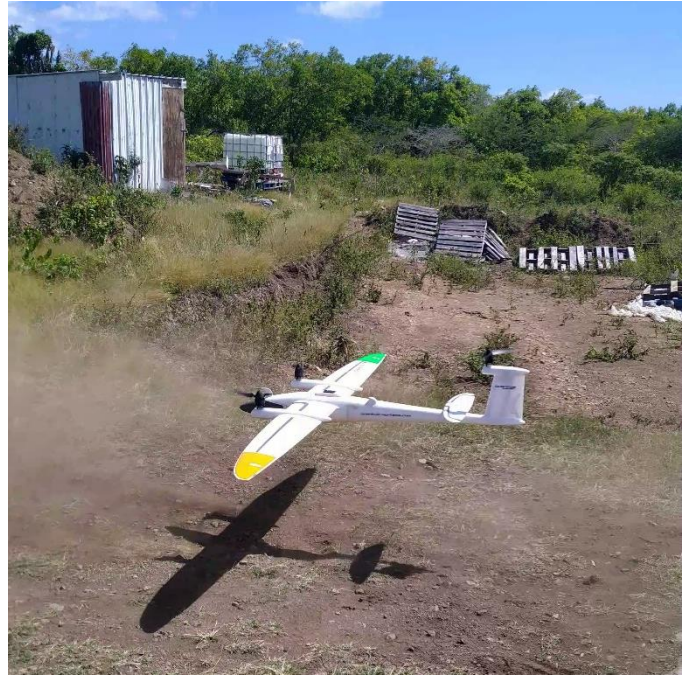
Figure 4.1: Trinity F90+ performing a vertical take-off

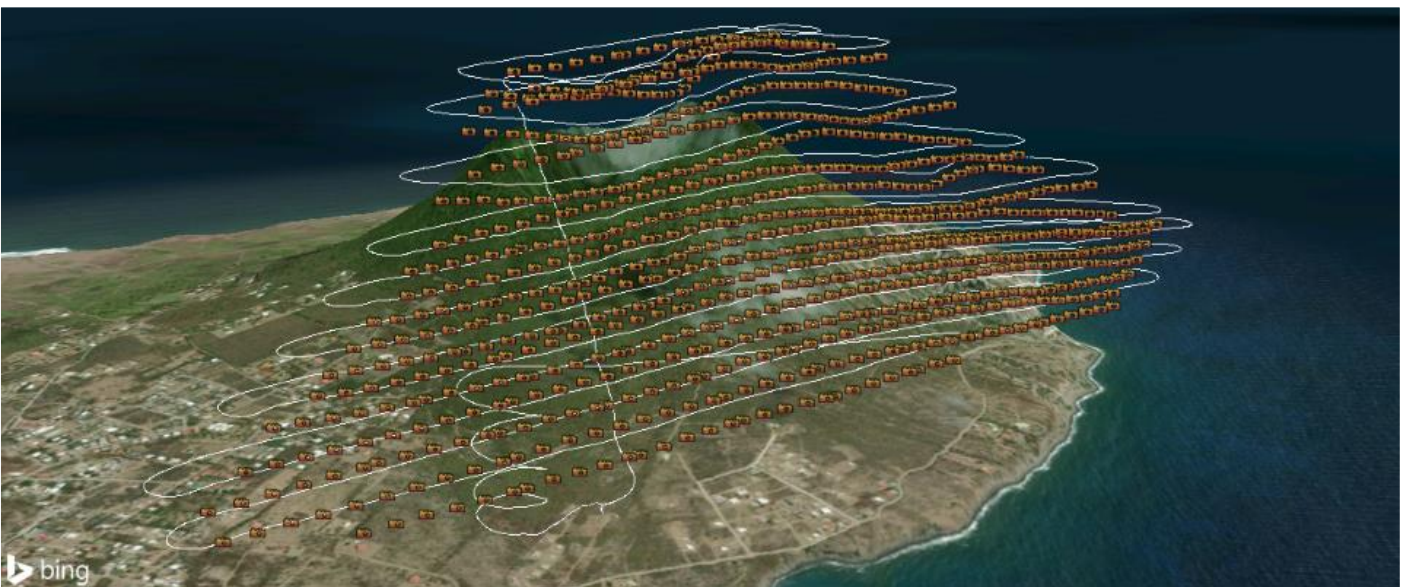
Figure 4.2: Flight track and locations of captured aerial photographs. The flight tracks were oriented roughly parallel to the elevation contours at a height of approximately 310 metres above ground level. The mission started near the crater and progressed downslope towards the coastline.

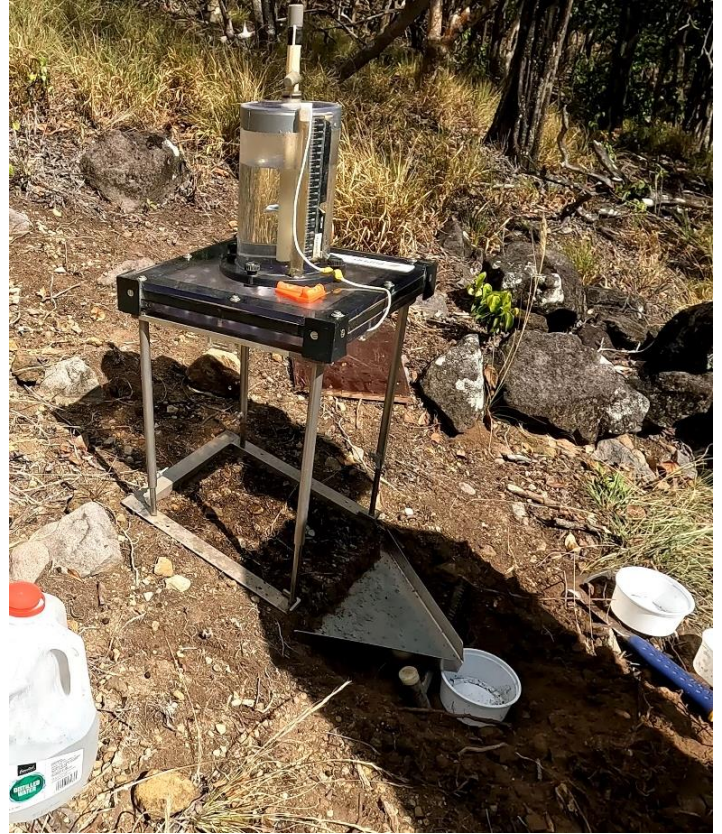
Figure 4.3: Schematic setup of the rainfall simulator, adapted from the instructions by Eijkelkamp (left); The rainfall simulator set up in the field (right). Over the course of the experiment, the hydraulic head in the reservoir remains constant, ensuring a steady input of water. Water drips through the perforations and is guided downslope via a trough into a collection container. At set intervals, the discharge from the reservoir and the runoff in the container are measured.

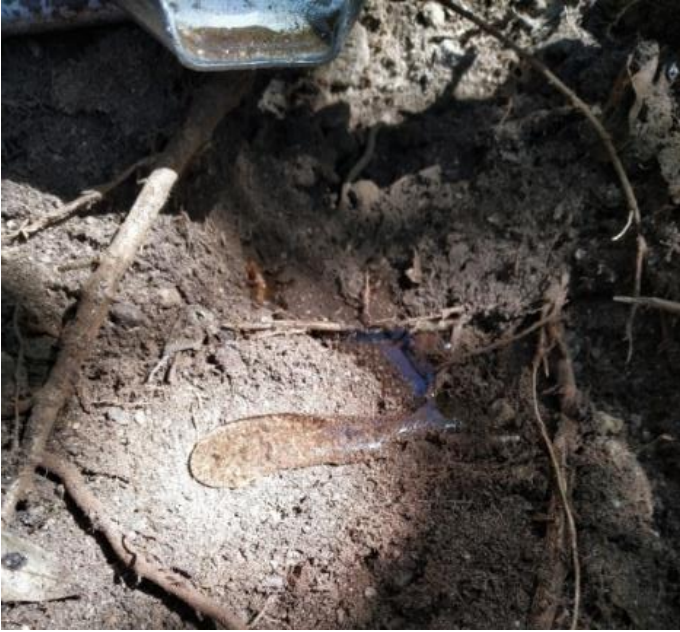
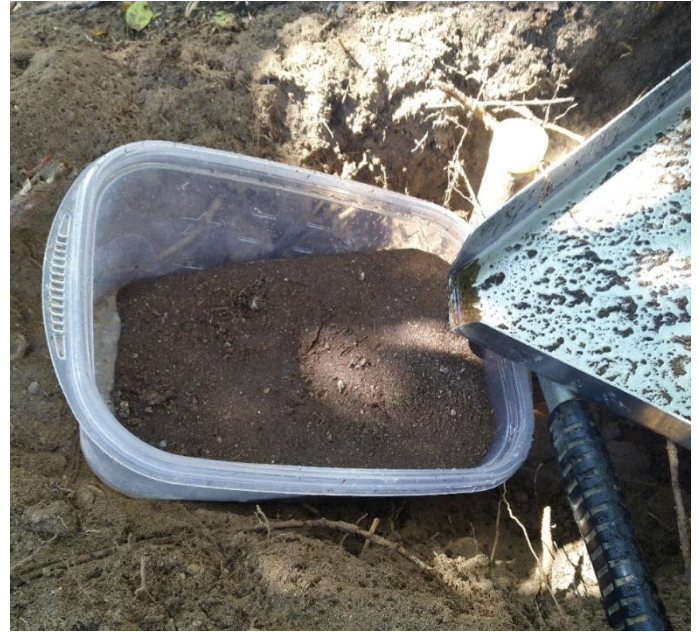
Figure 5.3: Water beading up on the soil in the runoff collection pit (left); soil particles staying afloat in a runoff collection container (right).

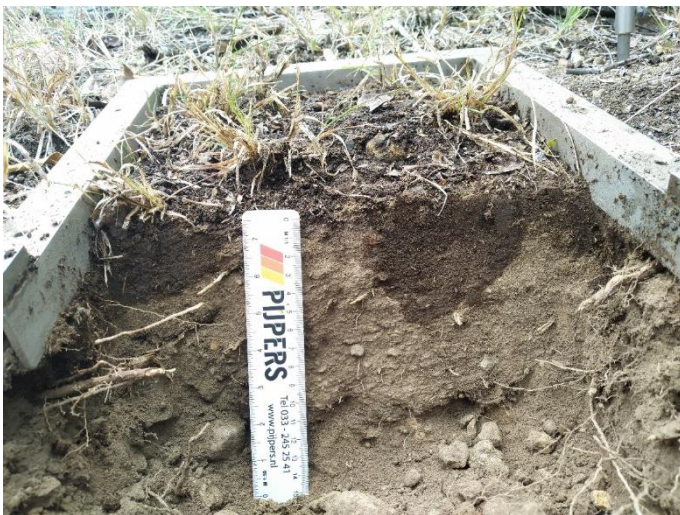
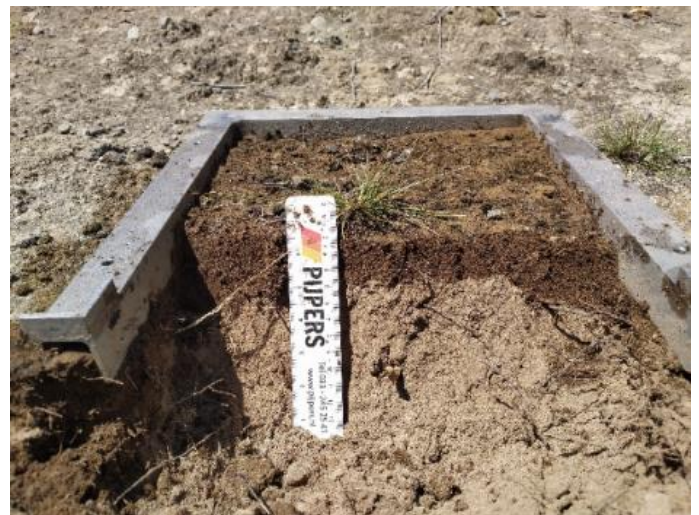
Figure 5.4: Preferential flow paths in a soil with low permeability (left). Besides the flow paths, infiltration in this soil was very limited; Uniform infiltration in a soil with high permeability (right).

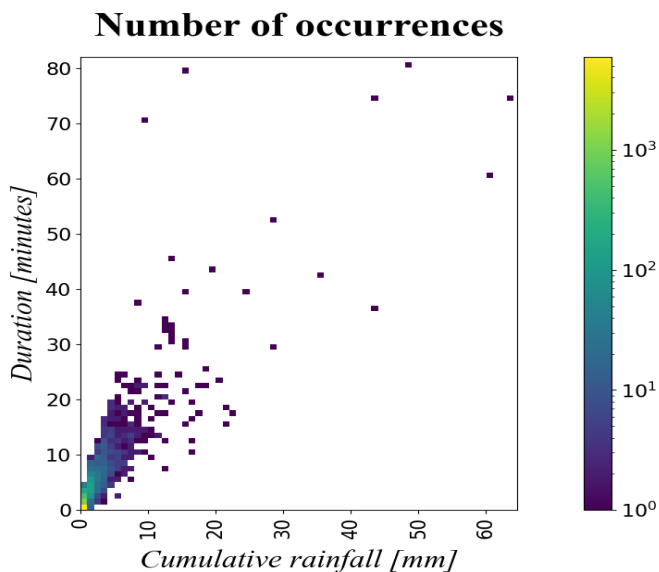
Figure 5.7: Number of events per duration and depth interval, amounting to a total of 8861 isolated events. Duration and depth intervals are 1 minute and 1 millimetre wide.

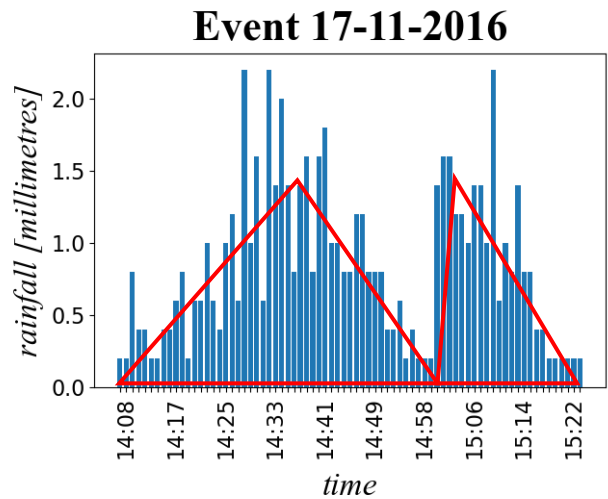
Figure 5.8: The largest event in the dataset in terms of yield, 63.6 mm. The event appears to consist of two heavy rainstorms that occurred in short succession.

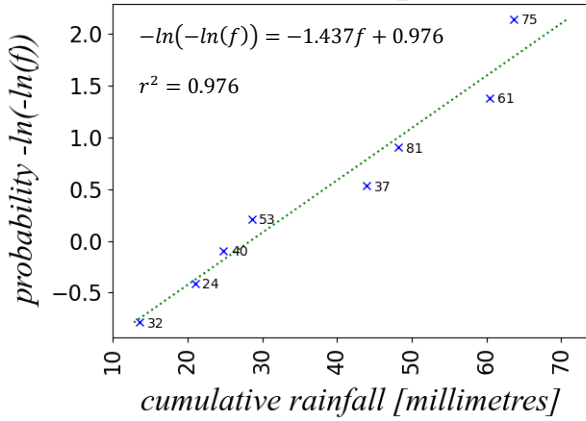
Figure 5.9: The ranked annual largest events in terms of cumulative rainfall, plotted against the logarithmic probability. The labels at each point show the duration (in minutes) of the event. The green line shows the relationship between cumulative rainfall and return period.

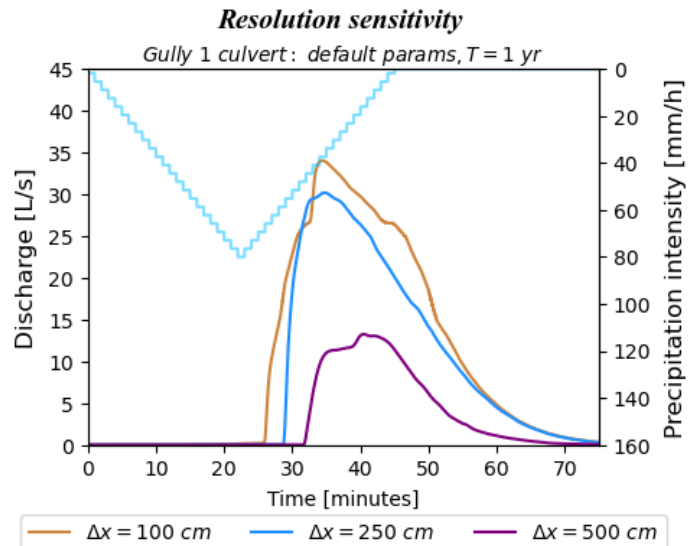
Figure 5.13: Effects of model resolution. For  $\Delta x = 100$  cm, the initial rise was caused by the flood wave from gully 1, after which the rerouted water from gully 2 arrived and was superimposed on the flood wave of gully 1. The flood wave of  $\Delta x = 250$  cm was retarded slightly, and there is no visible influence of gully 2. Nevertheless, the peak and total discharge are relatively similar. The flood wave of  $\Delta x = 500$  cm arrived much later, and the peak and total discharge are clearly lower.

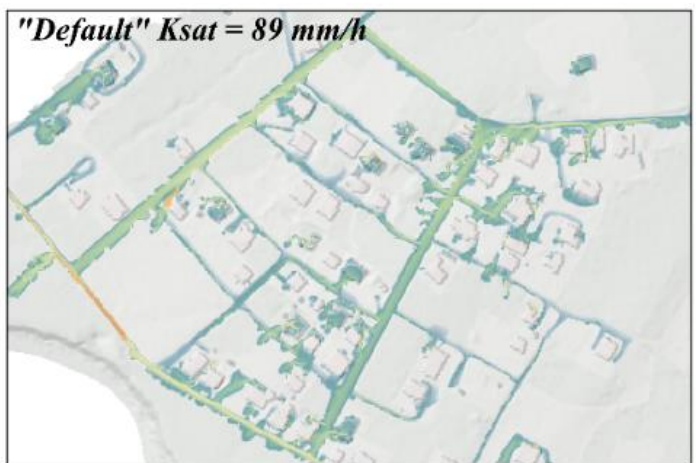
Figure 5.14a: Effects of loam  $K_{sat}$ . For "SWR", runoff from roads was able to flow overland slightly further before infiltrating completely. With "Low", small amounts of runoff could be generated well outside the subdivision, and runoff from paved surfaces did not appear to infiltrate much.

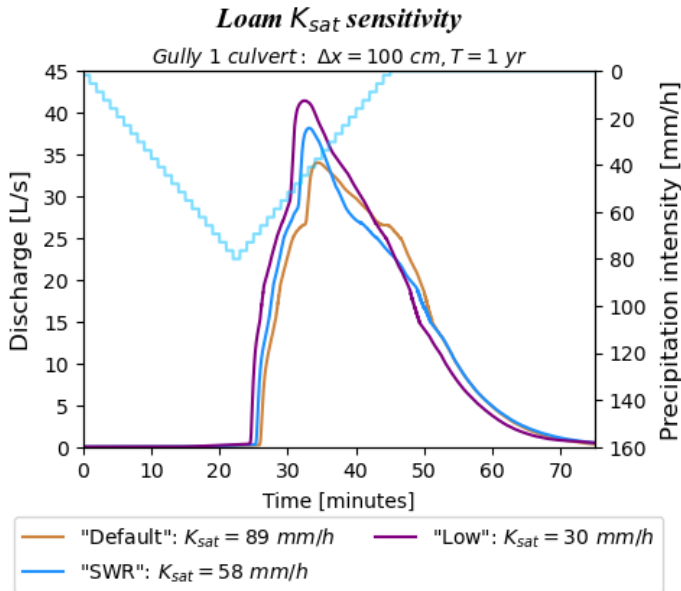
Figure 5.15: Effects of loam  $K_{sat}$ . With decreasing loam  $K_{sat}$ , the flood wave arrived and peaked slightly earlier, and peak discharge also became higher.

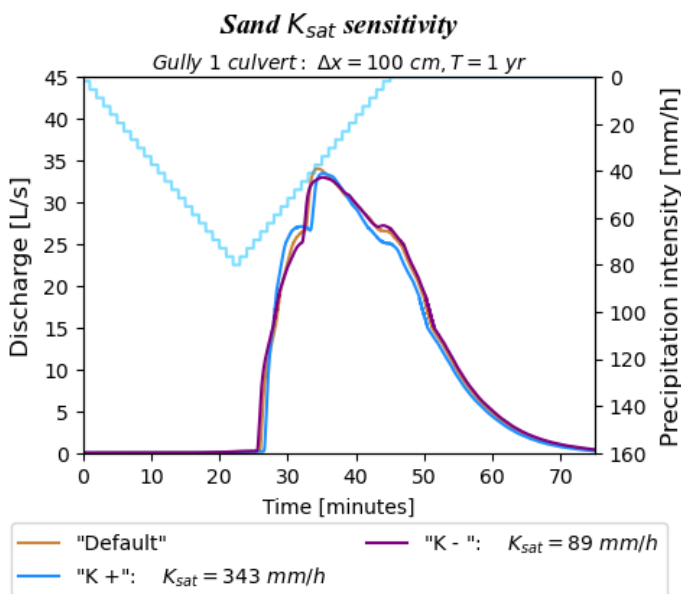
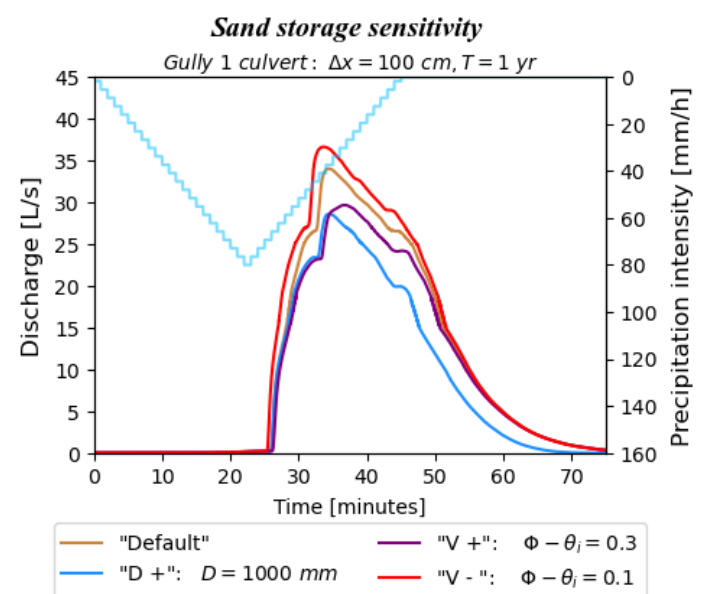
Figure 5.16: Effects of sand soil parameters. Hydrographs at the culvert of gully 1, for model runs with different channel sand hydraulic conductivities (left) and different storage capacities (right). The effects of the different hydraulic conductivities were very limited. In comparison, small changes in initial soil moisture had a much larger effect on peak and total discharge. Initially, the difference between “V-” and “D+” was small, but after the peak, the discharge rate decreased faster for “D+”.

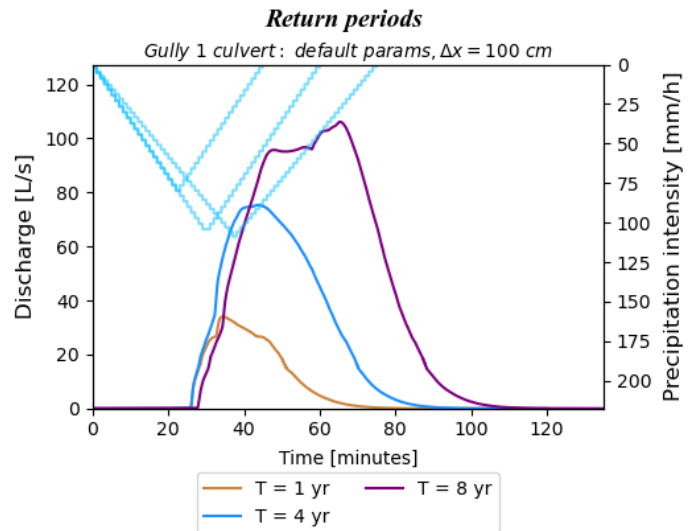
Figure 5.18: Effects of storm intensity. As could be expected, the peak and total discharge increase with storm intensity and duration. For  $T = 8$  yr, a second peak occurred after the loam topsoil became saturated and started to contribute runoff.

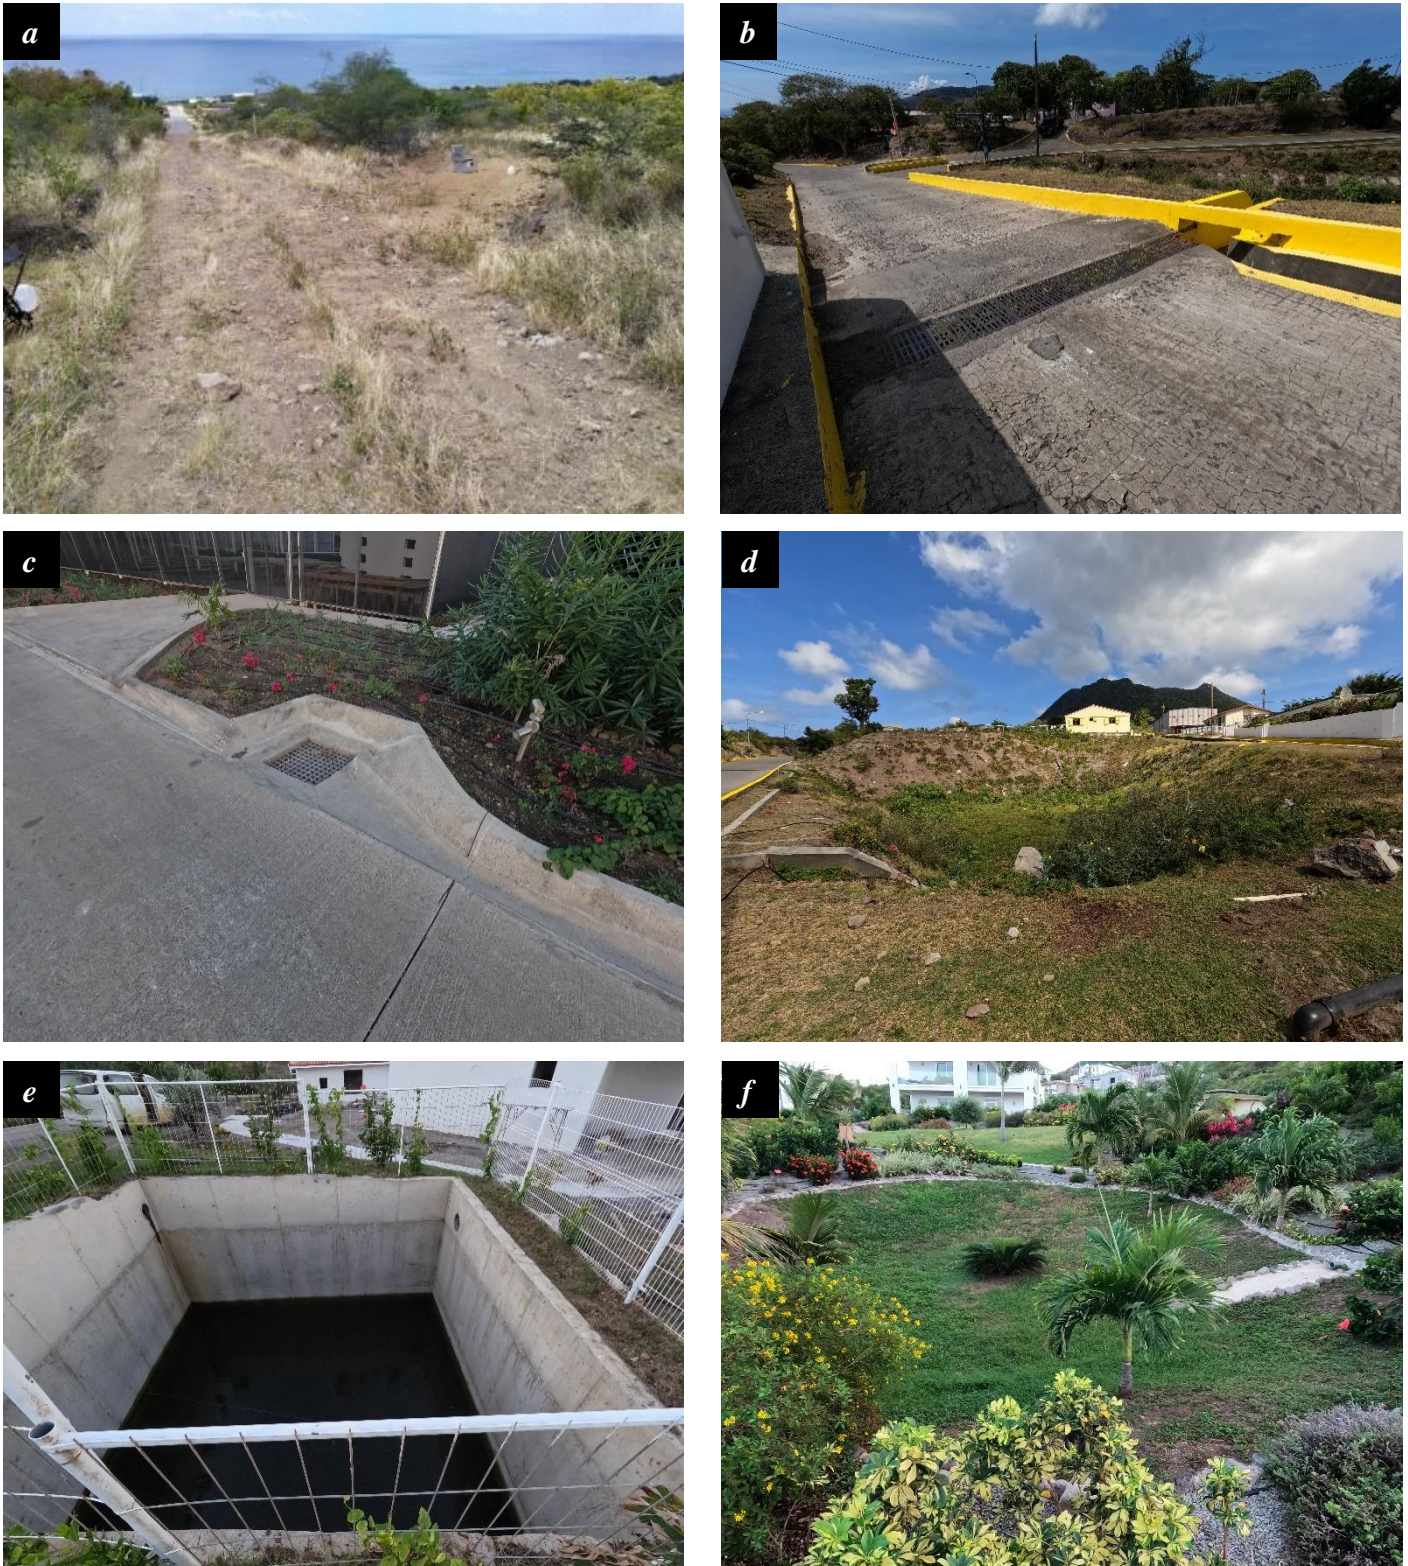
Figure 6.1: Some existing water management applications on Sint Eustatius. a. Infiltration pit at the side of an unpaved road; b. A linear drain followed by a speed bump. It discharges directly into an infiltration basin; c. A roadside storm drain; d. Large infiltration basin; e. Runoff storage facility; f. Small bioswale / infiltration basin. These photos are also included in **APPENDIX 4**.

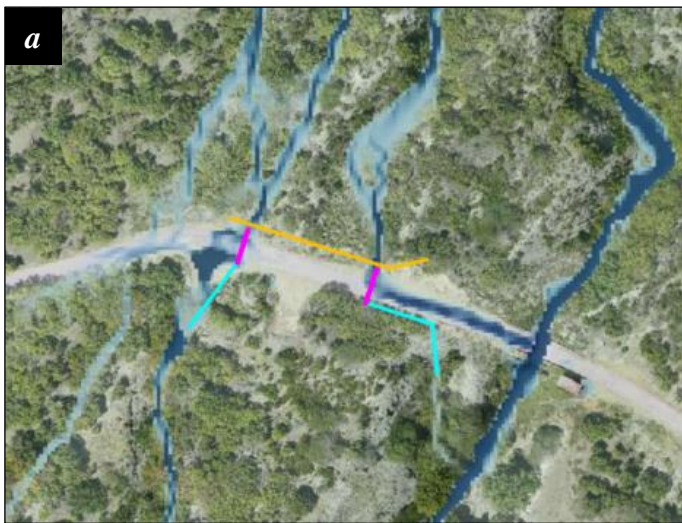
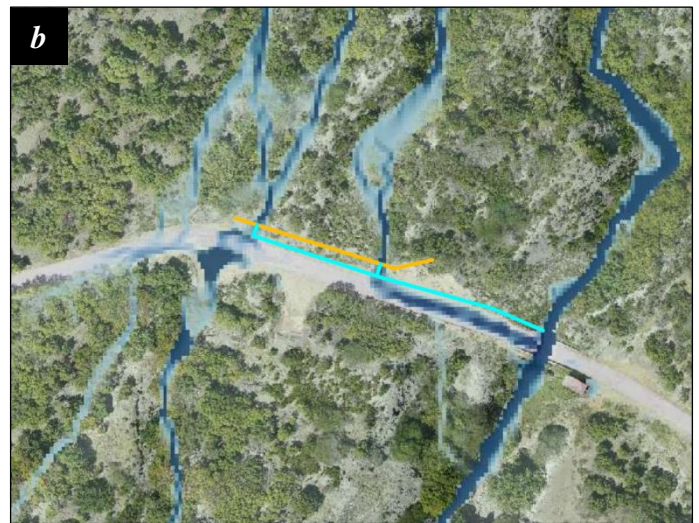
Figure 6.4: Possible drainage layouts for the active gullies. a. Two new culverts below Weg near White Wall for gully 2 and gully 3. A retaining wall at the upstream side should prevent runoff from circumventing the culvert. Protected outlets guide the runoff towards the downslope gully sections; b. Rerouting towards gully 1. A retaining wall concentrates the runoff towards channels that guide the water to the culvert of gully 1. These maps are included on a larger size in APPENDIX 4.

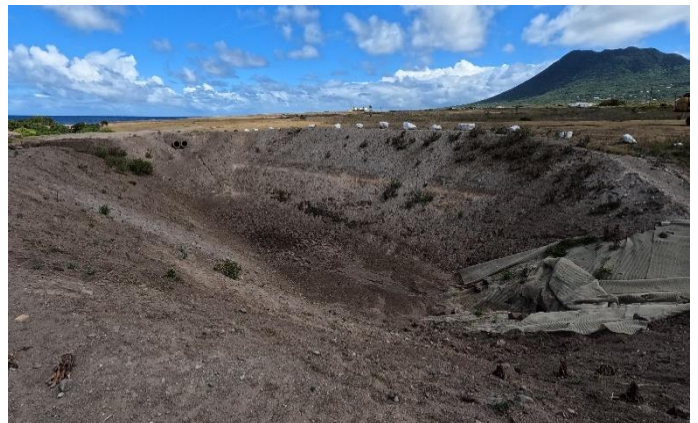
Figure 6.5: Large infiltration basin created inside a gully. Erosion by inflowing water is controlled with a geotextile. A spillway is installed in the dam at the downstream end of the basin. This photo is included in APPENDIX 4
