Petit Buëch River Dynamics and Bank Erosion

Analysis by Using Photogrammetry and LIDAR data between 2014-2023

Sercan Yilmaz, s.yilmaz1@students.uu.nl

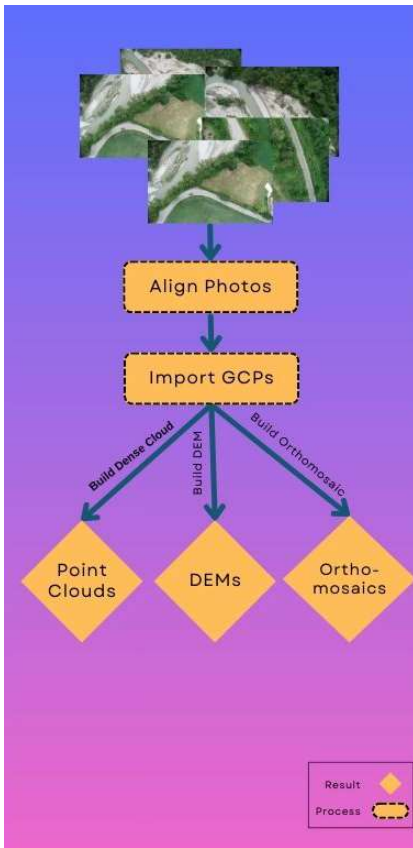
Figure 7: General steps of generating data through Agisoft Metashape

Bundle adjustment also makes sure that the cost function is kept to a minimum (Zhang et al., 2006). In order to analyze two-dimensional (2D) and three-dimensional (3D) morphological changes of the surfaces, the SfM approach produced point clouds, DSMs, and OrthoMosaics, which can provide highly valuable data in many different large- and small-scale investigations (Akay et al., 2019). The acquired UAV photos will be processed into a Digital Elevation Model (DEM), Point Clouds and OrthoMosaic (Figure 7) using Agisoft Metashape Professional utilizing SfM (Agisoft, 2023). These models for every mentioned year will be georeferenced based on all markers identified in the images. Only taking into consideration sharp, non-blurred, overhead angles aerial images captured by UAVs will be used. Marked specific points in these images and their positions were accurately measured using RTK-GPS. To create a coherent 3D model, alignment process is carried out. This alignment process produced a sparse point cloud after removing any obviously incorrect points from it. Subsequently, scaling up this sparse point cloud to generate a high-quality dense point cloud consisting of millions of points is another step. From this dense point cloud, a detailed surface mesh is created. This mesh is then further refined to produce a georeferenced Digital Elevation

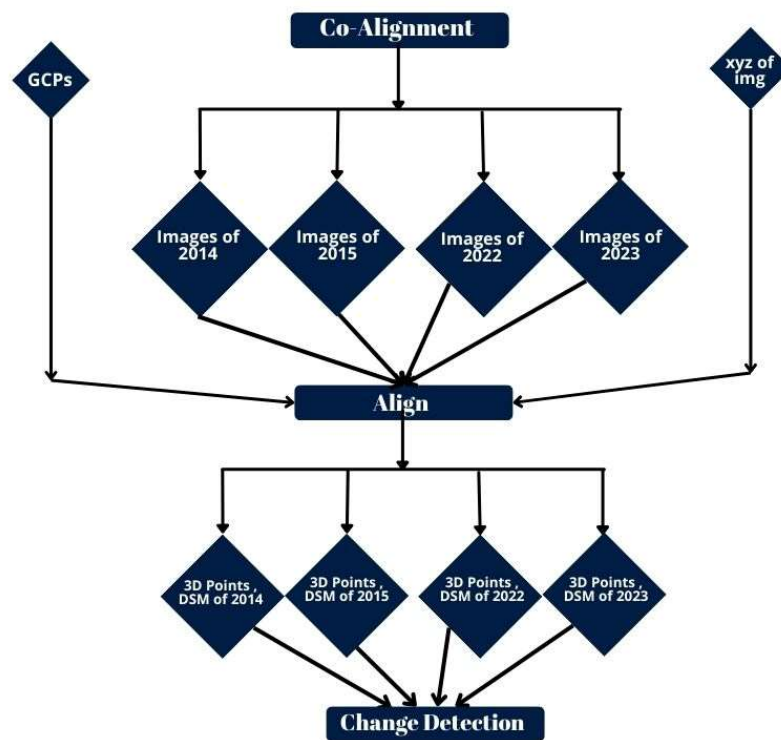
Figure 9: Flow chart of Co-alignment process (Nota et al., 2022)

The primary aim of co-alignment is to enhance the accuracy of Digital Surface Models (DSMs) generated through Unmanned Aerial Vehicle Structure-from-Motion (UAV-SfM) photogrammetry. And, co-alignment is also a robust method for comparing point clouds in change detection (Saponaro et al., 2021). Co-alignment is utilized to create multi-temporal models by processing UAV imagery from multiple surveys as a single block during the alignment step (Feurer & Vinatier, 2018). After alignment all of the images together, they are separated to blocks again for further steps (Figure 9). This method aims to improve the relative

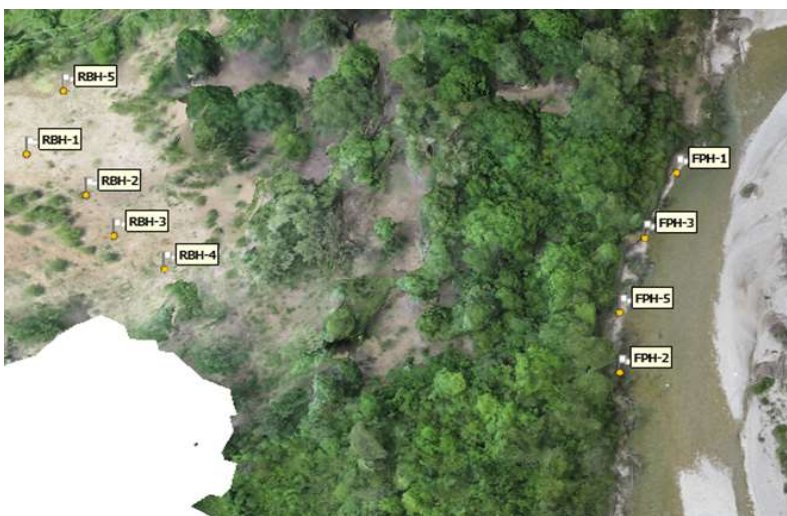
Figure 12: Points chosen for representation of river bank and floodplain height for the eroded area between 2015-2014

vegetation cover, toppled trees and shrubs in the river. Thus, 5 points outside of the vegetated area for river bank height and 5 points for floodplain height were taken into account and averaged in order to decrease inaccuracies. Furthermore, choosing appropriate points process should be carried out carefully in order to represent intended surface .River banks height points were chosen by taking being close to the

eroded area into consideration. Floodplain height points were selected out of area including toppled trees and shrubs. Figure 12 indicates the points defined by with these rules. The former is 701,88 m. \pm 0,12 m. and the latter is 699,93 m. \pm 0,08 m. for differences between 2015 and 2014(Figure 13). After these ,eroded volume between 2015 and 2014 was assessed obeying this rules. Figure 14 indicates a blue dashed area west of the river that was eroded in the 2015 image. The dimensions of the eroded area are approximately 170m up to a maximum of 45m perpendicular on the channel. The total eroded volume is approximates 6040 m³ \pm 492 m³ and its surface area is 3473 m².

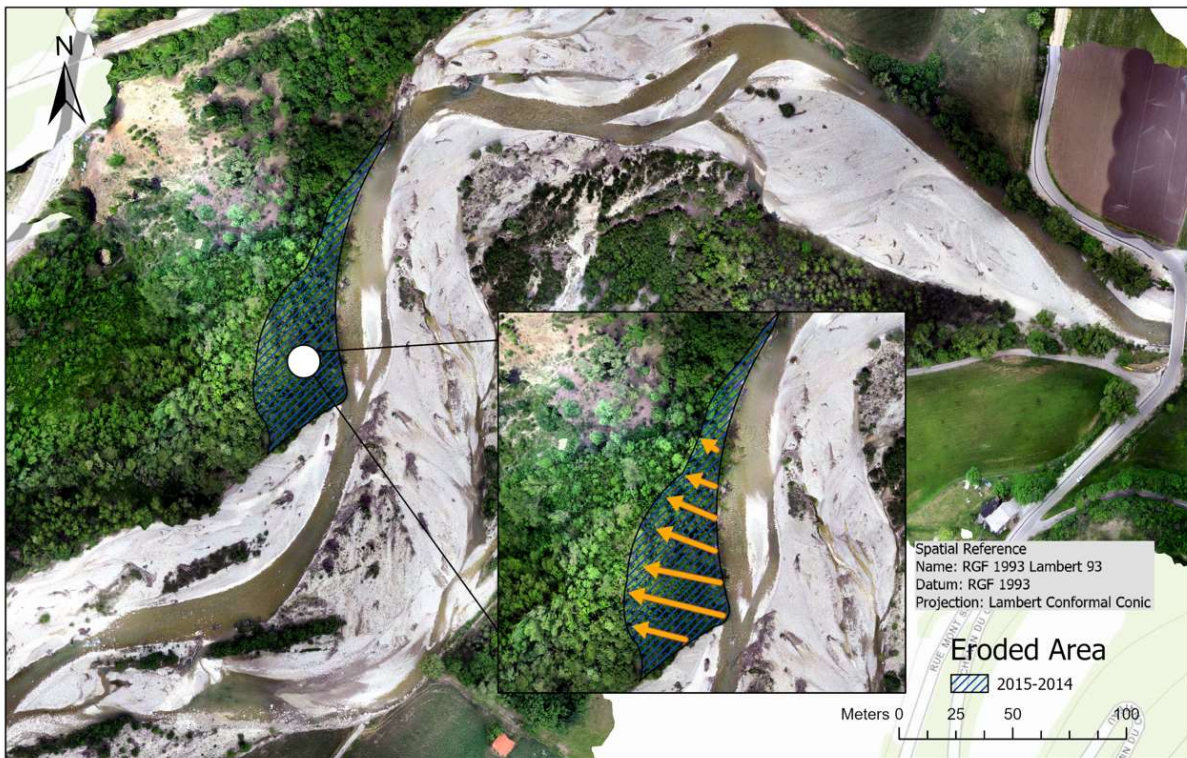
Figure 14 : Total eroded area between 2015 and 2014 , which is approximates 6040 m³ .

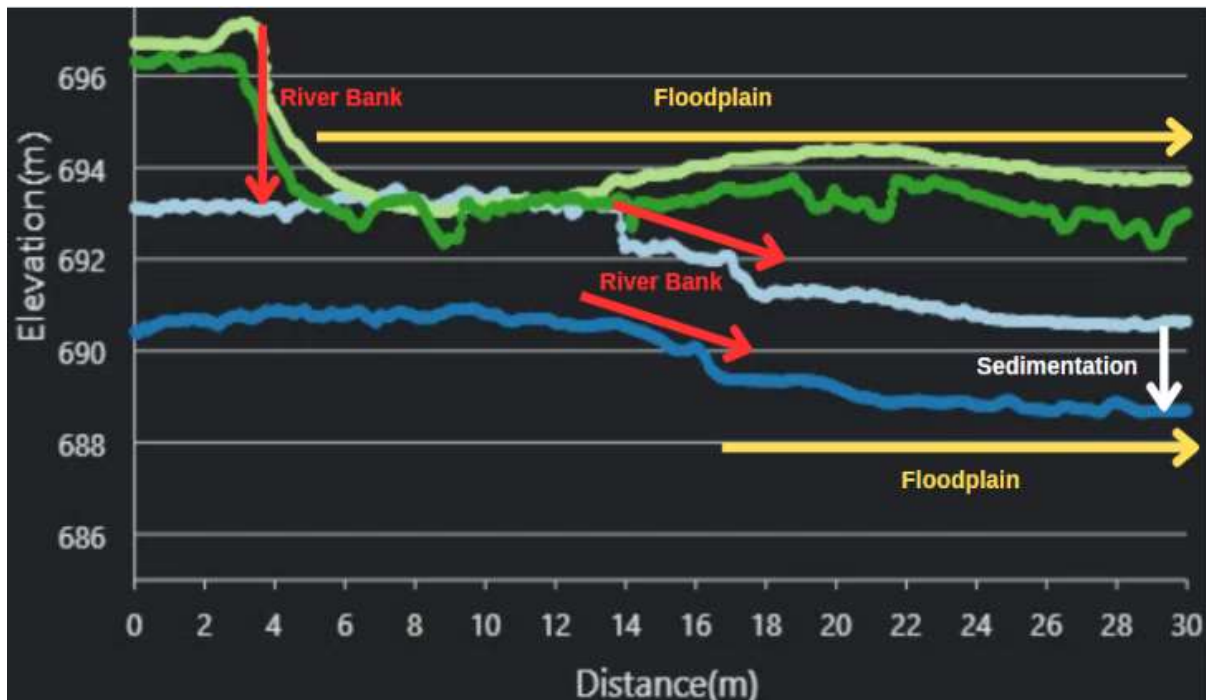
Figure 19 : Interpretation of profiles

Firstly , it should be known how interpret the profiles. Sharp elevation differences indicates river bank as the profile lines encounter considerable elevation decrease when passing through river bank(Figure 19) .After identifying river bank location , amount of retreatment can be calculated by subtracting river bank location between years. Furthermore , floodplain is represented relatively flat line after river bank. Sedimentation is also estimated comparing elevation differences between floodplain(Figure 19). Furthermore ,at the upper left of profile (Figure 20A) around 2 meters of sediment was deposited between 2015 and 2014 . However, there are relatively small deposited sediment monitored between 2023 and 2022. It is also evident that there is 12 meters retreating on the river bank as sharp elevation differences compared . Although, there is significant decrease at the 2 meters distance of profile in the 2023 and 2022 , relatively smooth decrease is observed at the 2015 and 2014 at 14 meters distance of profile. In addition , river bank height declined around 2 meters between 2015 and 2014 while there is around 15 cm decrease between 2023 and 2022. This patterns is same for profile B(Figure 20B). When it comes to the lower left(C) and right of profile(D) (Figure 20C-D), there is around 20 meters shift in the river banks. Whereas, river bank height fell of around 2,5 meters between 2015 and 2014 , there is also 1 meter drop between 2023 and 2022. Sedimentation is also observed in these profiles around 1.5 meter in both profiles and compared years. Additionally, there is a sharp rise in profile C at the 24 meters of distance since one of the small tree lead increase in the DEM(Figure 20C).Nevertheless ,these analyses cannot be carried out along the entire river as vegetation cover on the river bank and tumbled trees in the channel hamper an open view and complicate the identification of bank erosion , which problems also addressed by Tamminga et al., (2015). Complete identification of bank erosion is only possible in open, vegetation free sites.

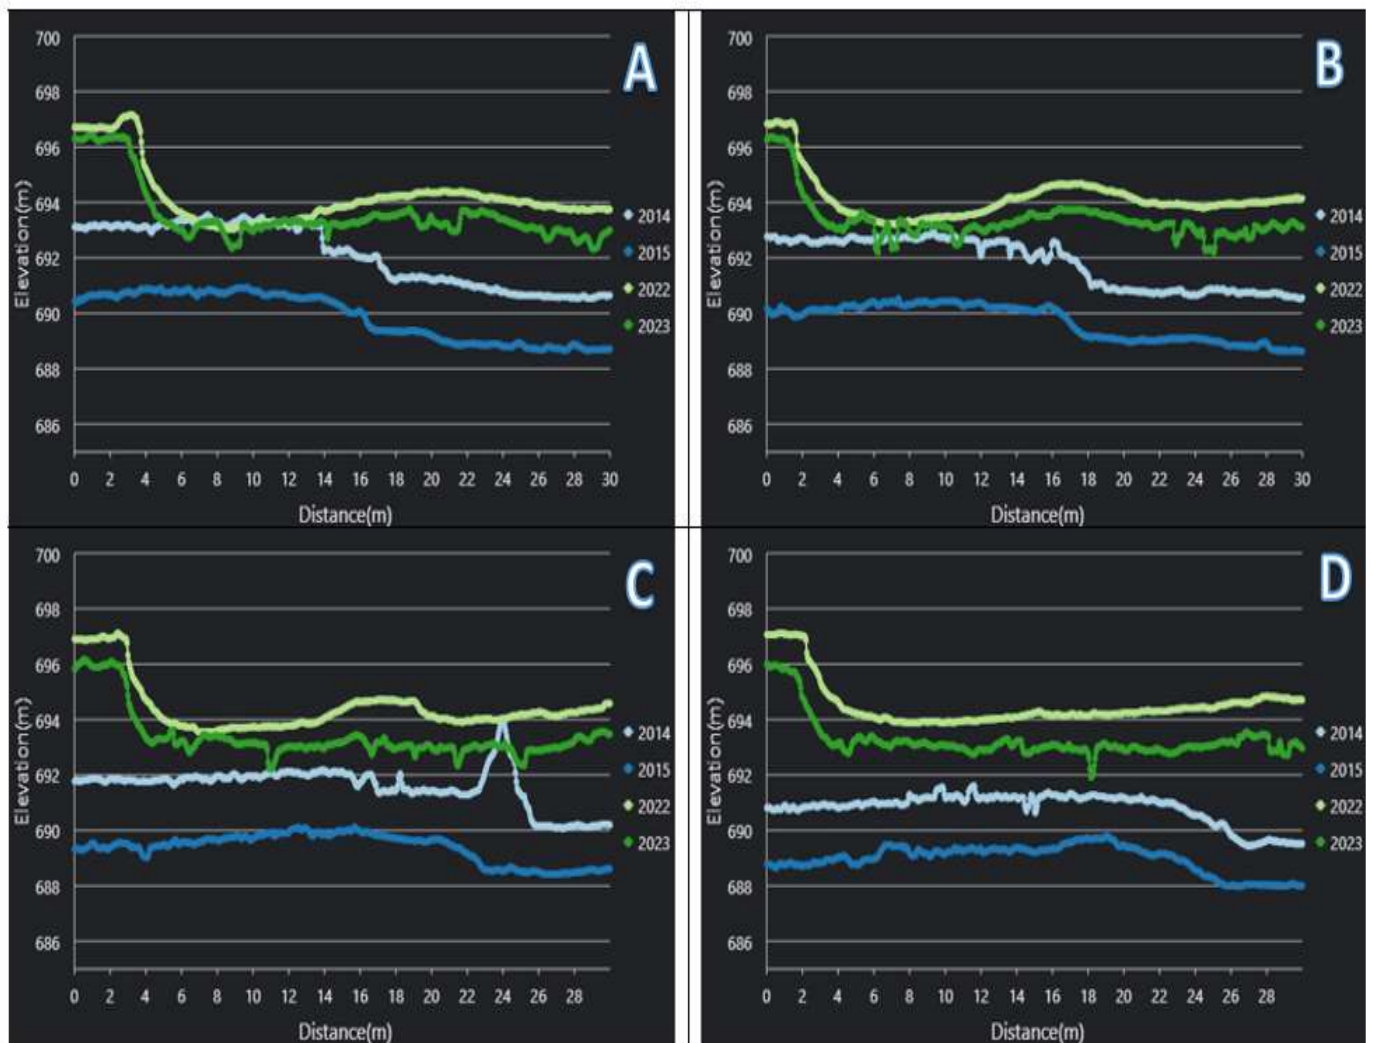
Figure 20 : Elevation profiles for the four transects (A to D) in every year.

Figure 20 shows the elevation profiles for these four transects derived from the DEMs, color of every line represents different years. Fig. 18B-E shows deepening of the channels and retreating river bank. Channel depth is not certainly defined because of the glitter and mirroring effects of the water. However ,active ongoing sedimentation and erosion processes can be easily seen in the profiles and OrthoMosaics. Thus, the retreating banks are clearly visible in the four transects.

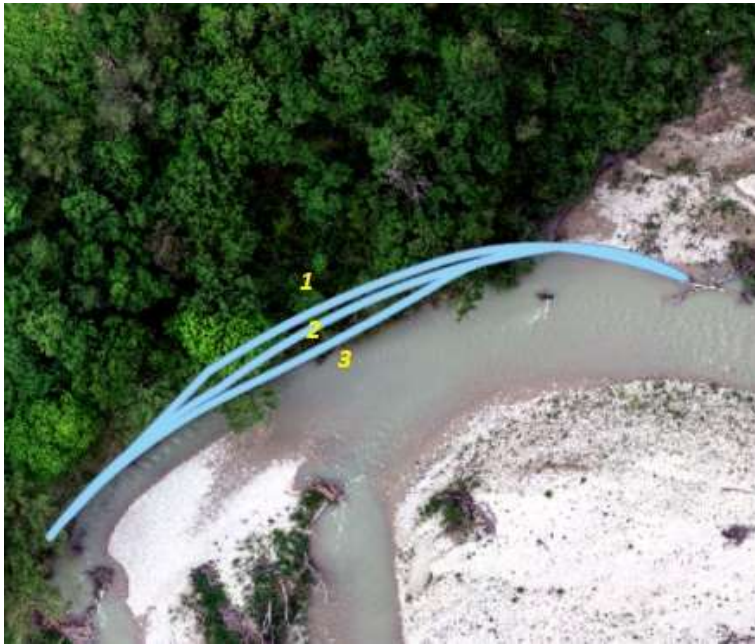
Figure 37 : Estimation of river boundary because of hampering by trees

estimating the boundary, as direct drawing of bank lines was hindered by trees growing through the river. Bank line might be estimated as it is shown in *Figure 37* .Even if LIDAR point cloud were taken into consideration to distinguish bank line for 2023 , it is not possible to draw actual bank line. This problem is also encountered at the location of bridge. Even though estimated bank lines were drawn , there is not considerable differences observed (*Figure 38*). Thus , it can be deduced that there is not problematic situation occurred in this location.

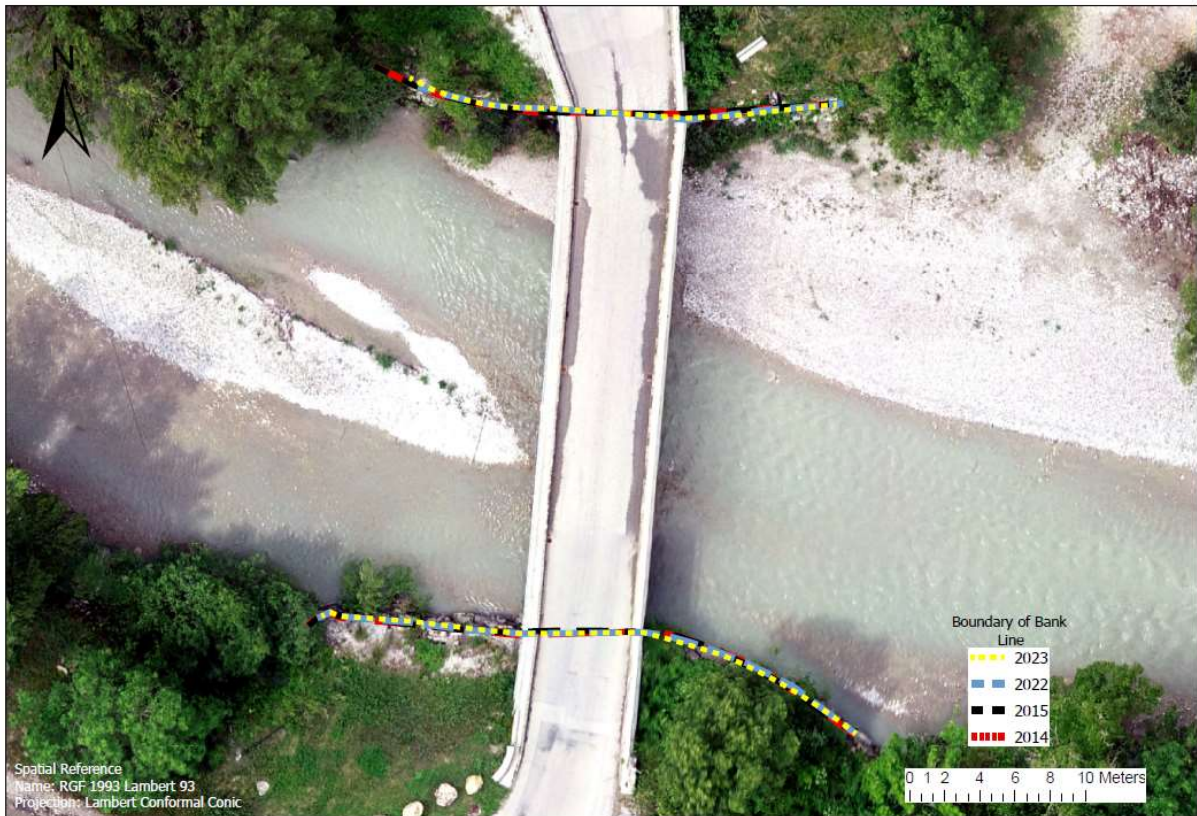
Figure 38 : Bank lines at the location of bridge in every year , represented on Orthomosaic of 2023

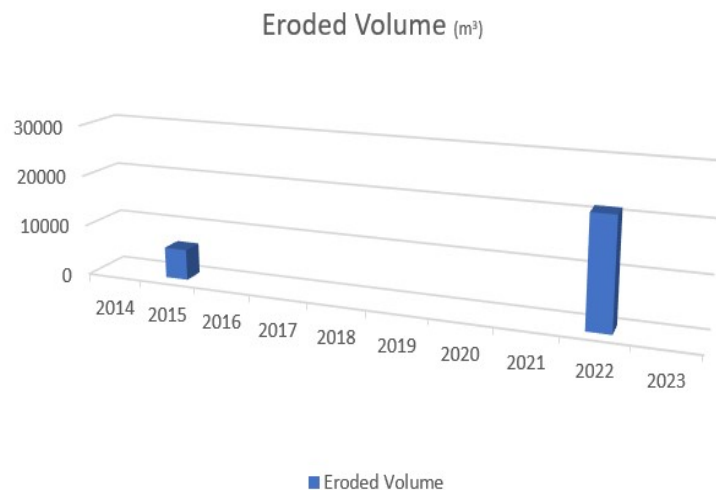
Figure 39: Eroded volume graph to show disconnected volume values
